Column Tests

In order to evaluate the effect of fabric formwork on structural behaviour of a column, full size fabric-formed and conventionally formed reinforced concrete columns were designed and tested to failure under concentric axial load. The variables in these tests were two types of formwork; permeable fabric versus cardboard and two types of concrete; Flyash concrete and normal concrete. The fabric of choice was Geotex 315ST due to its better surface finish.

Permanent link:
http://fabwiki.fabric-formedconcrete.com/doku.php?id=fabwiki:research:canada:delijani:chapter_5

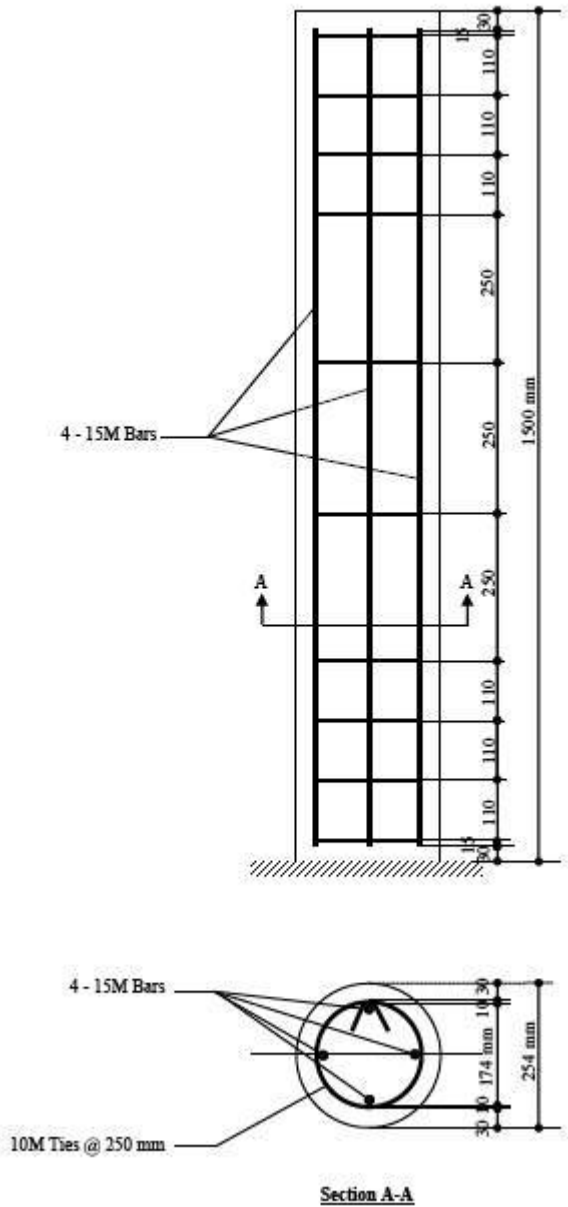
All columns had 254 mm radius and the column height was limited to 1500 mm. Based on calculations, four 15M bars were considered as the longitudinal bars, tie size was selected as 10M and tie spacing(s) was calculated as 250 mm (center to centre) and tie hooks, were set as 135 degrees. Arrangement and configuration of the reinforcement in the column has been shown in Figure 42.

Figure 42: Column reinforcement details.

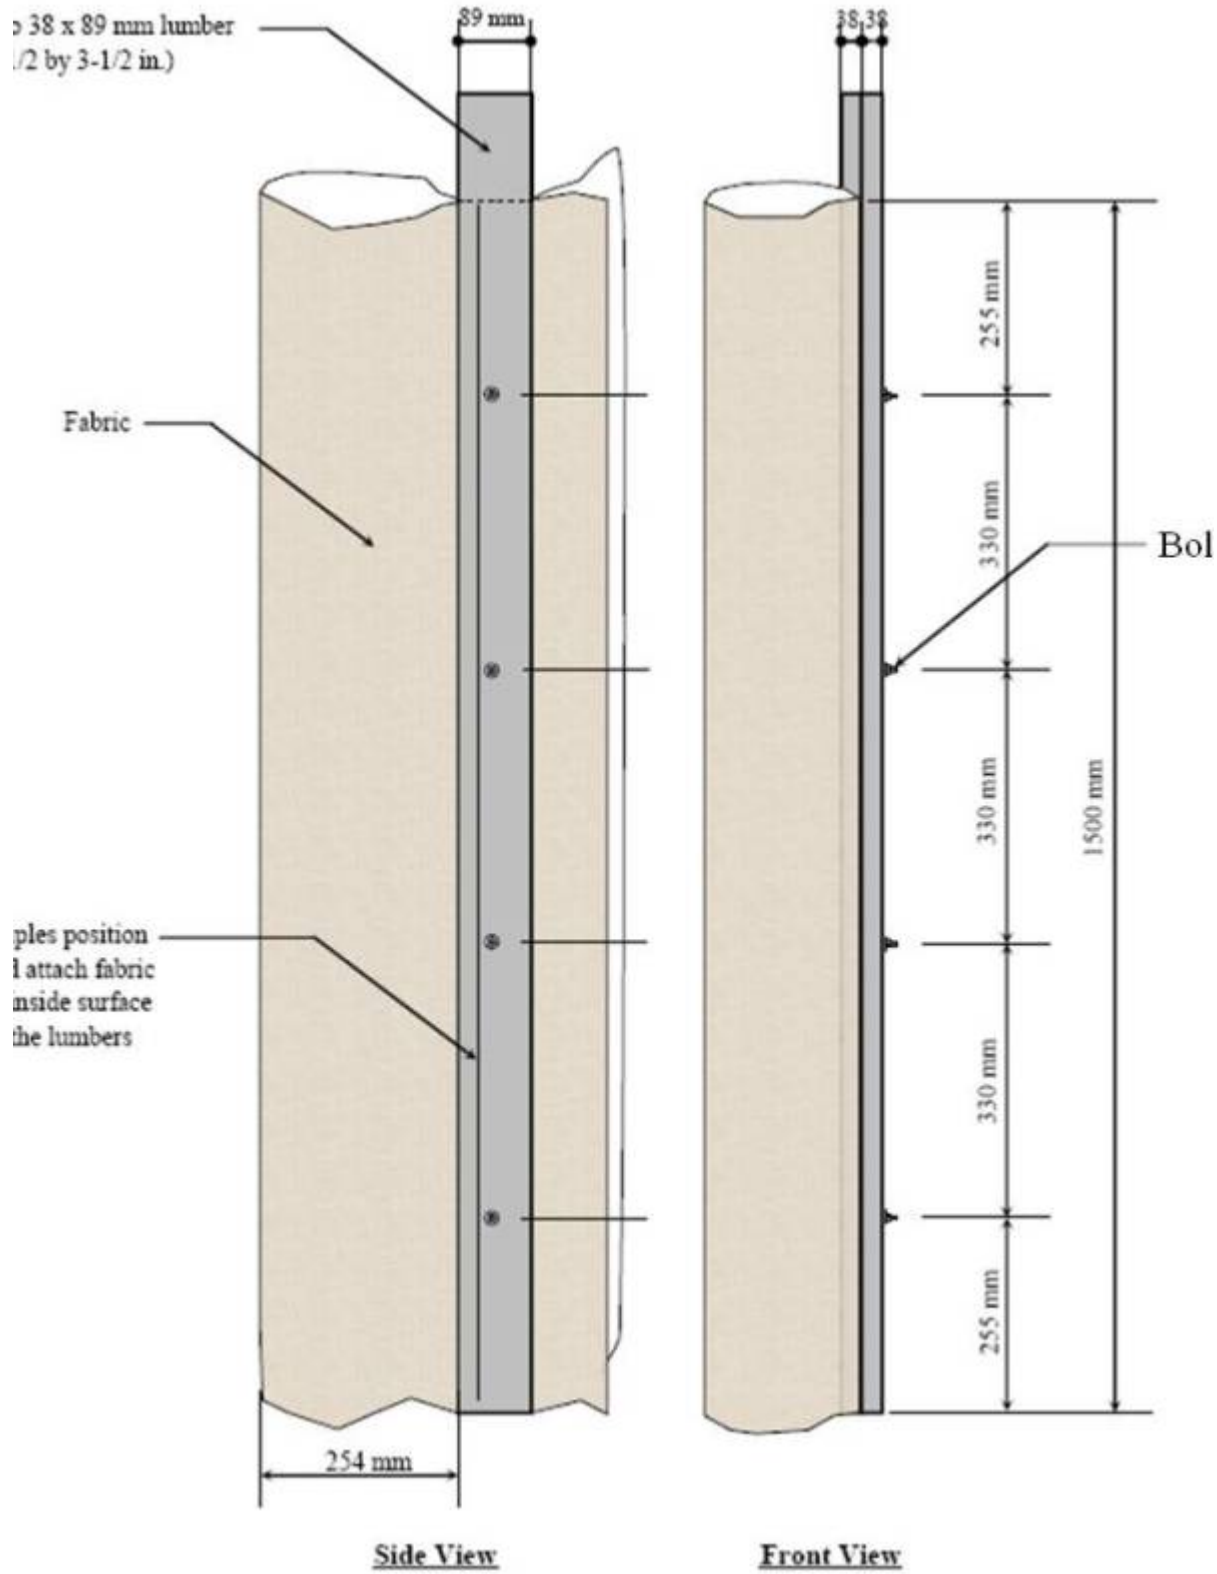
batch. The columns were cast using normal concrete and flyash concrete. Total of 6 columns were cast. As shown in Figure 43, the formwork was essentially the same as that used to cast the earlier cylinder specimens. The formwork was made of a single, rectangular, piece of fabric sandwiched between two vertical pieces of 38 x 89 mm lumber (2" by 4"). The fabric was first fitted to create the proper diameter and stapled to the lumber pieces.

Figure 43: Configuration of the fabric formwork for reinforced concrete column.

from each other (though less staples would be probably also sufficient), providing a stitch line from top to bottom of the formwork. Orientation of the stitch line can be seen in Figure 43. Stapling provided an even distribution of the hoop forces along the height of the formwork and resulted in a uniform cylindrical geometry. The variation in diameter of the column along its length was dramatically reduced as demonstrated in Figure 68.

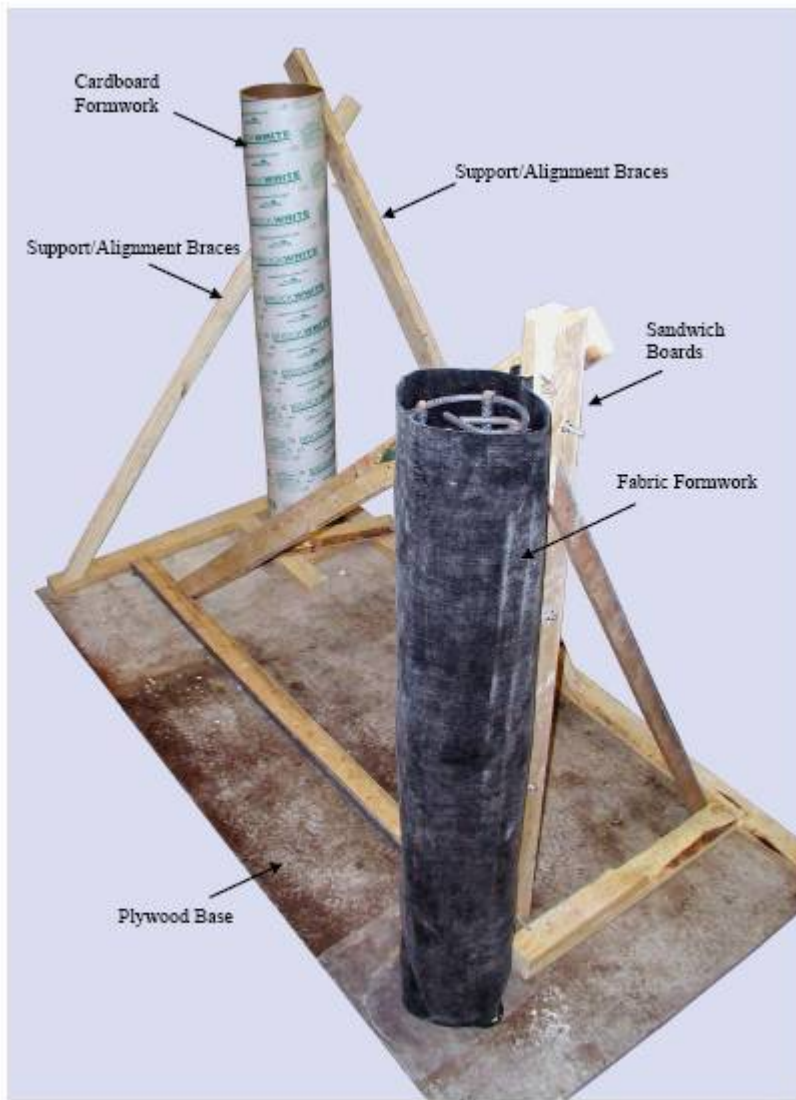
After that, the wooden pieces were bolted together in four locations along the length of the formwork to make the closure of the formwork as a cylindrical vessel. Figure 44 shows the finished formwork set up for both cardboard and fabric formworks. Both formworks were supported in a vertical position by diagonal braces in two directions for lateral support. Plastic spacers (PVC chairs) were installed beneath the reinforcement cages in order to create a 30 mm space between the longitudinal bars and ties and the bottom of the columns. The cages were centered and then fixed to the wood floor using handmade aluminum braces in order to avoid possible movements of the reinforcement cage during the casting as shown in Figure 45.

Figure 44: Setup for reinforced concrete columns formed with fabric and...

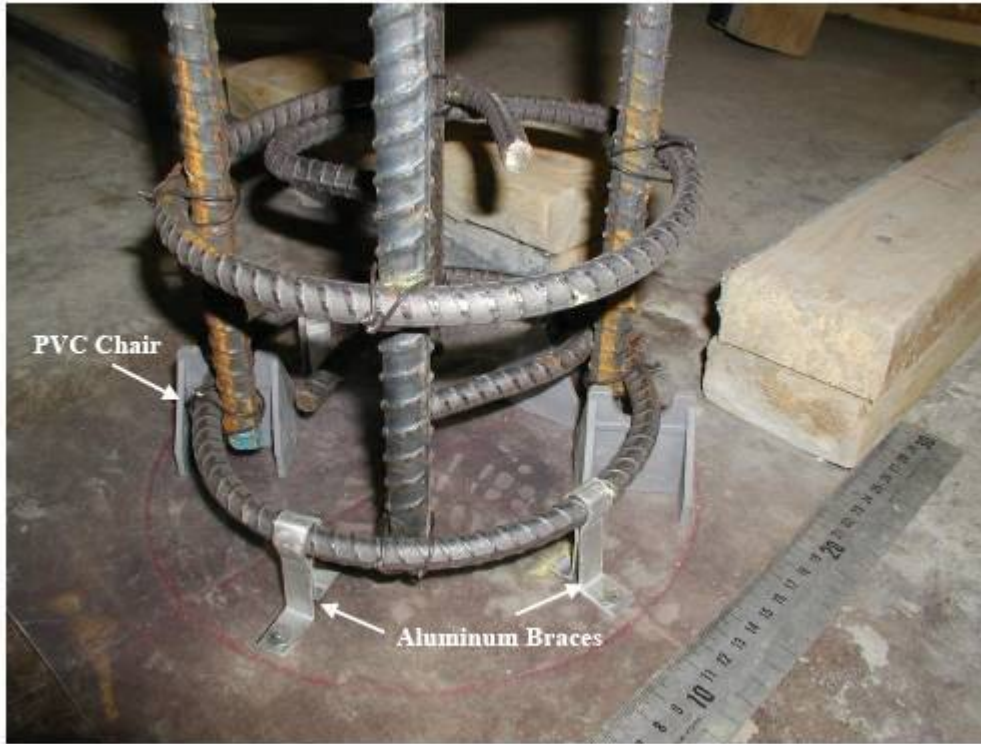
Figure 45: Details of the bottom of the column.

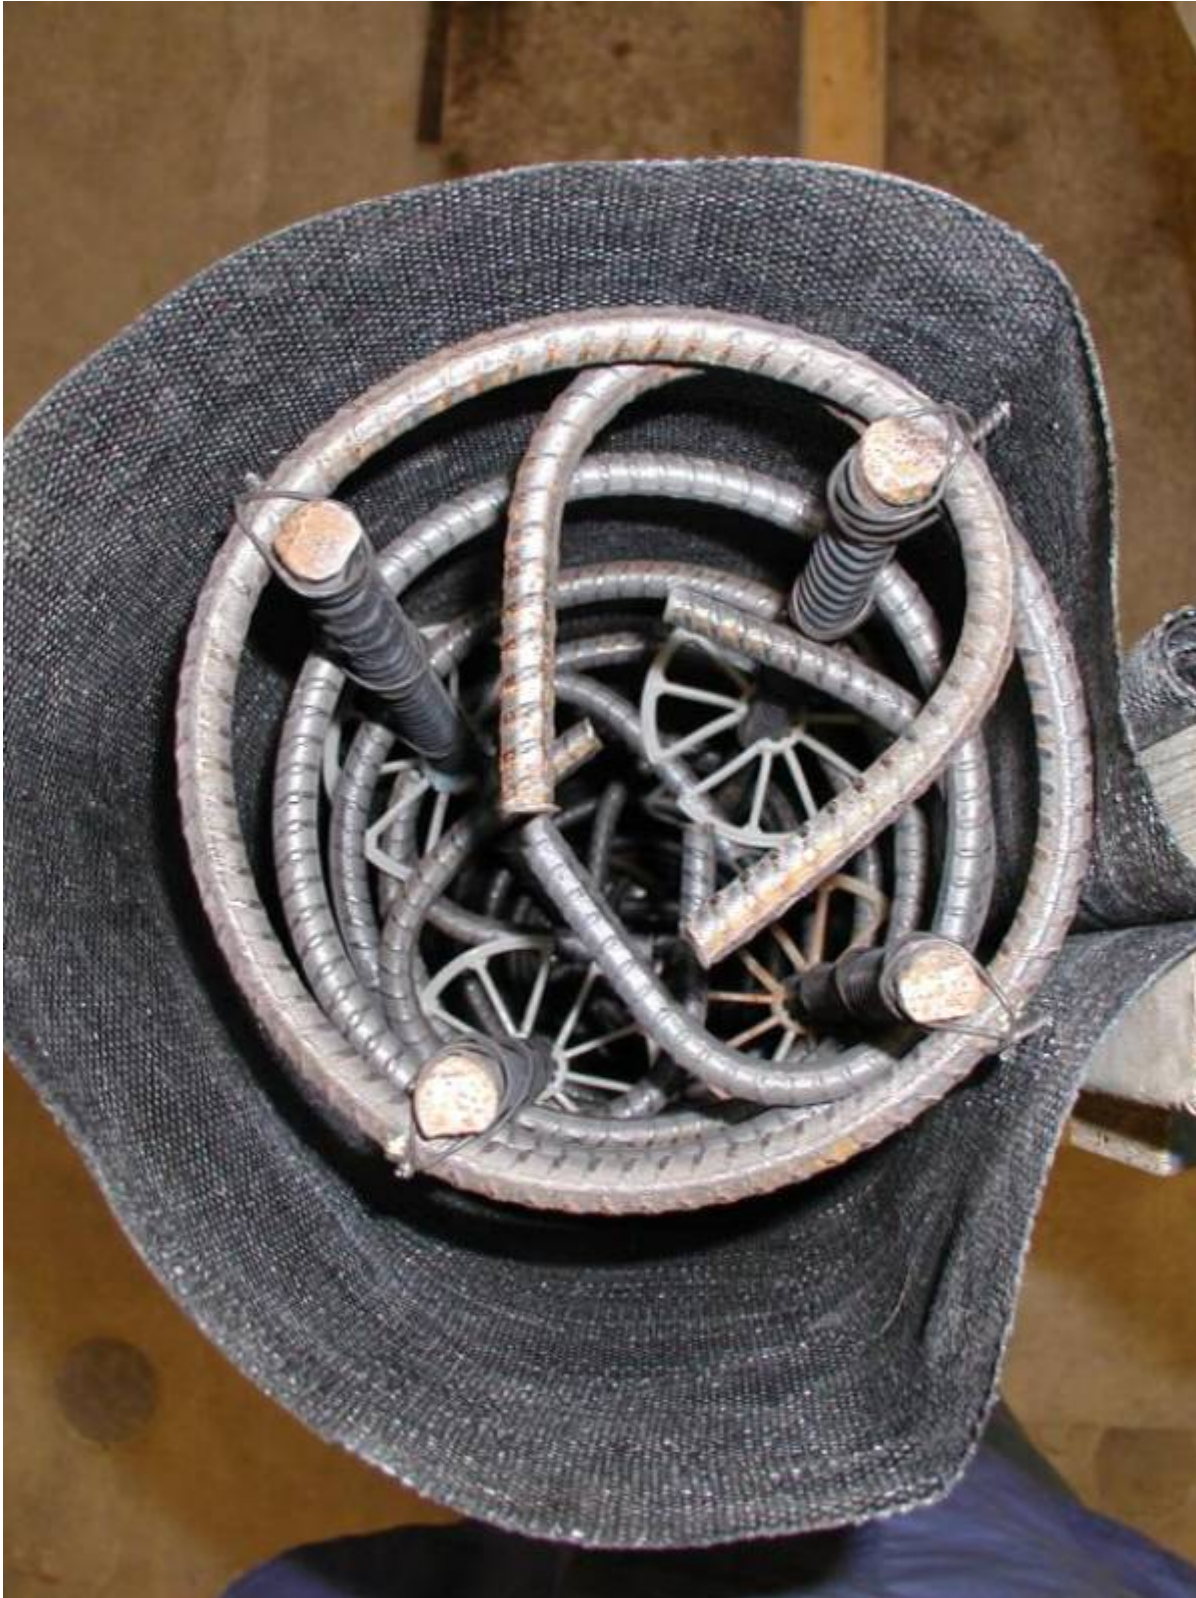
«fs medium>The cover distance between both fabric and cardboard formworks was maintained by using plastic wheel spacers on the longitudinal bars. These spacers were also used to keep the reinforcement cage in the centre of the formwork during casting as shown in Figure 46.</fs>

Figure 46: Reinforcement cage.

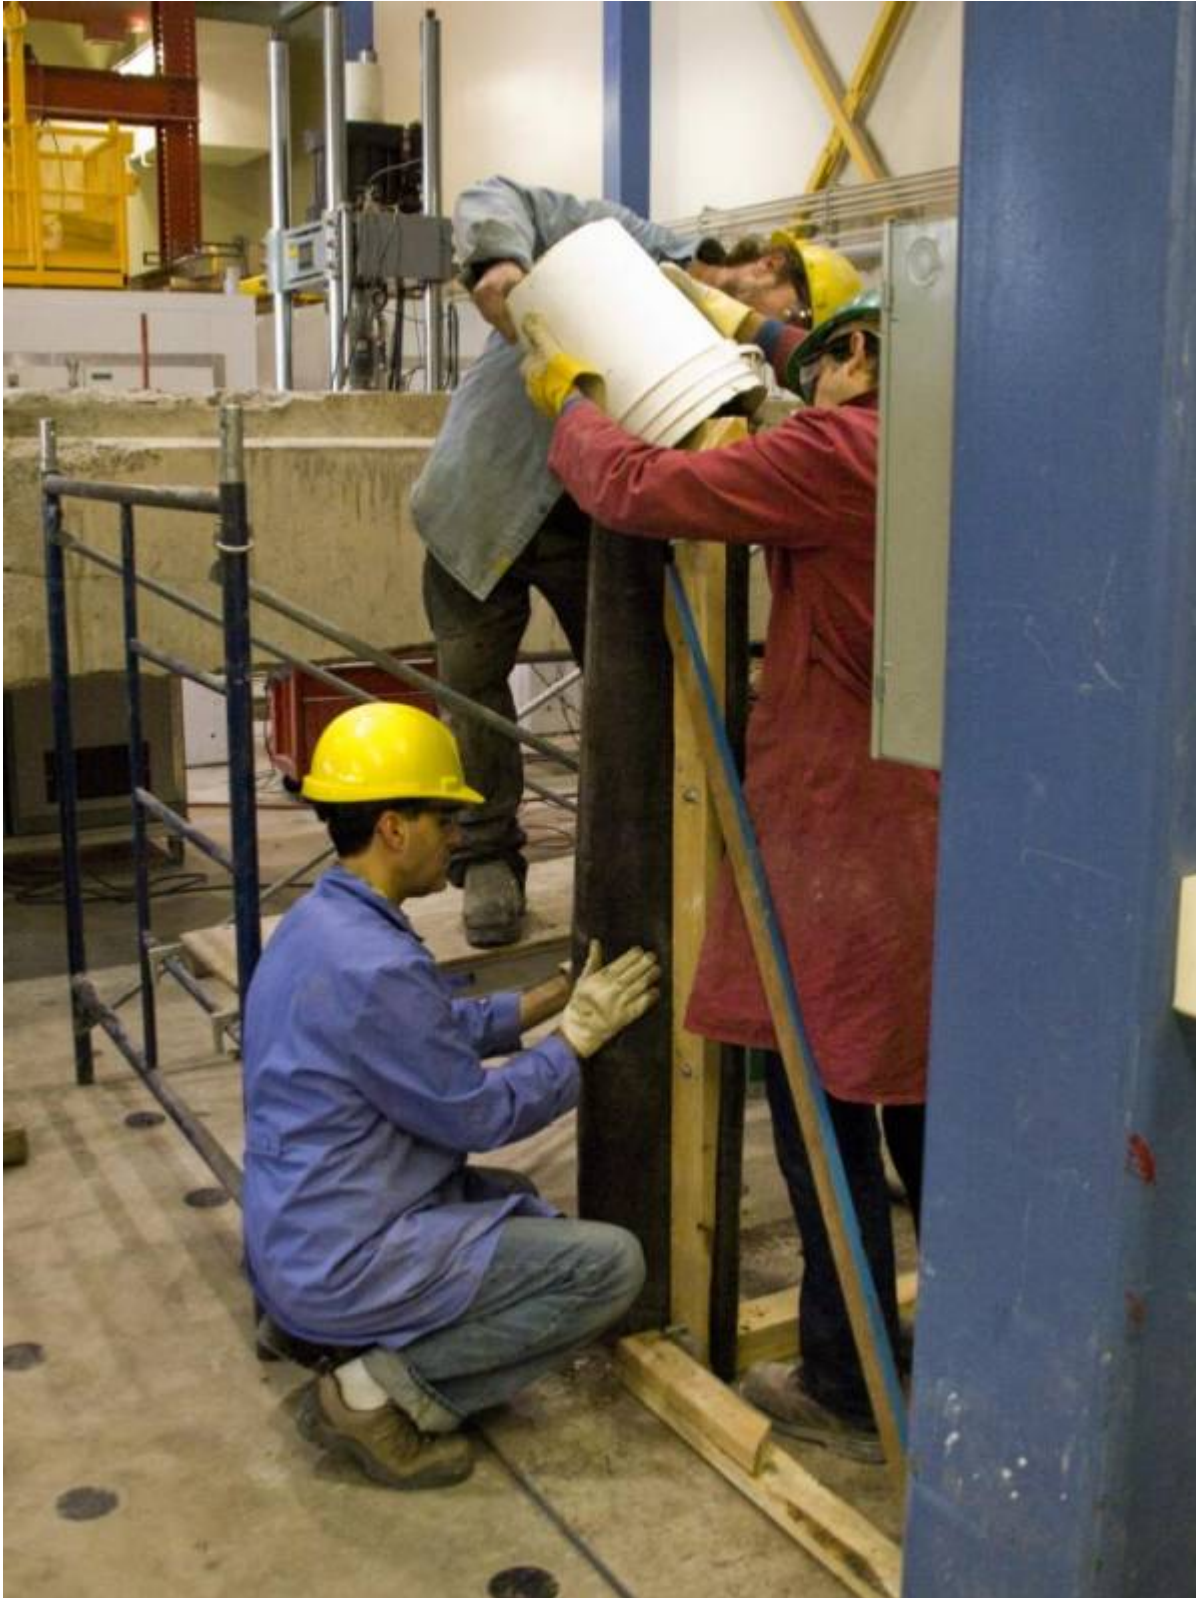
When the concrete was delivered, the slump value was measured and fifteen 101 by 203 mm (4 by 8 in.) PVC control compressive strength test specimens were cast. Fresh concrete was transferred by hand directly from the truck mixer's discharge chute to buckets and then into the forms as demonstrated in Figure 47. Each specimen was vibrated both inside and outside, using a portable electric internal vibrator at 5 to 15 second intervals. In case of fabric formwork, hand tapping the mold wall was also used to vibrate the concrete and help the bleeding of the air bubbles and extra water from the concrete. All columns and companion cylinders were cured in the same manner. Forms were stripped after one day, after which the columns, as well as the control samples were cured for another 3 days using wet burlap and plastic sheets as vapour barrier cover. Unlike in the cardboard formed columns, no sign of color variation was observed in fabric formed columns. No imperfections such as bug holes or the appearance of large aggregates were seen on the fabric-formed concrete surface. Such column could be easily used as exposed concrete structural members with no necessity for expensive patch ups, epoxy coatings or paintings or architectural veneers.

Figure 47: casting of column in fabric formwork.

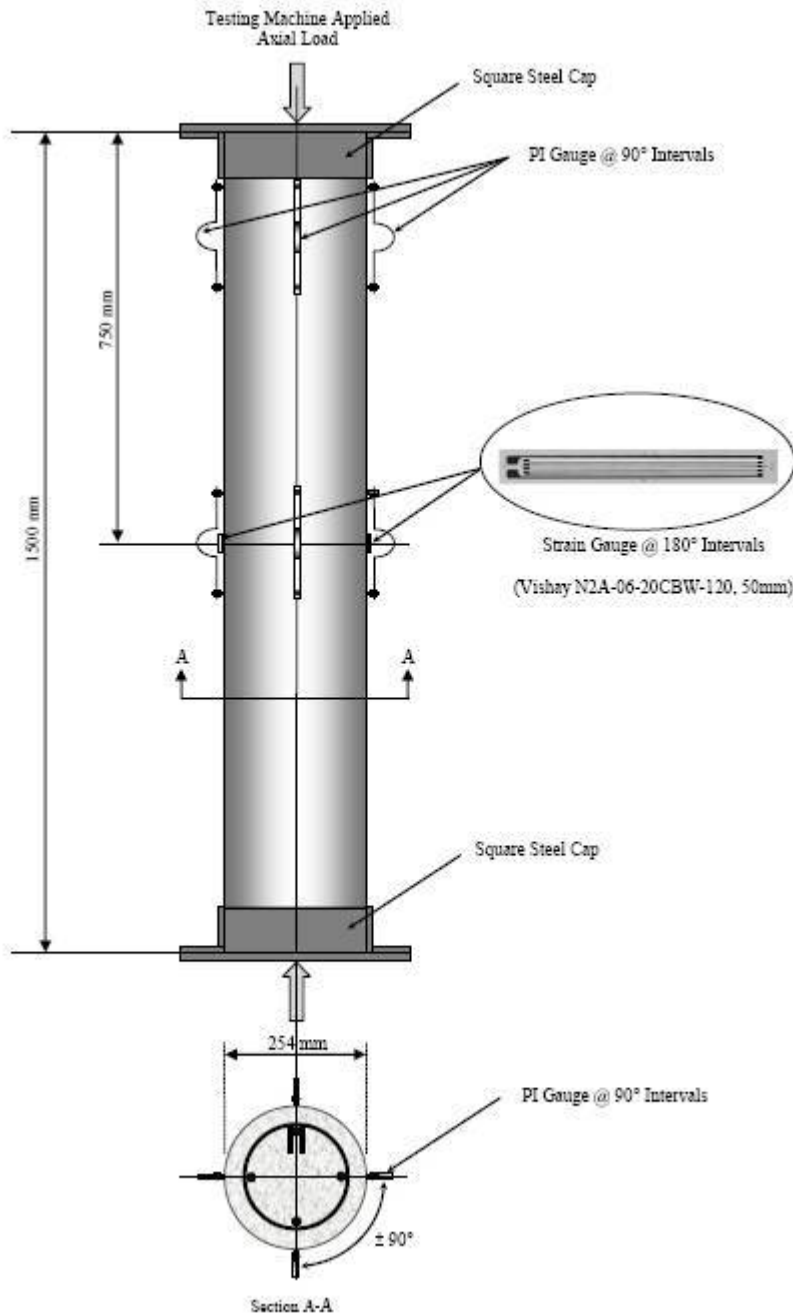
Cured, ready-to-test columns were instrumented at mid-height and top end to measure the longitudinal and circumferential strains under the axial load. To measure circumferential strains, two strain gauges

were installed on mid-height of each column, 750 mm from the top end with a 180 degree interval. The concrete surface was first scrubbed with a grinder before the installation of the strain gauges. Voids were then filled with epoxy. After about one hour, extra epoxy was removed by sanding the surface down. Strain gauges were then attached to the smooth void-free concrete surface using adhesive. Strain gauges were tested for correct resistance after installation using a volt meter. Wires were soldered to the strain gauges and then covered with a protective film of acrylic coating to protect them from possible damage before testing. Except the first two columns (FF-NC-1 and CT-NC-1) which had pi-gauges only on mid-height, a total of eight pi-gauges were in-stalled on each column. Four pi-gauges were placed on mid-height and four at the top end of each column to measure the displacement over the initial 200 mm length of the pi-gauges as shown in Figure 48. A Data Acquisition System (DAQ) was used to record the information gathered from 11 channels coming from the column instrumentations and testing machine (8 channels for the pi-gauges, 2 channels for the strain gauges and one channel for the load applied to the columns by the machine). Strain and pi-gauges were all tested for proper resistance and calibration just before every test session.

Figure 48: Configuration of the instrumentation of the concrete columns.

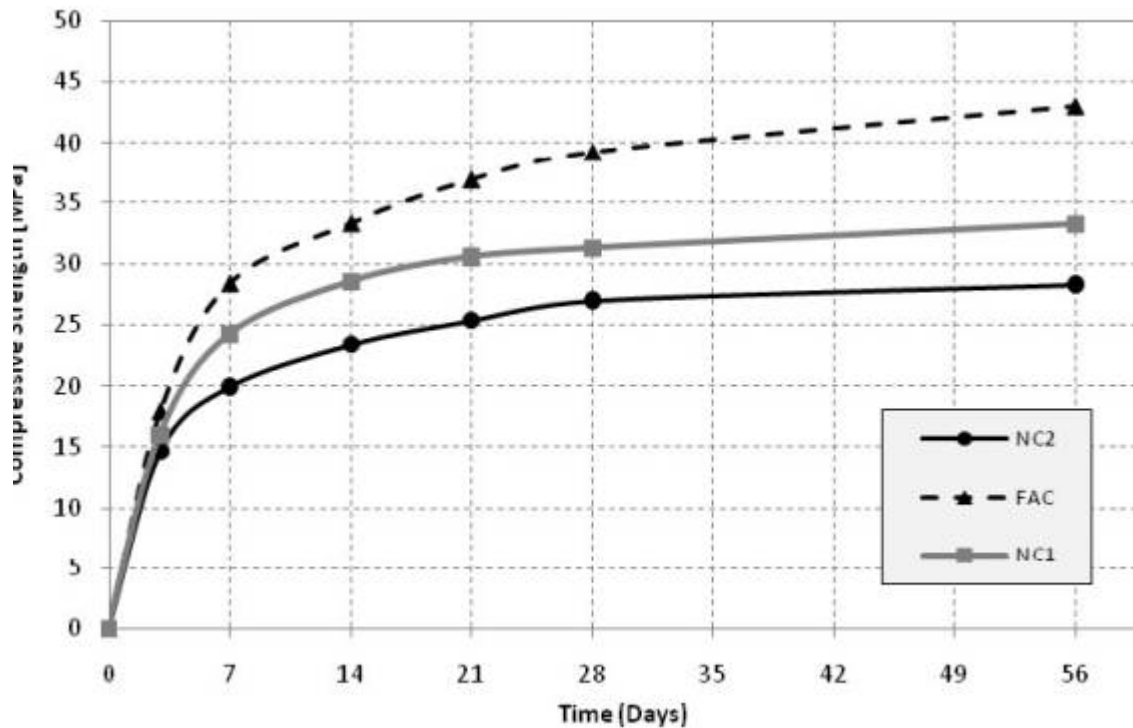
A compression testing machine was used to test the companion 101 by 203 mm (4 by 8 in.) concrete cylinders at the ages of 3, 7, 14, 28 and 56 days. All cured columns and the concrete cylinders were taken out of their molds simultaneously and were kept in the laboratory till testing. Figure 49 provides the data concluded from the cylinder compression tests. Both batches were specified to reach compressive strength of 25 MPa at 28 days but as the results show, the flyash concrete gained more compressive strength compared to the normal concrete. As seen in Figure 49, average compressive strength of the flyash sample at 28 days was measured as 39.2 MPa while the normal concrete specimens had average compression strength of 27 and 28.30 MPa. The actual compressive strength in both concretes was used to estimate the actual maximum axial load capacity of the columns.

Figure 49: Concrete strength gain with time.

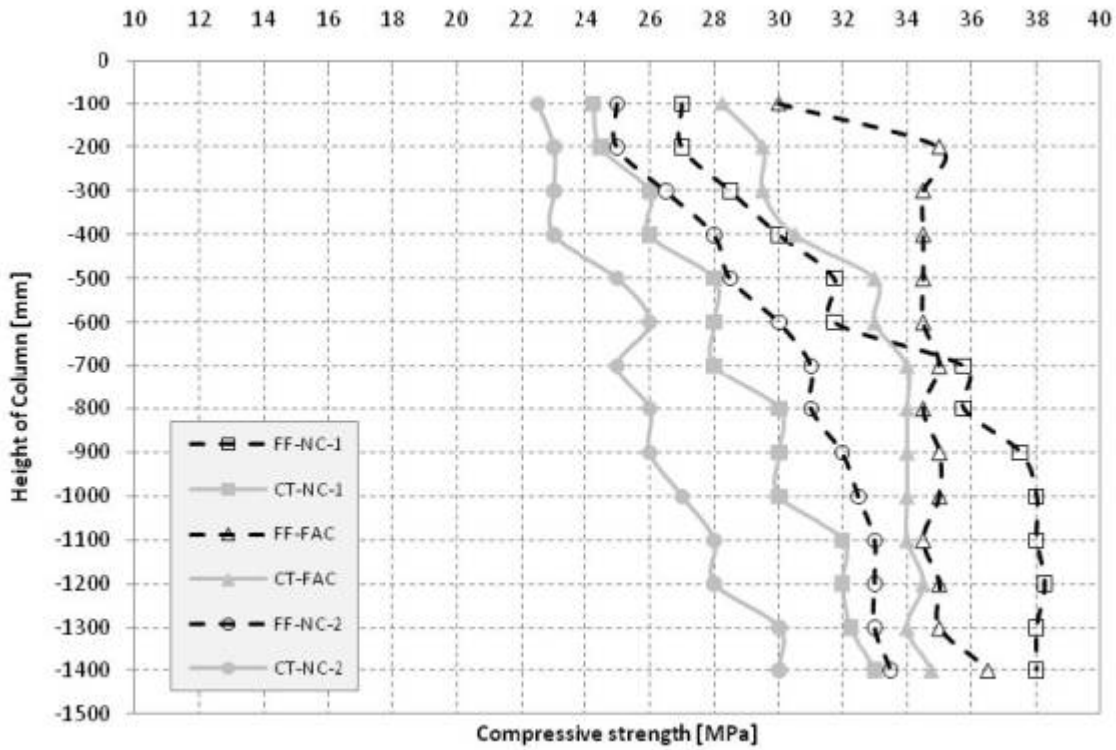
As seen in the chart, all columns formed with fabric showed more surface strength than those formed with cardboard. When normal concrete is used, the difference between the compressive strength of the specimens cast in cardboard versus fabric formwork at the bottom of the column is between 12 and 15%. The difference between the formworks when using flyash concrete has minimal significance (5% difference). This is an indication of flyash particles possibly clogging fabric pores and therefore, reducing the amount of water bleeding and eventually resulting in less increase in compressive strength. In

addition, regardless of the formwork type and referring to the results obtained from Schmidt hammer tests, the top end of the columns always proved to be weaker than other sections of the column. A phenomenon that appeared in both cardboard and fabric formed columns due to less compaction and less concrete density at top end of each column.

Figure 50: Results from the Rebound tests showing the variation of strength...

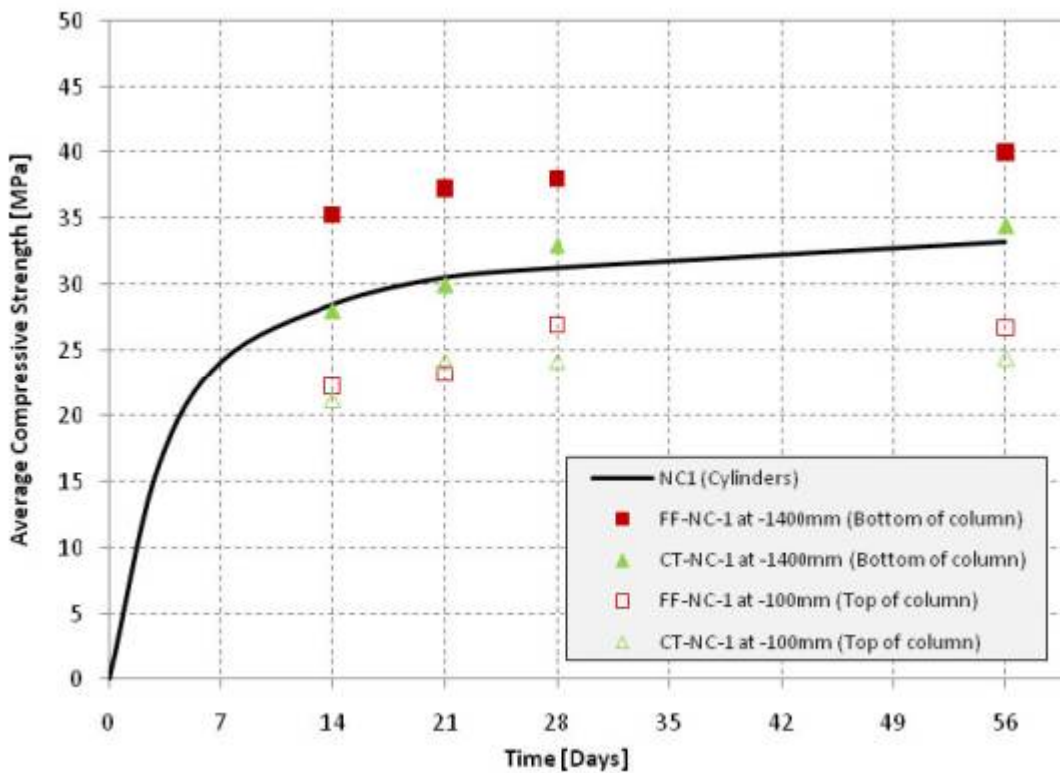
As seen in Figure 51, compared to results from cylinder tests fabric formed column has gained an average of 21.8% extra strength at the bottom of the column while the bottom of the cardboard formed column shows almost the same results as the cylinders. At the top of the column, both cardboard and fabric formed columns showed an average of 28% less strength compared to the cylinder test results. As seen in Figure 52, cylinder test results for flyash concrete show more compressive strength than both top and bottom readings of the Schmidt hammer.

Figure 51: Normal concrete cylinders compared to Schmidt hammer results (Columns...

Compression strength test results from Schmidt hammer test have been compared to those from cylinder test for both normal and flyash concrete. As seen in Figures 51, 52 and 53, there are some fluctuations between the results obtained from Schmidt hammer and the PVC formed cylinders. The filled markers in the graph represent the bottom of the column, while the empty ones represent the top of the column.

It is clear from the comparisons that for normal concrete the strength data from Schmidt hammer and from the cylinder test is comparable. Schmidt hammer is usually used to evaluate concrete strength of existing structures and it was shown in the previous figures that the strength is evaluated accurately. The method seems to be less accurate for the flyash concrete.

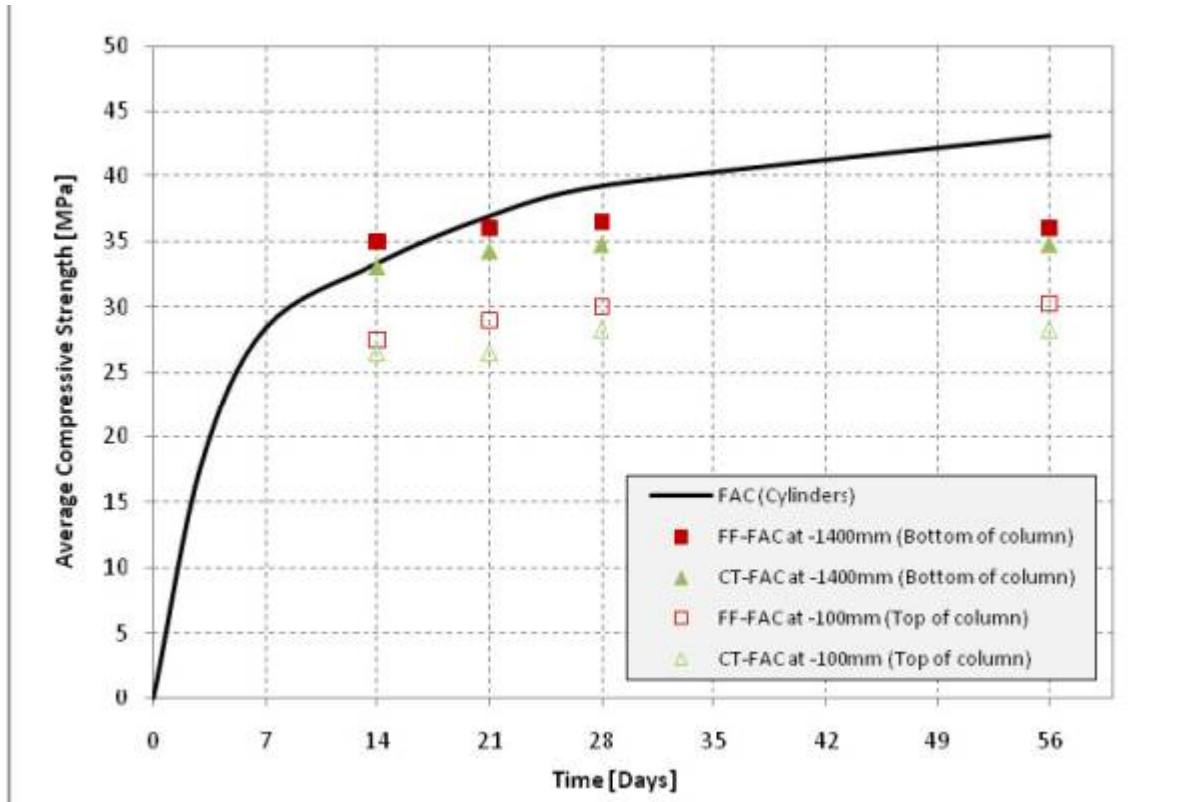
Figure 52: Flyash concrete cylinders compared to Schmidt hammer results (Columns...

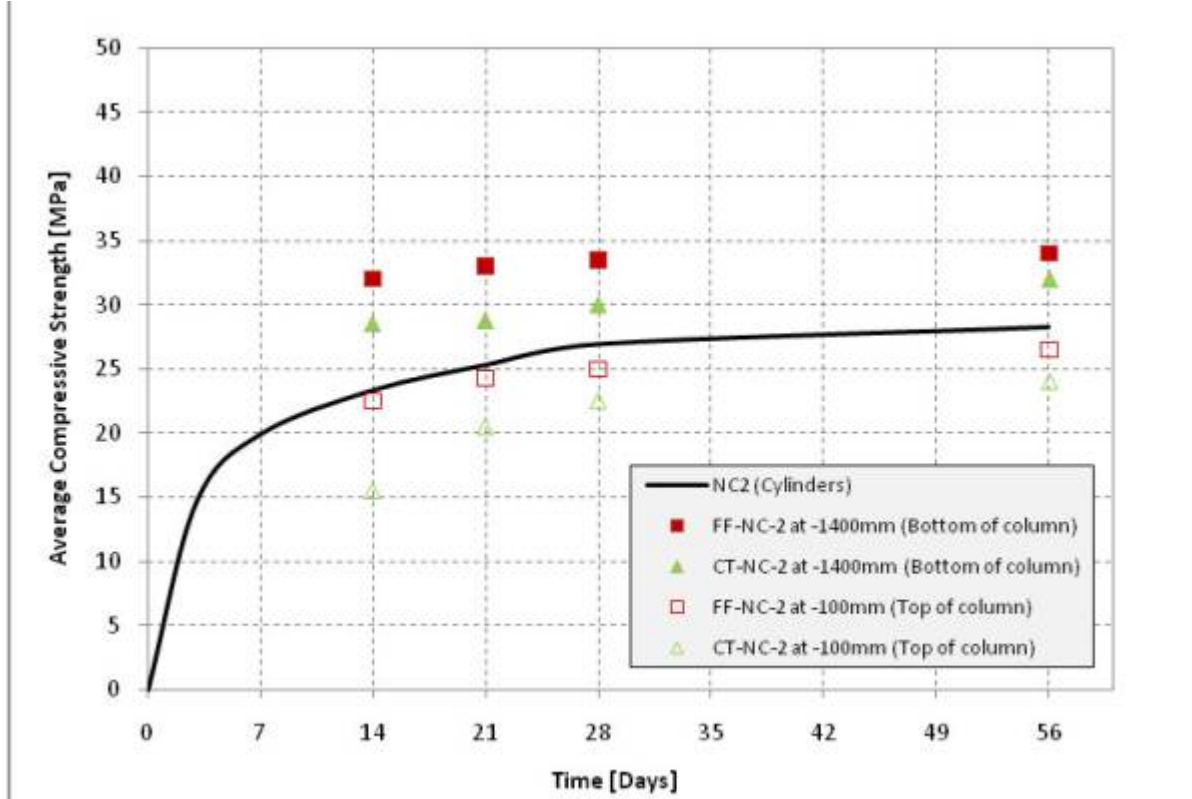
The difference between the readings of the Schmidt hammer at different ages stays constant but for some reason does not follow the strength indicated from cylinder tests. For the second set of normal concrete columns and cylinders, it can be seen in Figure 53 that compared to results from cylinder tests, fabric formed column has gained an average of 28% extra strength at the bottom of the column while cardboard formed column shows 14% difference. Schmidt hammer reading from the top of the columns shows 15% less compressive strength for cardboard formed columns and 6% less for fabric formed columns.

Figure 53: Normal concrete cylinders compared to Schmidt hammer results (Columns...

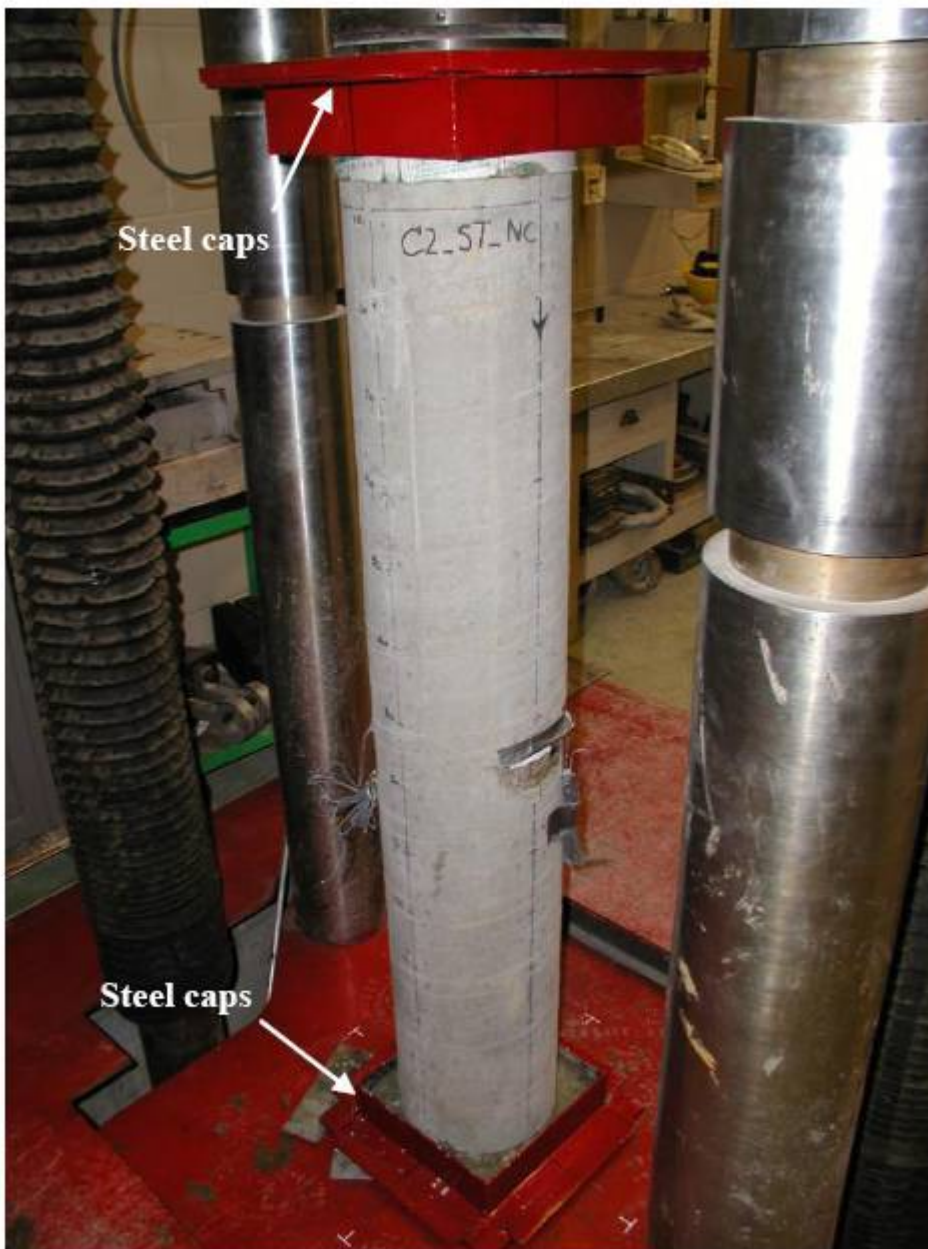
Two 280 by 280 mm (11 by 11 in.) custom made steel caps were made using a square base plate and four pieces of steel L-profiles welded vertically to the base plate as shown in Figure 54. Steel caps were made to confine the levelling grout on both ends of each column so that the axial load was evenly distributed over the column sections. No lateral supports were used to support the caps or columns.

Sika Grout 212 HP was used to level top and bottom of each column. Each column was first brought to the loading position, then lifted vertically using straps and cross head of the loading machine for about two feet. While the column was hung in the air, the steel cap was filled with 10-20 mm of the grout mixture.

The column was then slowly brought down to sit in the centre of the cap. After levelling the columns in a vertical position, specimen was left in place for 48 hours prior to testing day to let the grout gain its proper strength. To cap the top end of the column, a 75 mm circular cardboard mold was cut and used as a collar to retain the fresh grout in place when grouting the top end. First the collar was installed on top of the column, leaving only small room for the levelling grout. Then, grout mix was poured on top of the concrete. Steel cap was immediately placed on the fresh grout and levelled. A slight engagement of the machine's load piston also helped the cap being fixed in position until the grout set.

Figure 54: Columns test setup.

Due to the hand-made construction of the fabric molds, the columns cast by fabric formwork, did not have a completely uniform diameter along their lengths, making for a slight undulation along their sides. This slightly uneven surface did not allow the direct use of a carpenter's level for alignment and vertical positioning. Once the columns were brought down to sit in the fresh grout inside the caps, they were aligned using two Theodolites and then fixed in place using the machine load piston. To achieve more accuracy in alignment when testing both types of the columns, they were pre-loaded to obtain some data readings and then using the data from the strain and pi-gauges, further adjustments were applied to centre the columns under the loading piston.

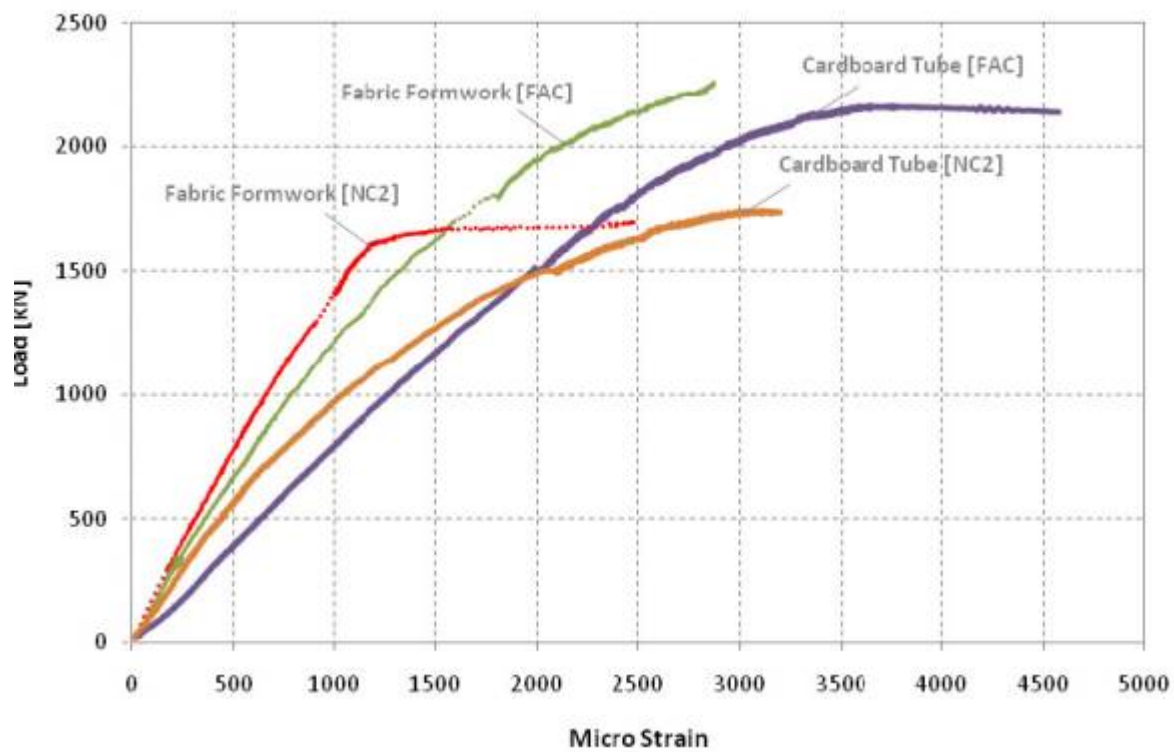
As seen in Table 8, the first two columns (FF-NC-1 and CT-NC-1), normal concrete columns formed with fabric and cardboard, withstood 1850 kN and 2200 kN of axial load, respectively. Maximum axial load of flyash specimen (FF-FAC and CT-FAC) was 2271 kN for fabric formed column and 2165 kN for cardboard formed column. As shown in Figure 55, for the last two columns (FF-NC-2 and CT-NC-2), normal concrete columns formed with fabric and cardboard carried 1703 kN and 1744 kN of axial load, respectively.

Figure 55: Maximum axial load of fabric-formed versus cardboard-formed steel...
