Column Tests

In order to evaluate the effect of fabric formwork on structural behaviour of a column, full size fabric-formed and conventionally formed reinforced concrete columns were designed and tested to failure under concentric axial load. The variables in these tests were two types of formwork; permeable fabric versus cardboard and two types of concrete; Flyash concrete and normal concrete. The fabric of choice was Geotex 315ST due to its better surface finish.

Permanent link:
http://fabwiki.fabric-formedconcrete.com/doku.php?id=fabwiki:research:canada:delijani:chapter_5

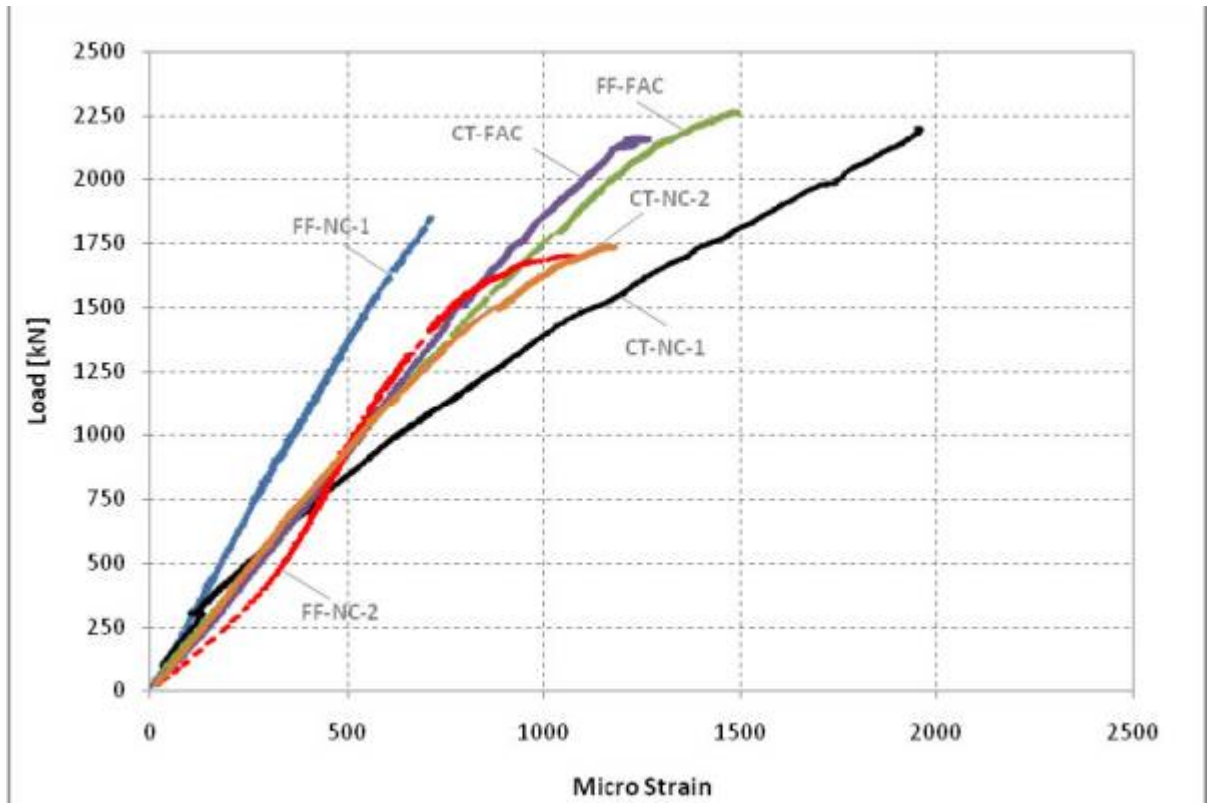
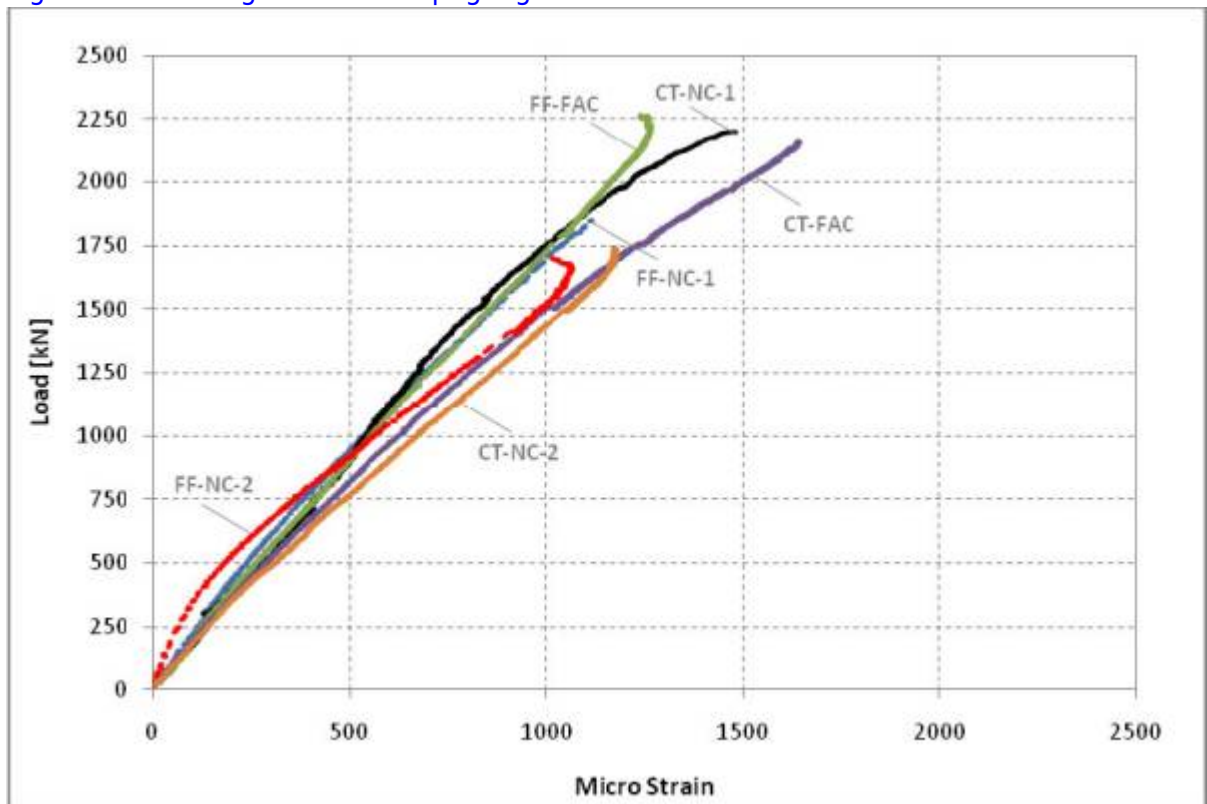
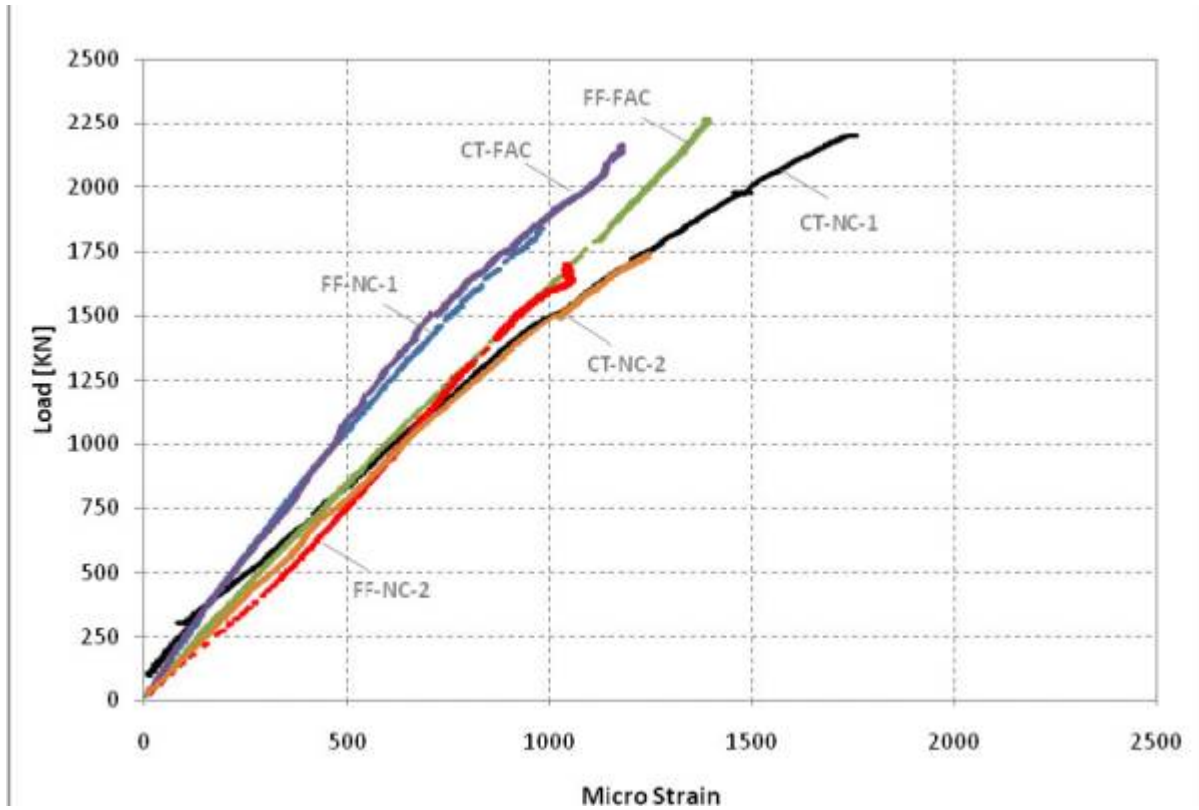
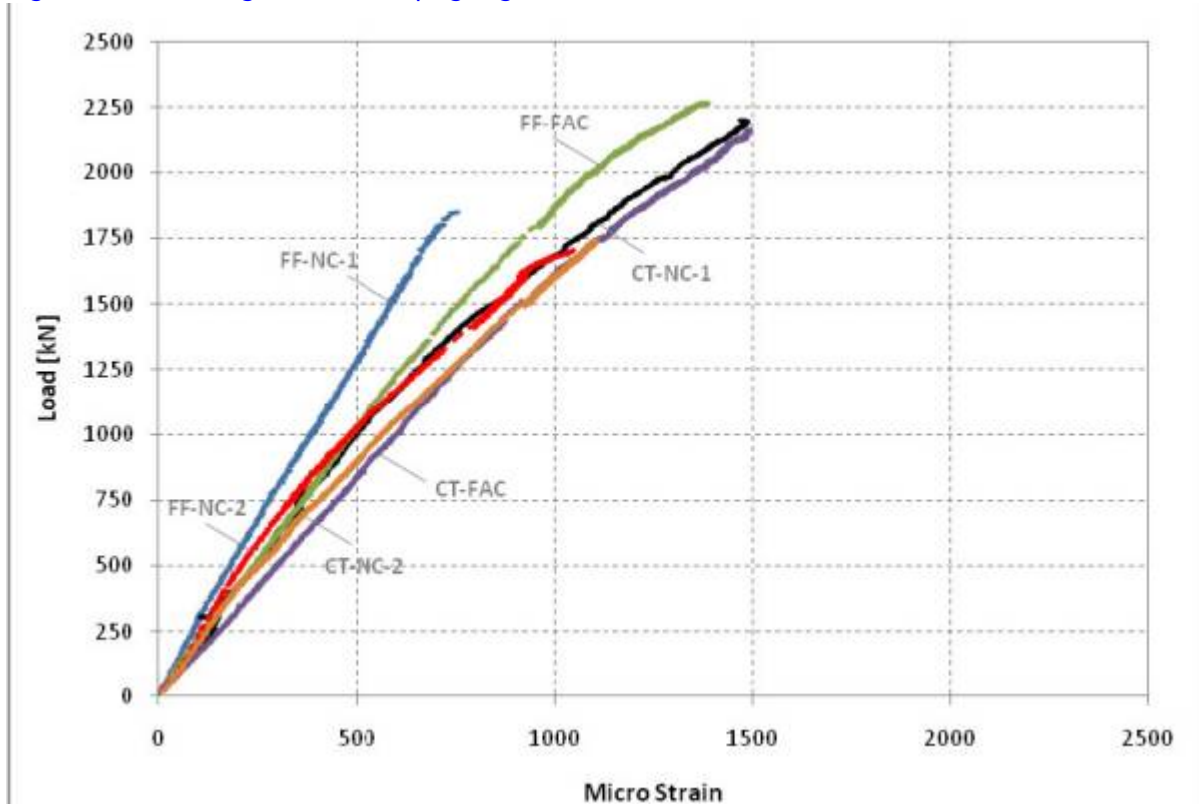
Figure 56 to 59 depict the strains in the middle, while Figures 60 to 63 depict the strains at the top of the column. Each figure represents one location either North, South, East or West and strains of that location in each column were plotted in the same graph for comparison.

Figure 56: Readings from North pi-gauges at the middle of all columns.

Figure 57: Readings from South pi-gauges at the middle of all columns.

Figure 58: Readings from East pi-gauges at the middle of all columns.

Figure 59: Readings from West pi-gauges at the middle of all columns.

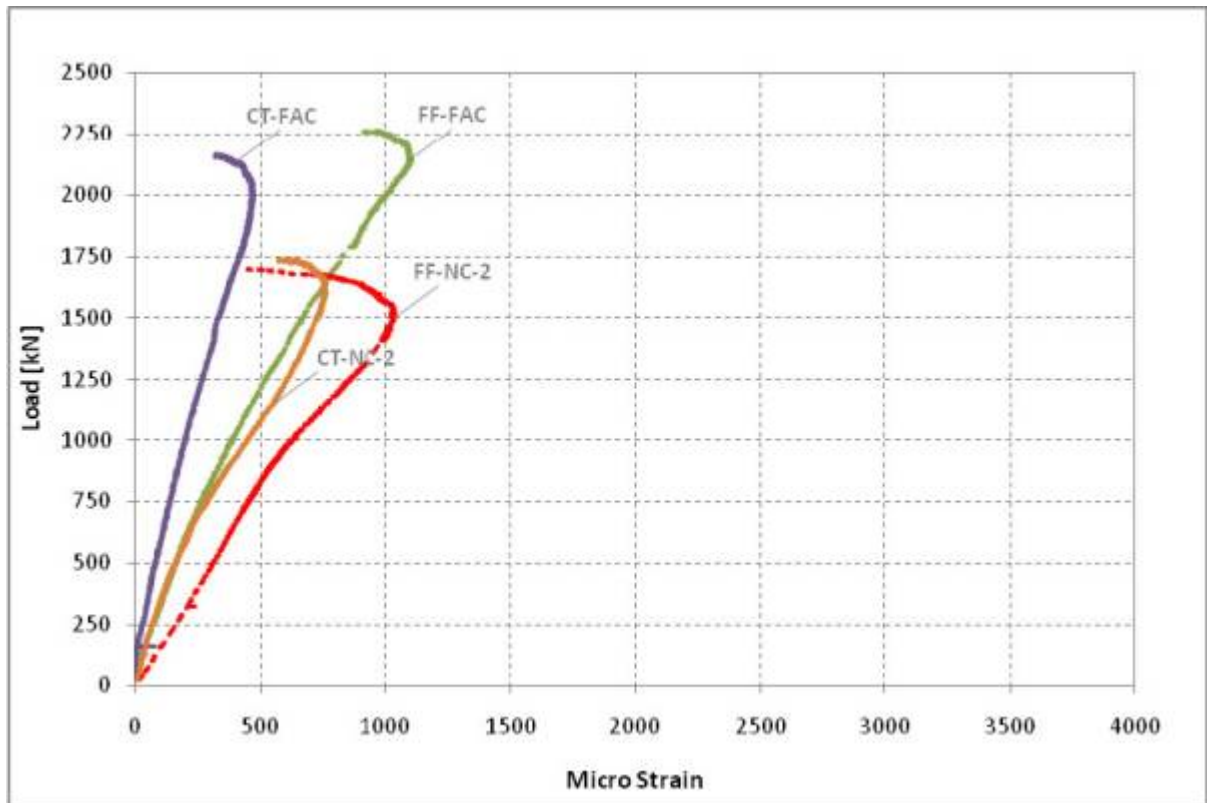
Figure 60: Readings from North pi-gauges at the top of all columns.

As seen in Figure 60 which represents the readings from North pi-gauges at the top of all columns, a trend of reverse strain close to the failure load is observed. This means that as columns were starting to crush at another location, the surrounding concrete was experiencing some tension. Figure 61 represents readings from South pi-gauges at the top of all columns. As seen in this figure, columns undergo much

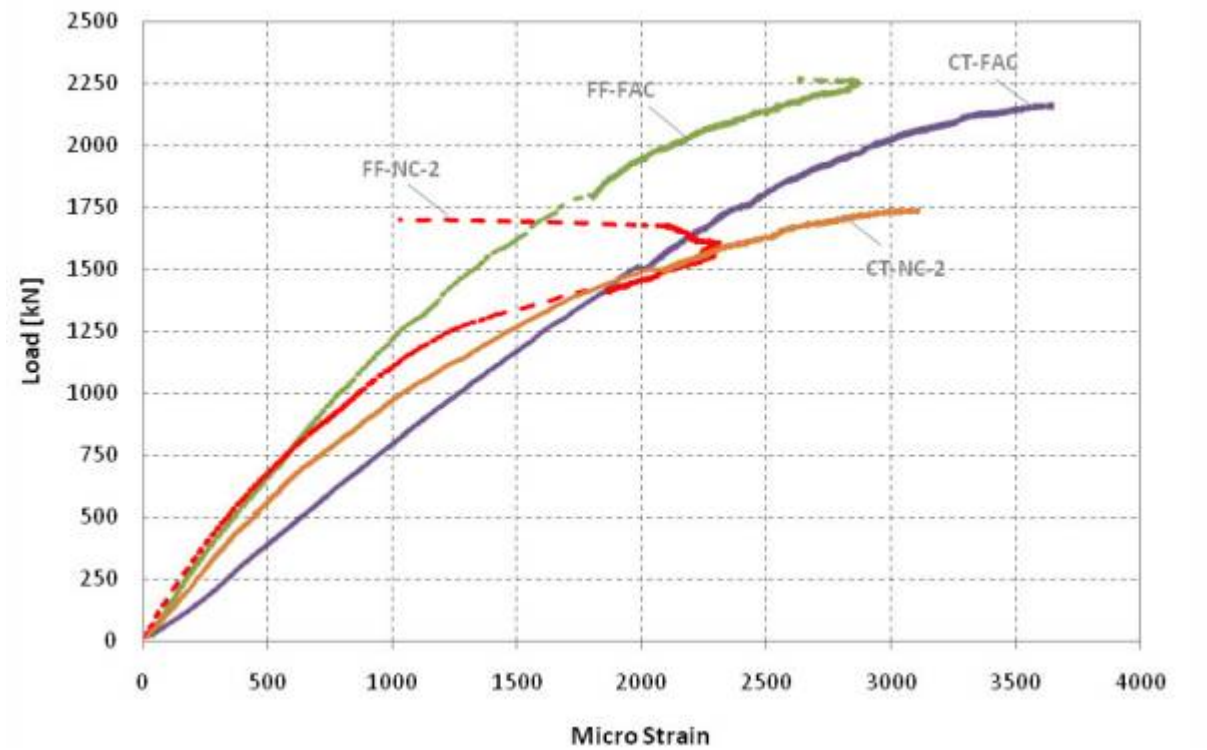
Figure 61: Readings from South pi-gauges at the top of all columns.

larger strain values as high as 3600 micro strain at the load of about 2150 kN in case of column CT-FAC. Strain values read from the south pi-gauge of column FF-NC-2 change direction from compression to tension close to the failure load. This has been caused by the uneven failure of the column at top. As seen in Figure 64, the opposite side of the column across from the south pi-gauge has failed in compression and caused some tension in south-top-zone of the column. Figure 62 which represents the readings from West pi-gauges at the top of all columns shows the highest strain in column CT-NC-2 as 3000 micro strain at the corresponding load of 1750 kN. A similar trend is observed in Figure 63 from the values taken from top-East pi-gauges. Column FF-FAC carries 2700 micro strain at the load of 2250 kN. As seen in all top pi-gauge curves, except column CT-NC-2, regardless of the form-work type, flyash concrete experienced more strain than normal concrete. As seen in Figure 65, all six columns failed at the top. This type of failure in columns has been documented before in research conducted by Bazant and Kwon [2] which found that regardless of the cross sectional size of the column, the fracture mechanism stayed the same. The reason for the top end failure is that the top end of a vertically cast member will always have less compressive strength than the lower parts of the member, due to increased pressure and compaction towards the bottom of the mold [3]. This holds true regardless of the formwork used.

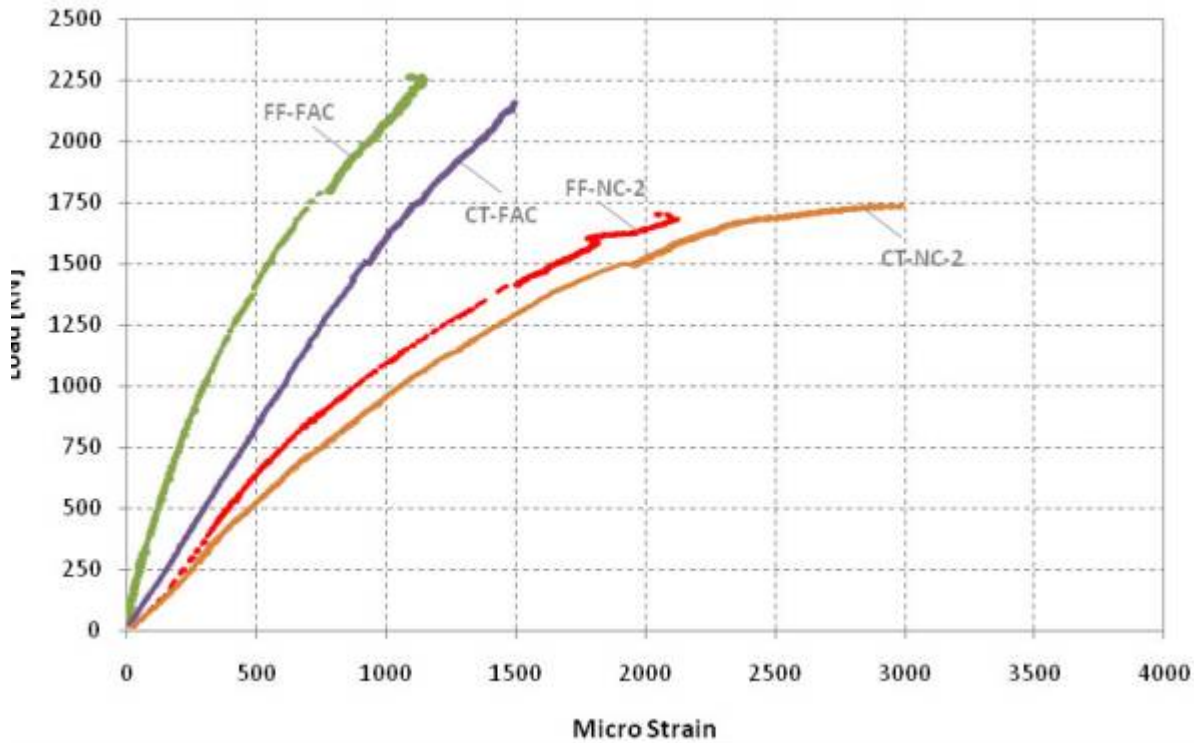
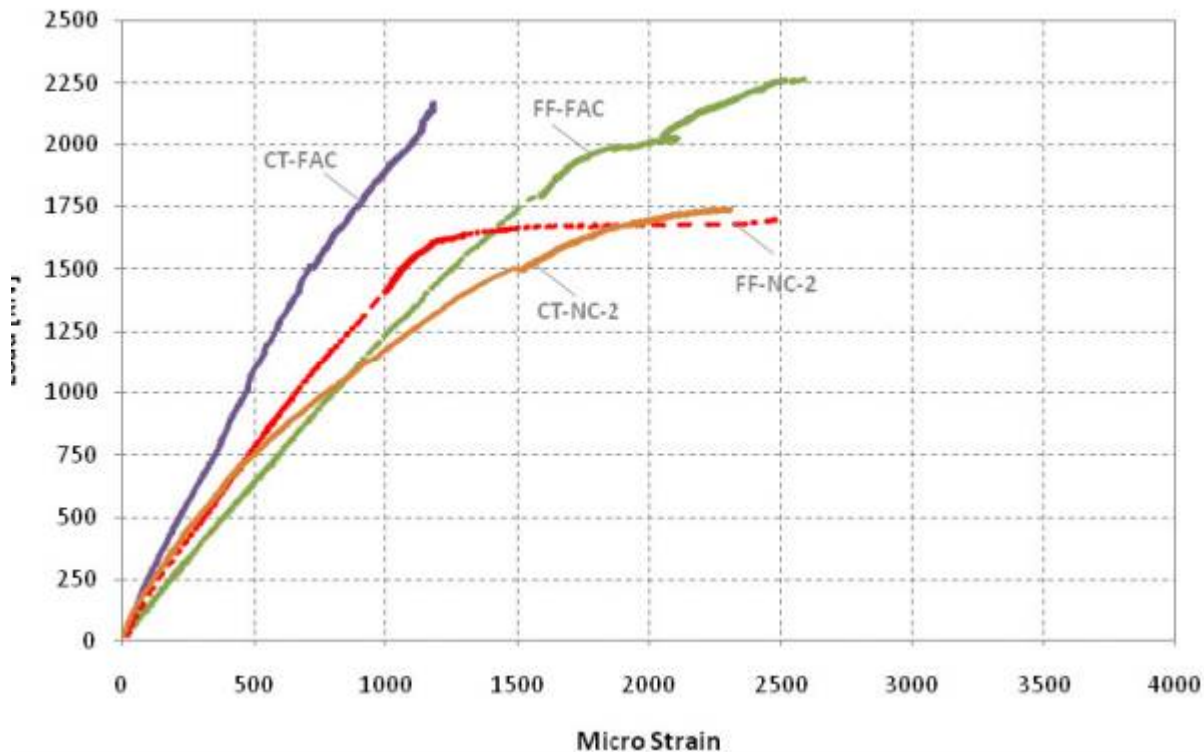
Figure 62: Readings from West pi-gauges at the top of all columns.

Figure 63: Readings from East pi-gauges at the top of all columns.

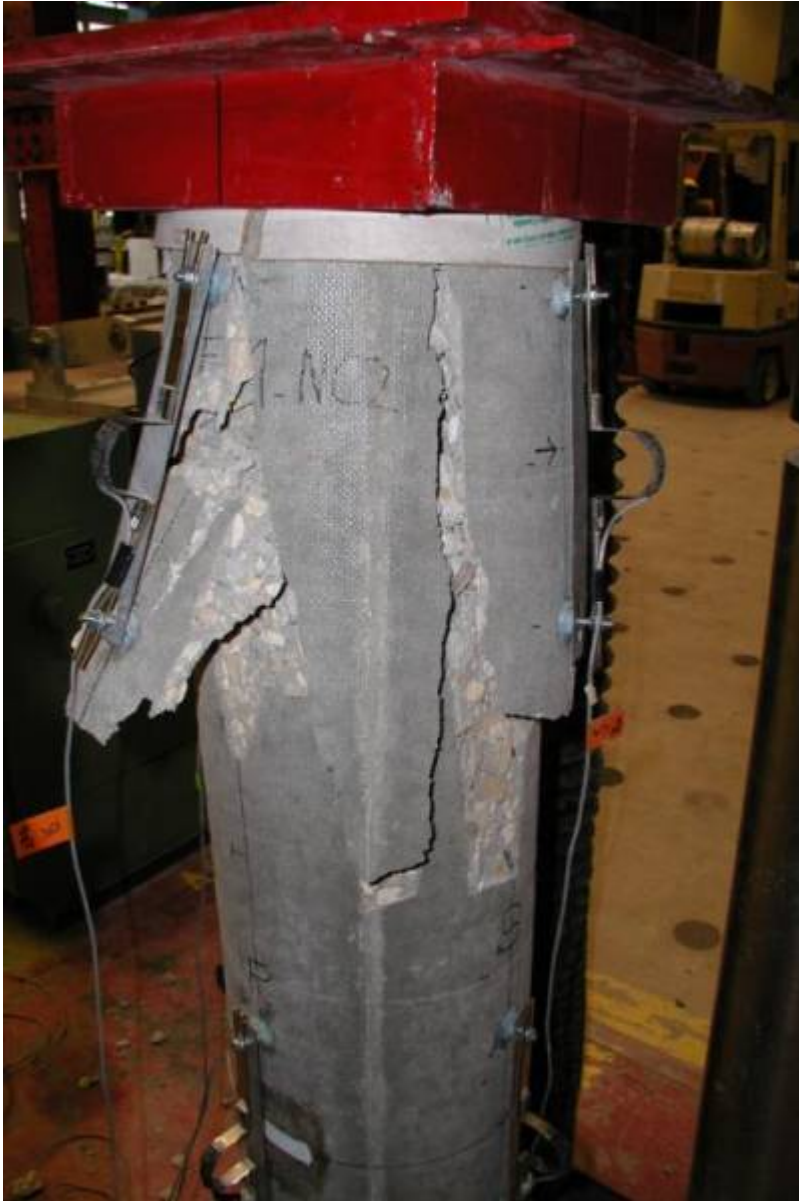
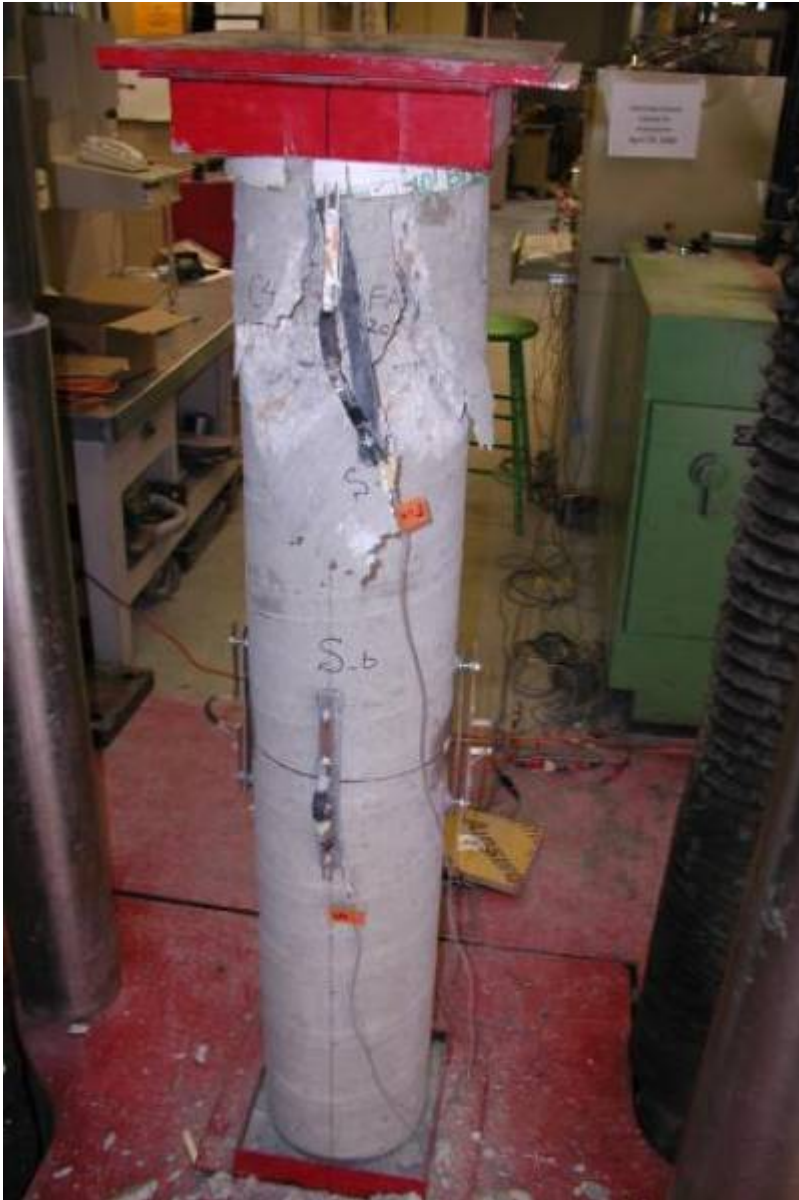
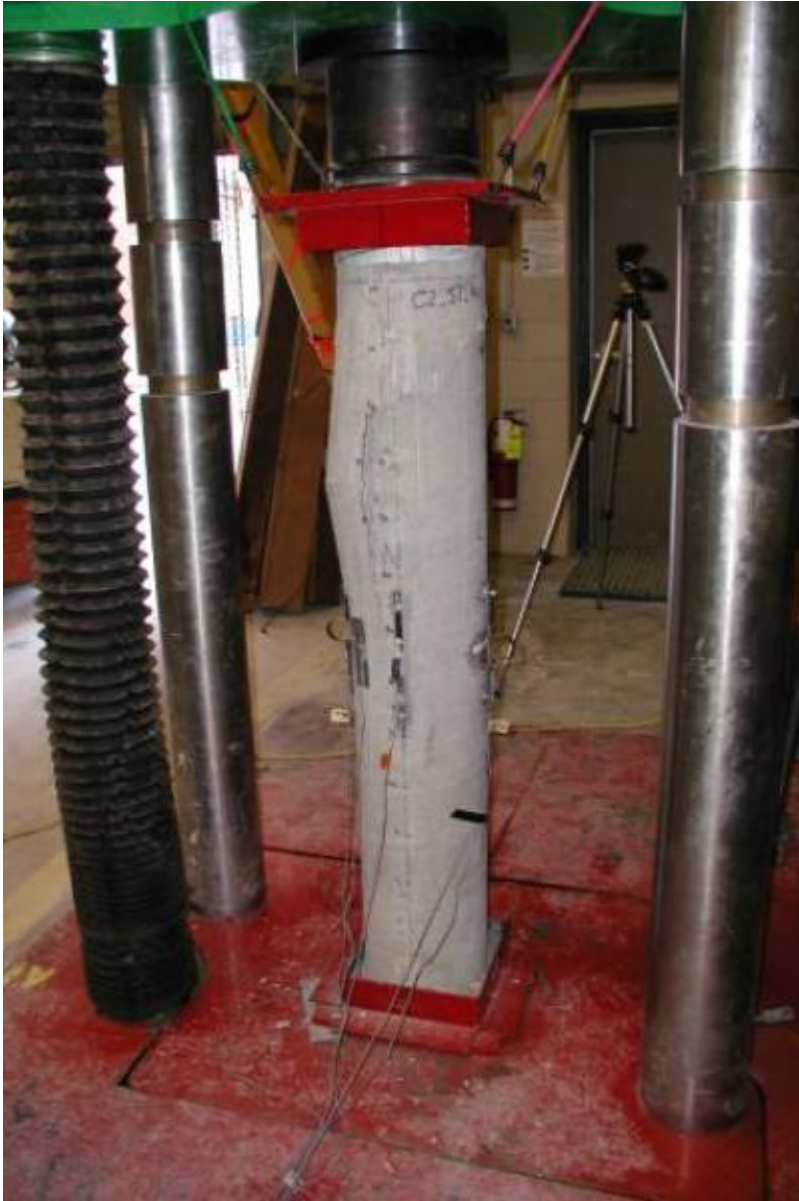
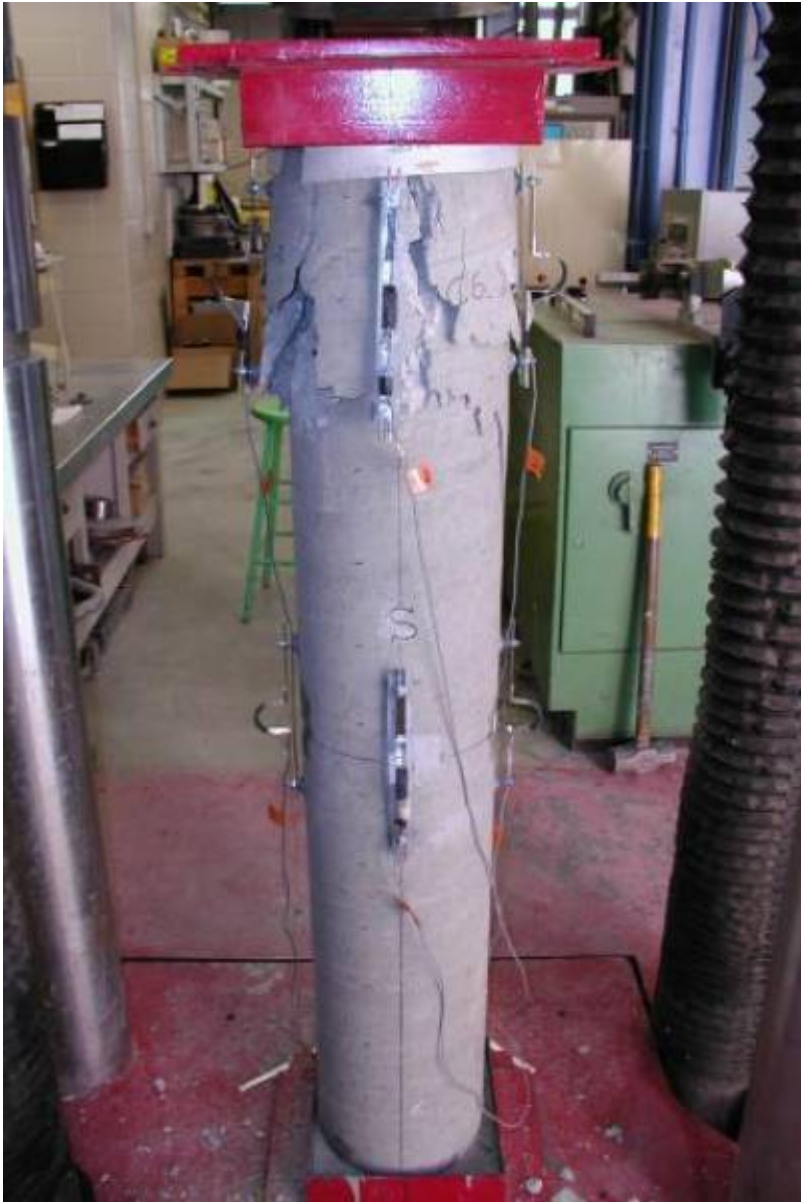
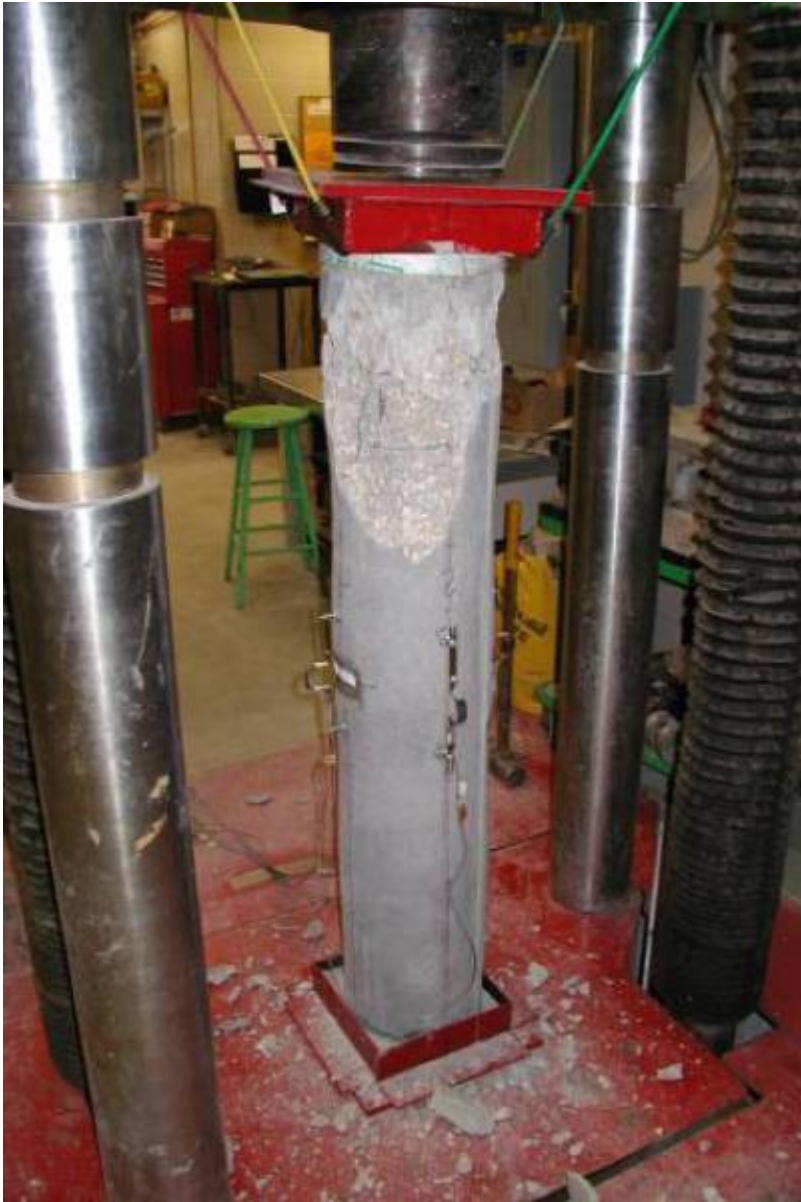
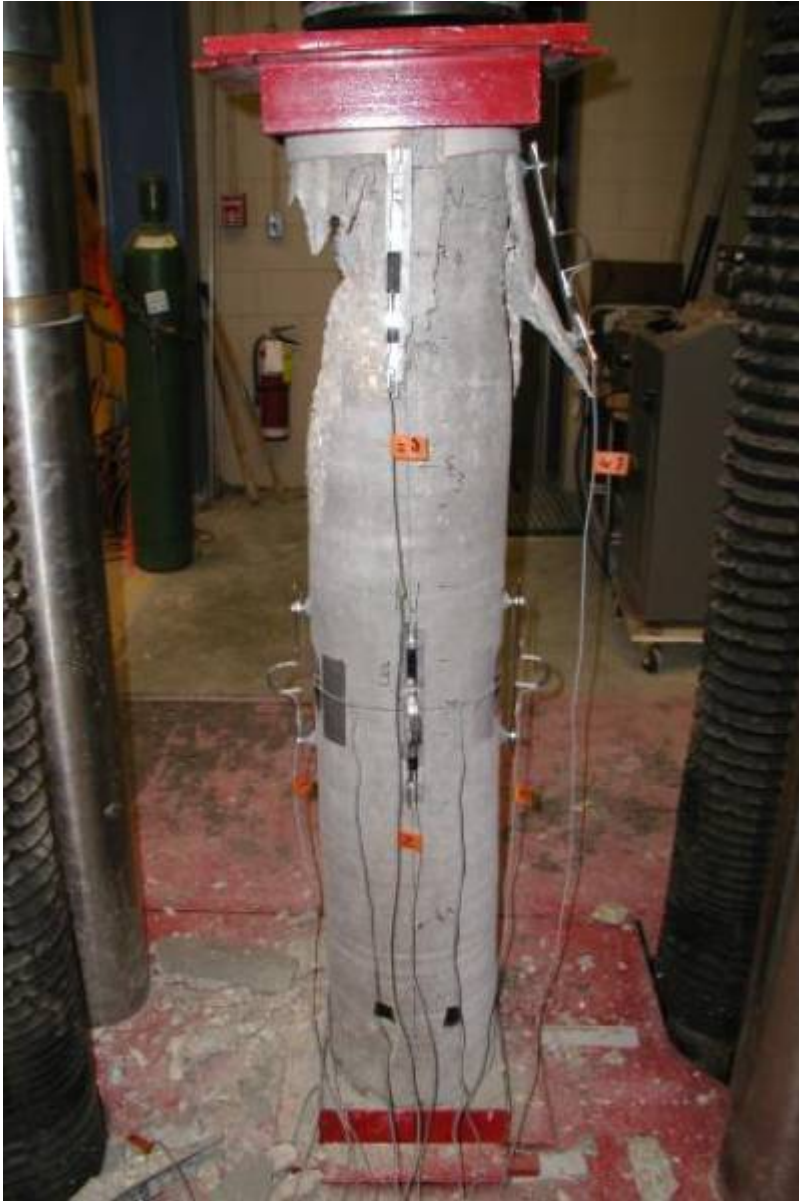
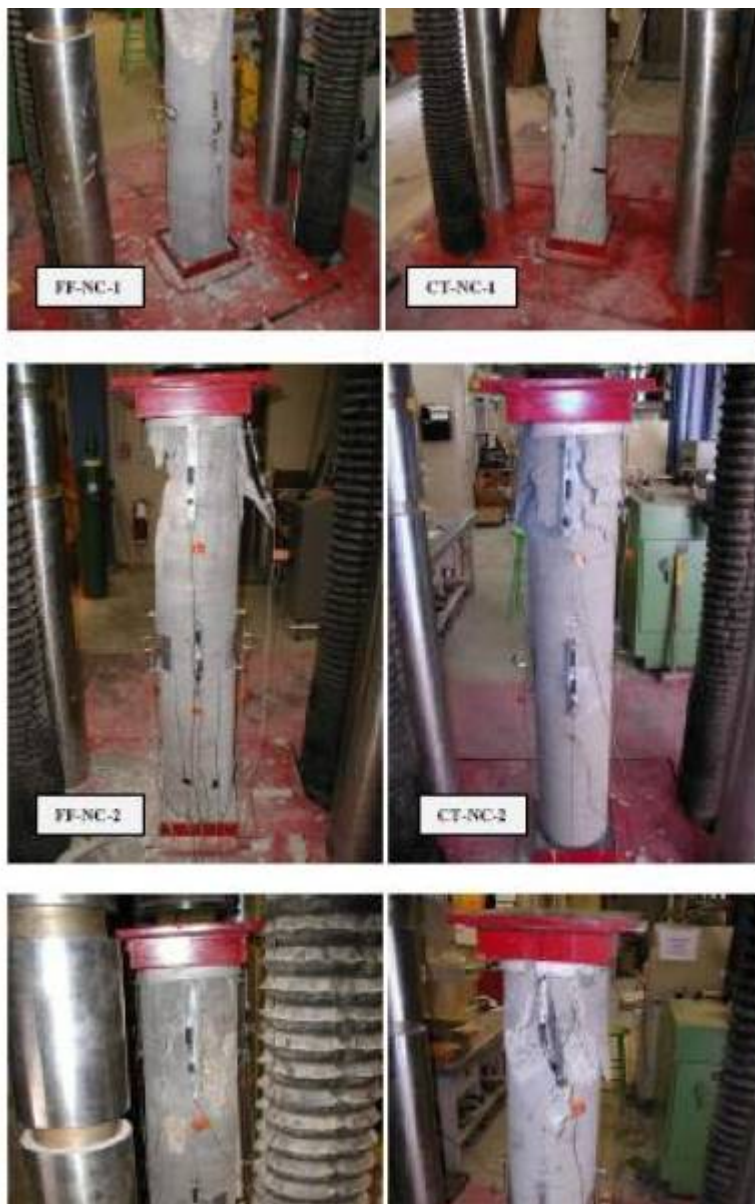
In order to be able to better observe behaviour and the failure pattern of the columns, all tests were videotaped. The failure pattern of the columns was a factor to be investigated in this phase of the study. Based on observations of the two cardboard and two fabric-formed column tested, the failure of the cardboard formed column started with crushing on top and then spalling till failure. Cardboard-formed columns presented a typical gradual failure with no sign of brittleness, no longitudinal cracks and no flaking. On the other hand, fabric-formed columns started with crushing on top and development of longitudinal cracks at the same time along with spalling. Also, some flaking and relative sudden failure of

outside surface was observed. Photographs of these column failures are shown in Figure 65 (page 82).

Figure 64: Column FF-NC-2 after failure.

Figure 65: Column CT-FAC after failure.

Figure 65: Column CT-NC-1 after failure.

Figure 65: Column CT-NC-2 after failure.

Figure 65: Column FF-FAC after failure.

Figure 65: Column FF-NC-1 after failure.

Figure 65: Column FT-NC-2 after failure.

Figure 65: All columns after failure.

Flaking and surface concrete delamination observed in the failure of both fabric-formed columns also confirms that the surface of the concrete cast in fabric formwork was more brittle than concrete cast in conventional formwork. The change in Poisson's ratio was also studied when these columns were tested. The value was derived from dividing the average value of the data from two circumferential strain gauges placed at 180° apart from one another, by their corresponding axial pi-gauges. Both flyash and normal concrete fabric formed columns, proved to have lower Poisson's ratio value which is another indication of brittleness and less surface deformation in the fabric-formed specimens. It is necessary to mention that it is nearly impossible to form a perfectly straight column using handmade fabric column formwork, so very small values of eccentricity in loading condition may occur. Since small values of the eccentricity do not create large moment values at end portion of the columns, the effects of small eccentricities can be neglected [2].

In each concrete type, both fabric-formed columns withstood the same axial load level as the cardboard formwork control samples. All samples failed at the top portion. At the extreme top portion of a concrete column, a permeable fabric mold does not loose appreciably more water than a conventional formwork or a cardboard tube. Therefore, in columns cast with the similar type of concrete, regardless of formwork material, strength of the concrete at top zone always remains the same and constitutes the area of weakest concrete in each column.

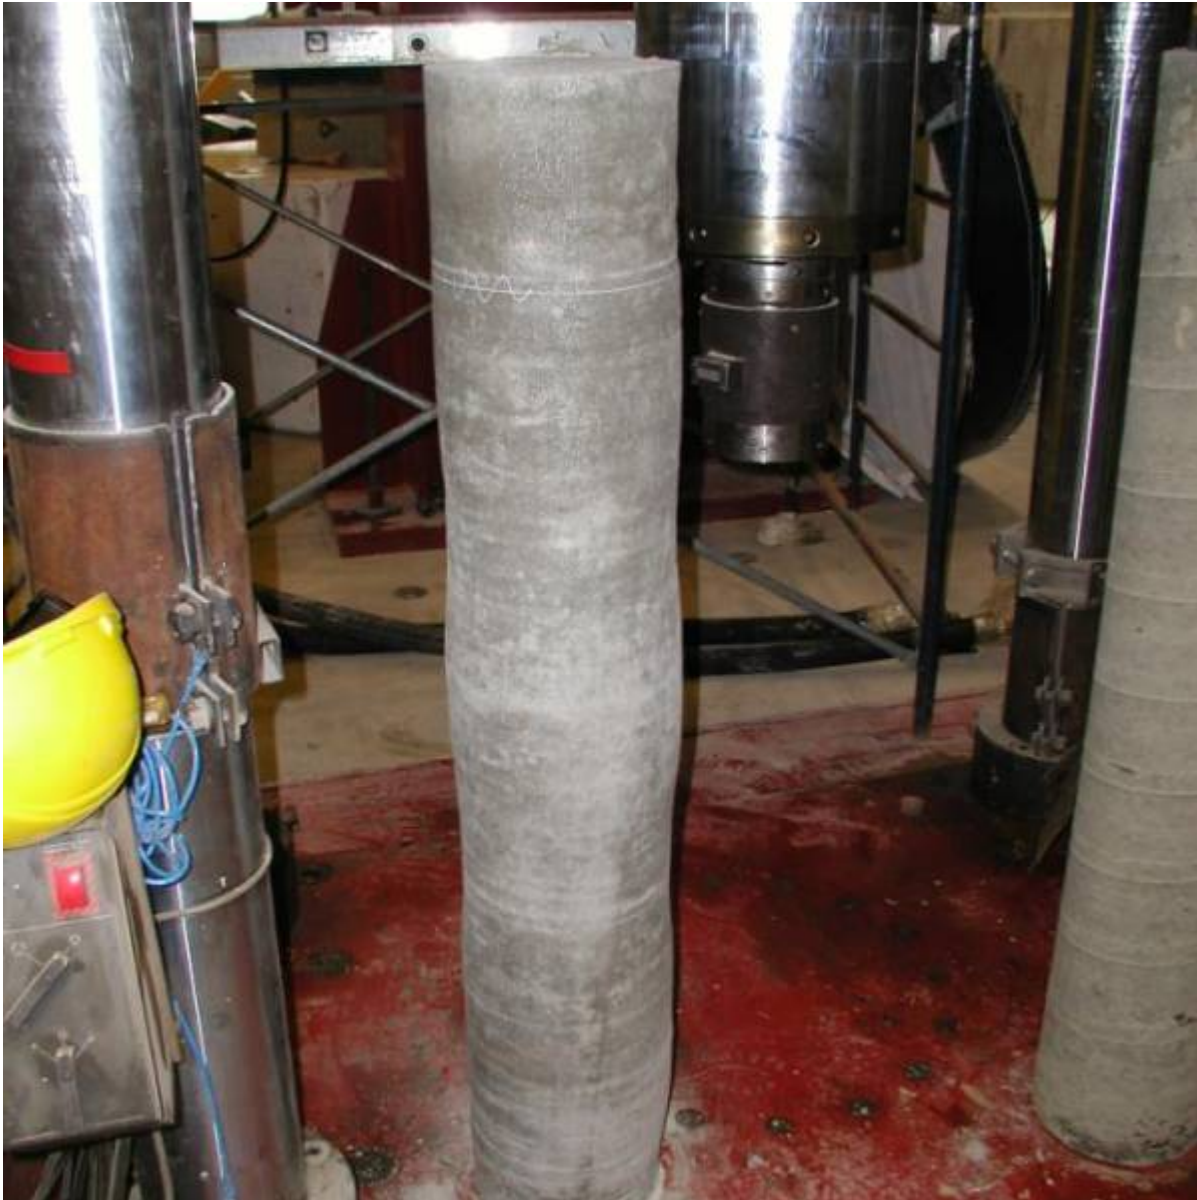
Our first attempt of casting a concrete column using fabric formwork was not quite successful. The column was bulgy at some points and it did not have constant diameter along its length while cardboard molds that are industrially manufactured are perfectly symmetrical tubes and form perfectly symmetrical columns. The reason for this problem was that the fabric was sandwiched between the boards using bolts and when the concrete was poured inside the mold, the hoop tension created by the liquid concrete pulled the fabric out between the bolts (Figure 66). Areas supported by bolts resisted the pressure while parts away from bolts deformed creating bulges along the length of the hardened concrete column, as shown in Figure 67.

Figure 67: Bulged concrete column.

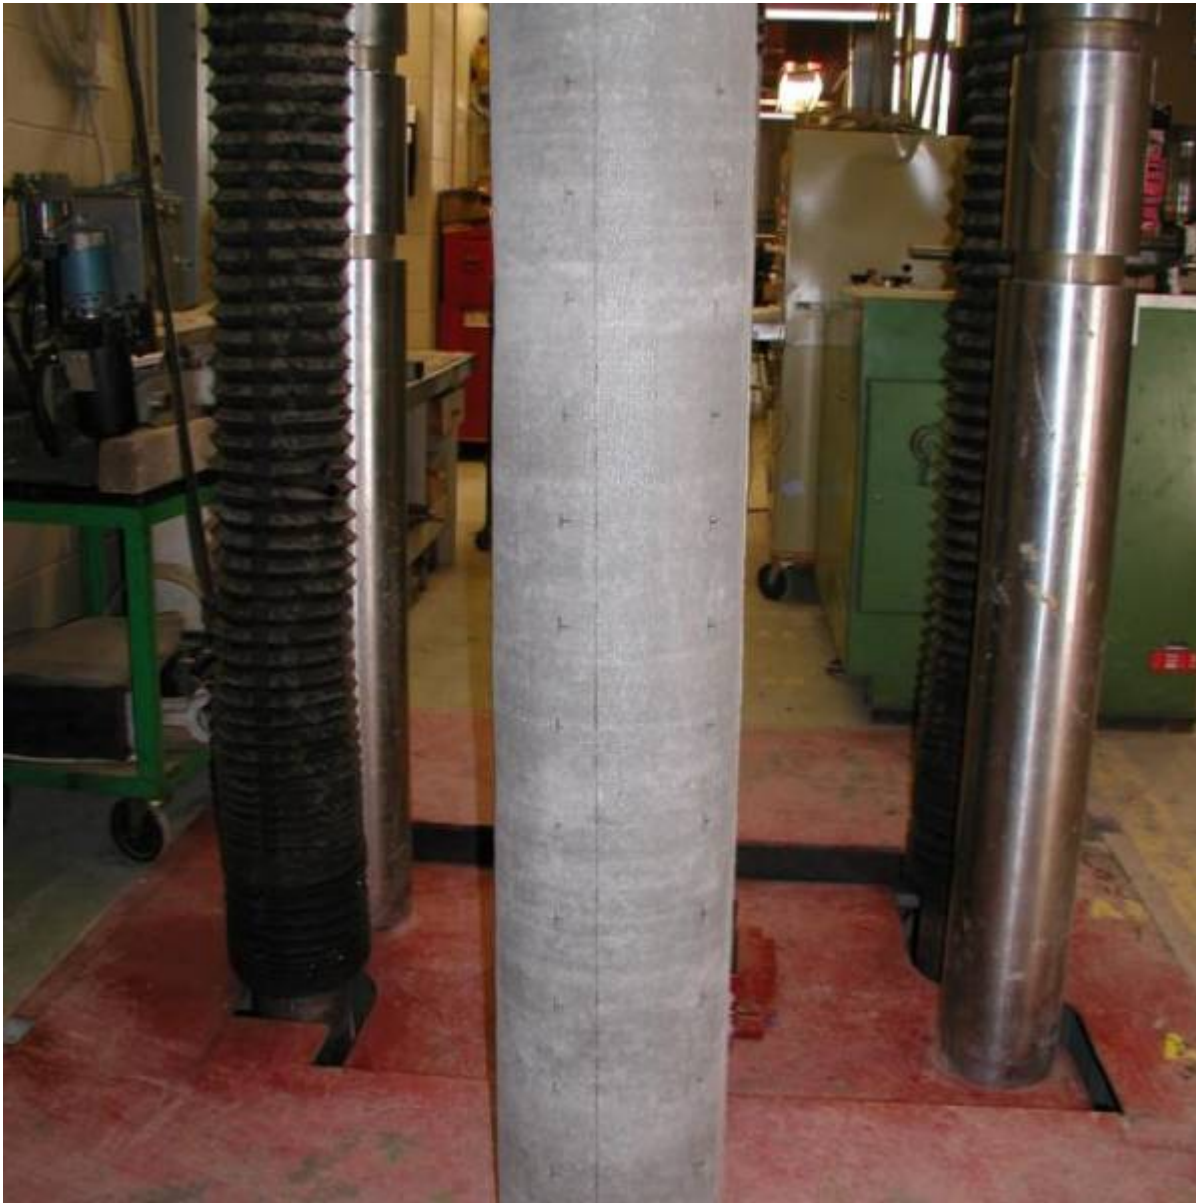
from each other (though less staples would be probably also sufficient), providing a stitch line from top to bottom of the formwork. Orientation of the stitch line can be seen in Figure 43. Stapling provided an even distribution of the hoop forces along the height of the formwork and resulted in a uniform cylindrical geometry. The variation in diameter of the column along its length was dramatically reduced as demonstrated in Figure 68.

Figure 68: Modified fabric formwork resulting in a straight column.
