Column Tests

In order to evaluate the effect of fabric formwork on structural behaviour of a column, full size fabric-formed and conventionally formed reinforced concrete columns were de-signed and tested to failure under concentric axial load. The variables in these tests were two types of formwork; permeable fabric versus cardboard and two types of concrete; Flyash concrete and normal concrete. The fabric of choice was Geotex 315ST due to its better surface finish.

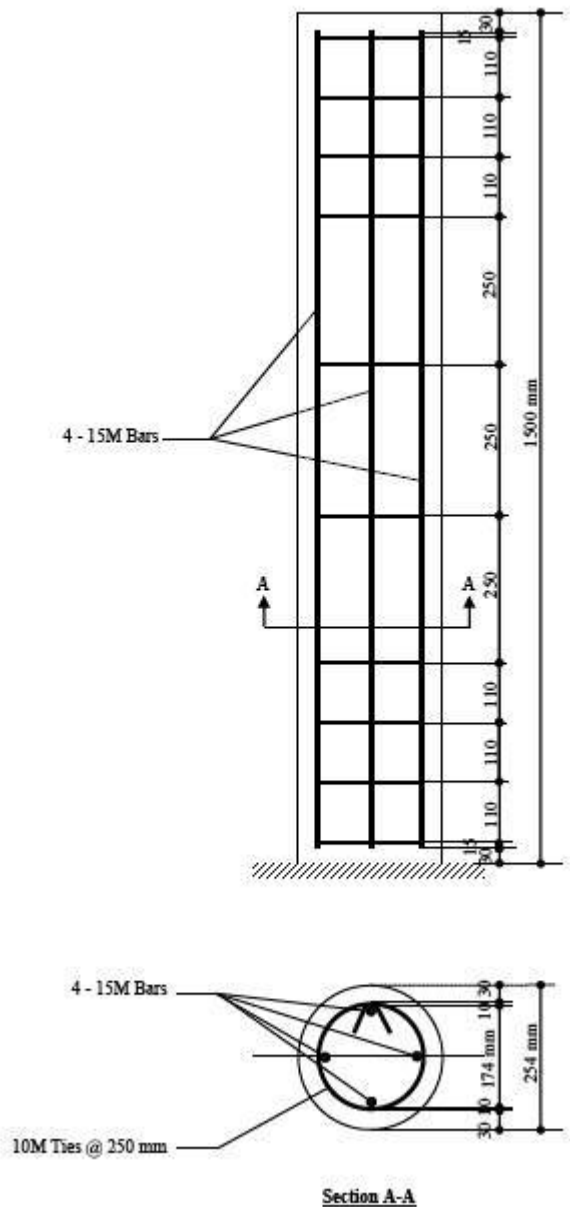
Figure 42: Column reinforcement details.

All columns had 254 mm radius and the column height was limited to 1500 mm. Based on calculations, four 15M bars were considered as the longitudinal bars, tie size was se-lected as 10M and tie spacing(s) was calculated as 250 mm (center to centre) and tie hooks, were set as 135 degrees. Arrangement and configuration of the reinforcement in the column has been shown in Figure 42.

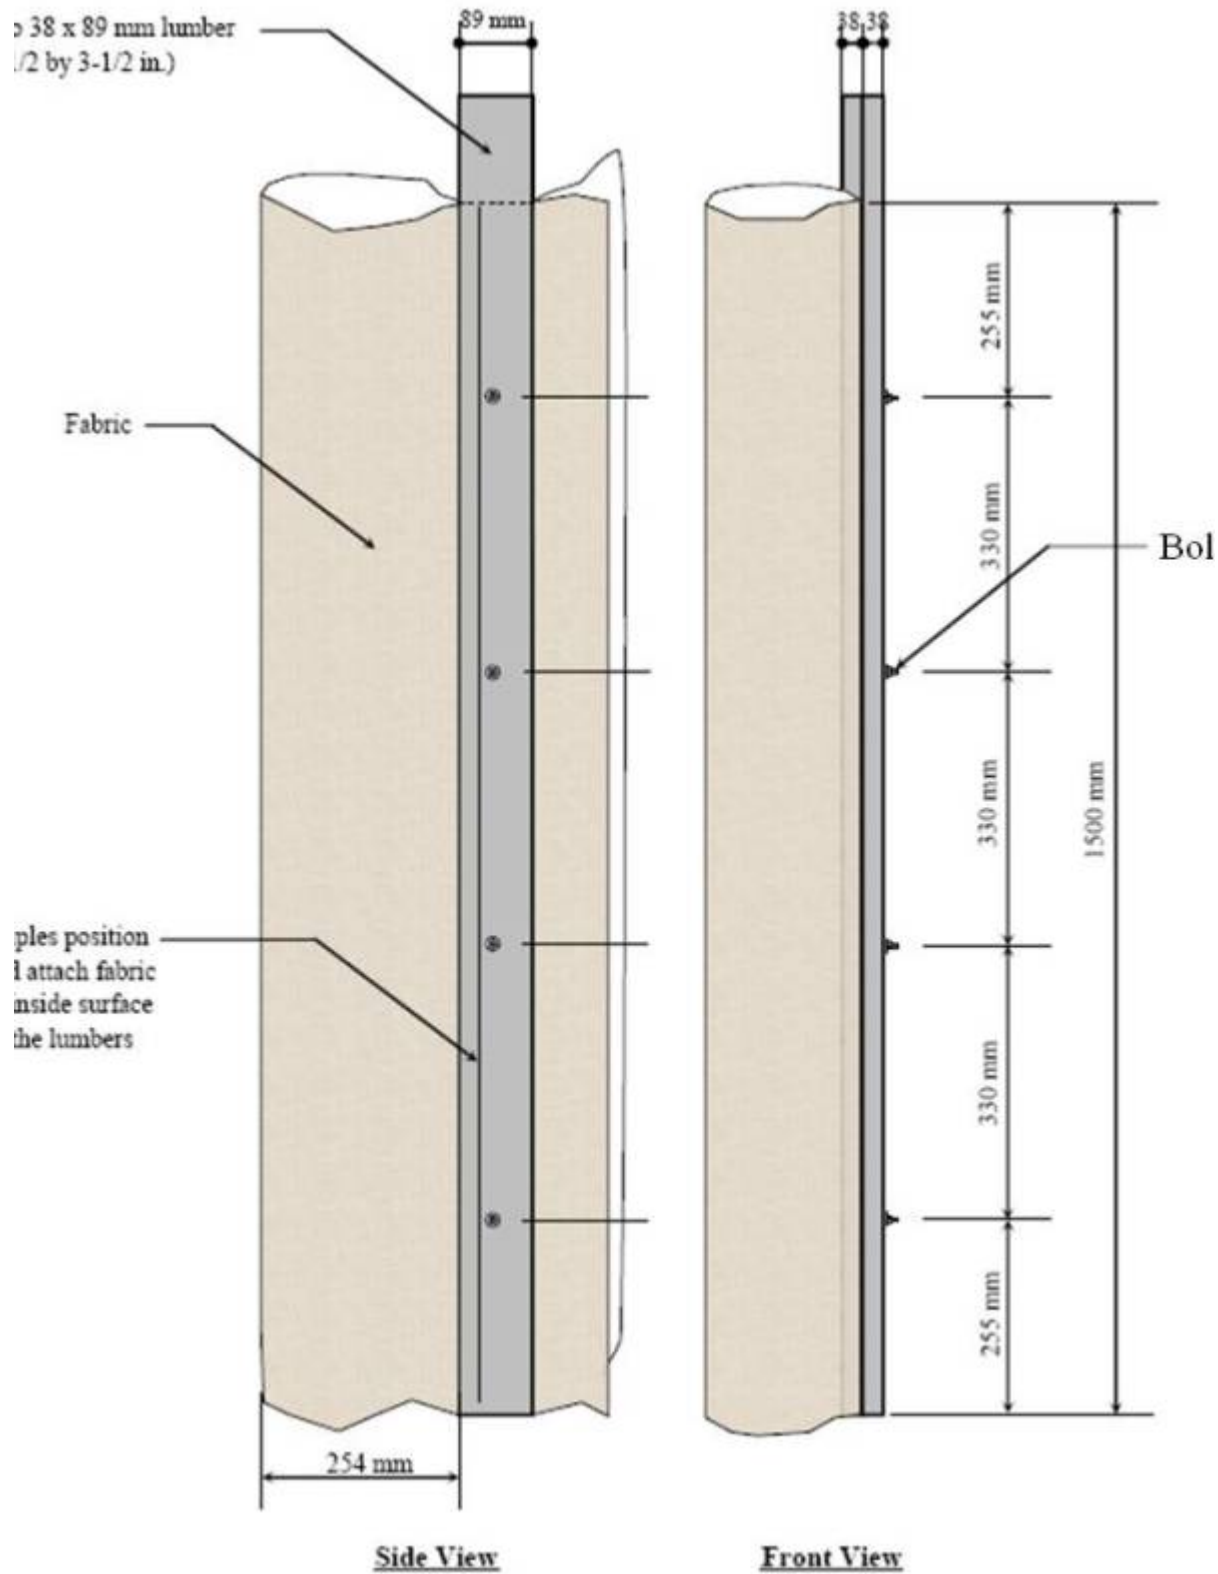
Figure 43: Configuration of the fabric formwork for reinforced concrete column.

batch. The columns were cast using normal concrete and flyash concrete. Total of 6 columns were cast. As shown in Figure 43, the formwork was essentially the same as that used to cast the earlier cylinder specimens. The formwork was made of a single, rectangular, piece of fabric sandwiched between two vertical pieces of 38 x 89 mm lumber (2" by 4"). The fabric was first fitted to create the proper diameter and stapled to the lumber pieces.

from each other (though less staples would be probably also sufficient), providing a stitch line from top to bottom of the formwork. Orientation of the stitch line can be seen in Figure 43. Stapling provided an even distribution of the hoop forces along the height of the formwork and resulted in a uniform cylindrical geometry. The variation in diameter of the column along its length was dramatically reduced as demonstrated in Figure 68.

[1] Comments by RPS on Discussion page for an alternative way to secure the column fabric, Figure 43.
<fs medium>[2] *Place text here.*

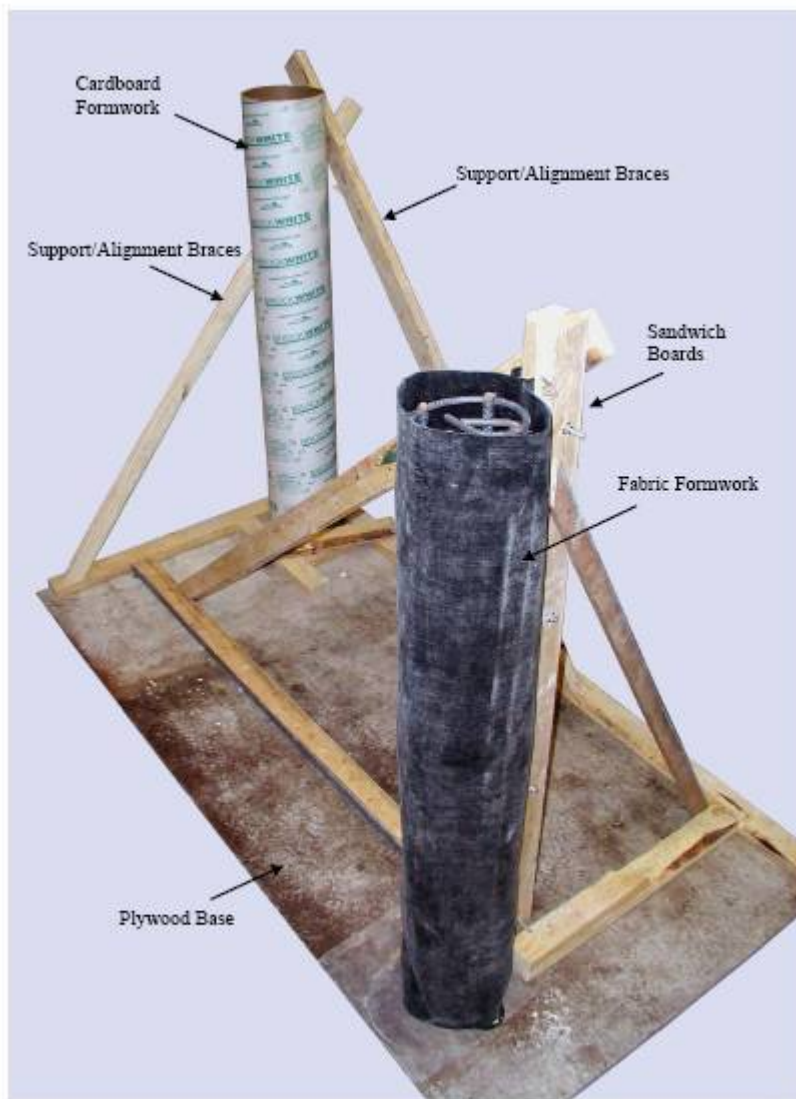
Figure 44: Setup for reinforced concrete columns formed with fabric and...

After that, the wooden pieces were bolted together in four locations along the length of the formwork to make the closure of the formwork as a cylindrical vessel. Figure 44 shows the finished formwork set up for both cardboard and fabric formworks. Both formworks were supported in a vertical position by diagonal braces in two directions for lateral support. Plastic spacers (PVC chairs) were installed beneath the reinforcement cages in order to create a 30 mm space between the longitudinal bars and ties and the bottom of the columns. The cages were centered and then fixed to the wood floor using handmade aluminum braces in order to avoid possible movements of the reinforcement cage during the casting as shown in Figure 45.

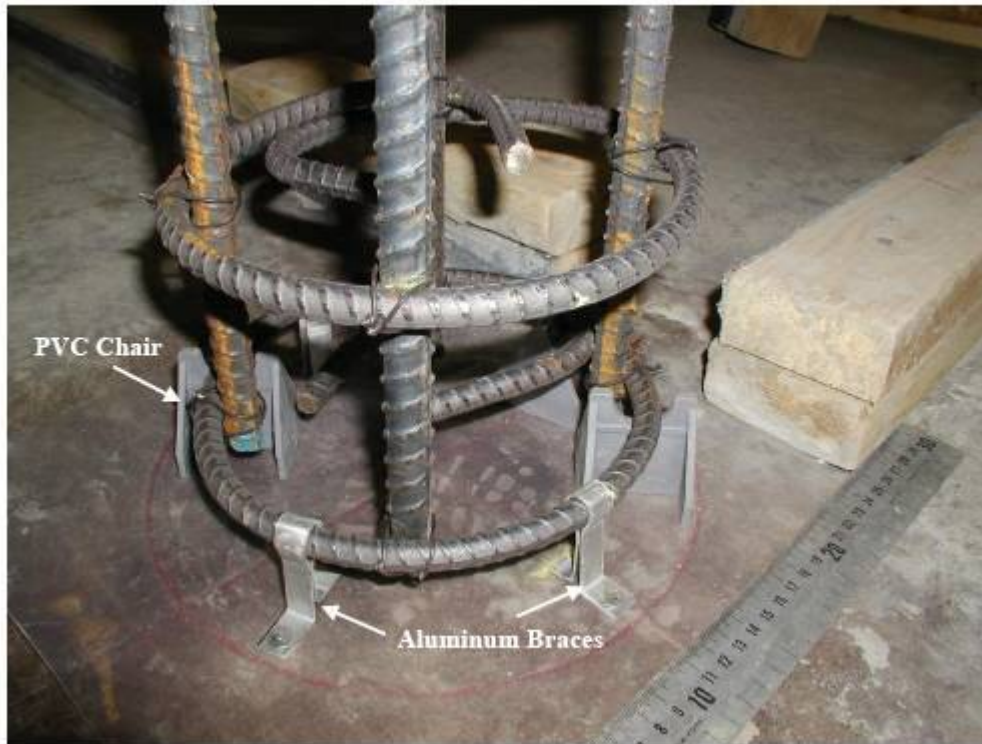
Figure 45: Details of the bottom of the column.

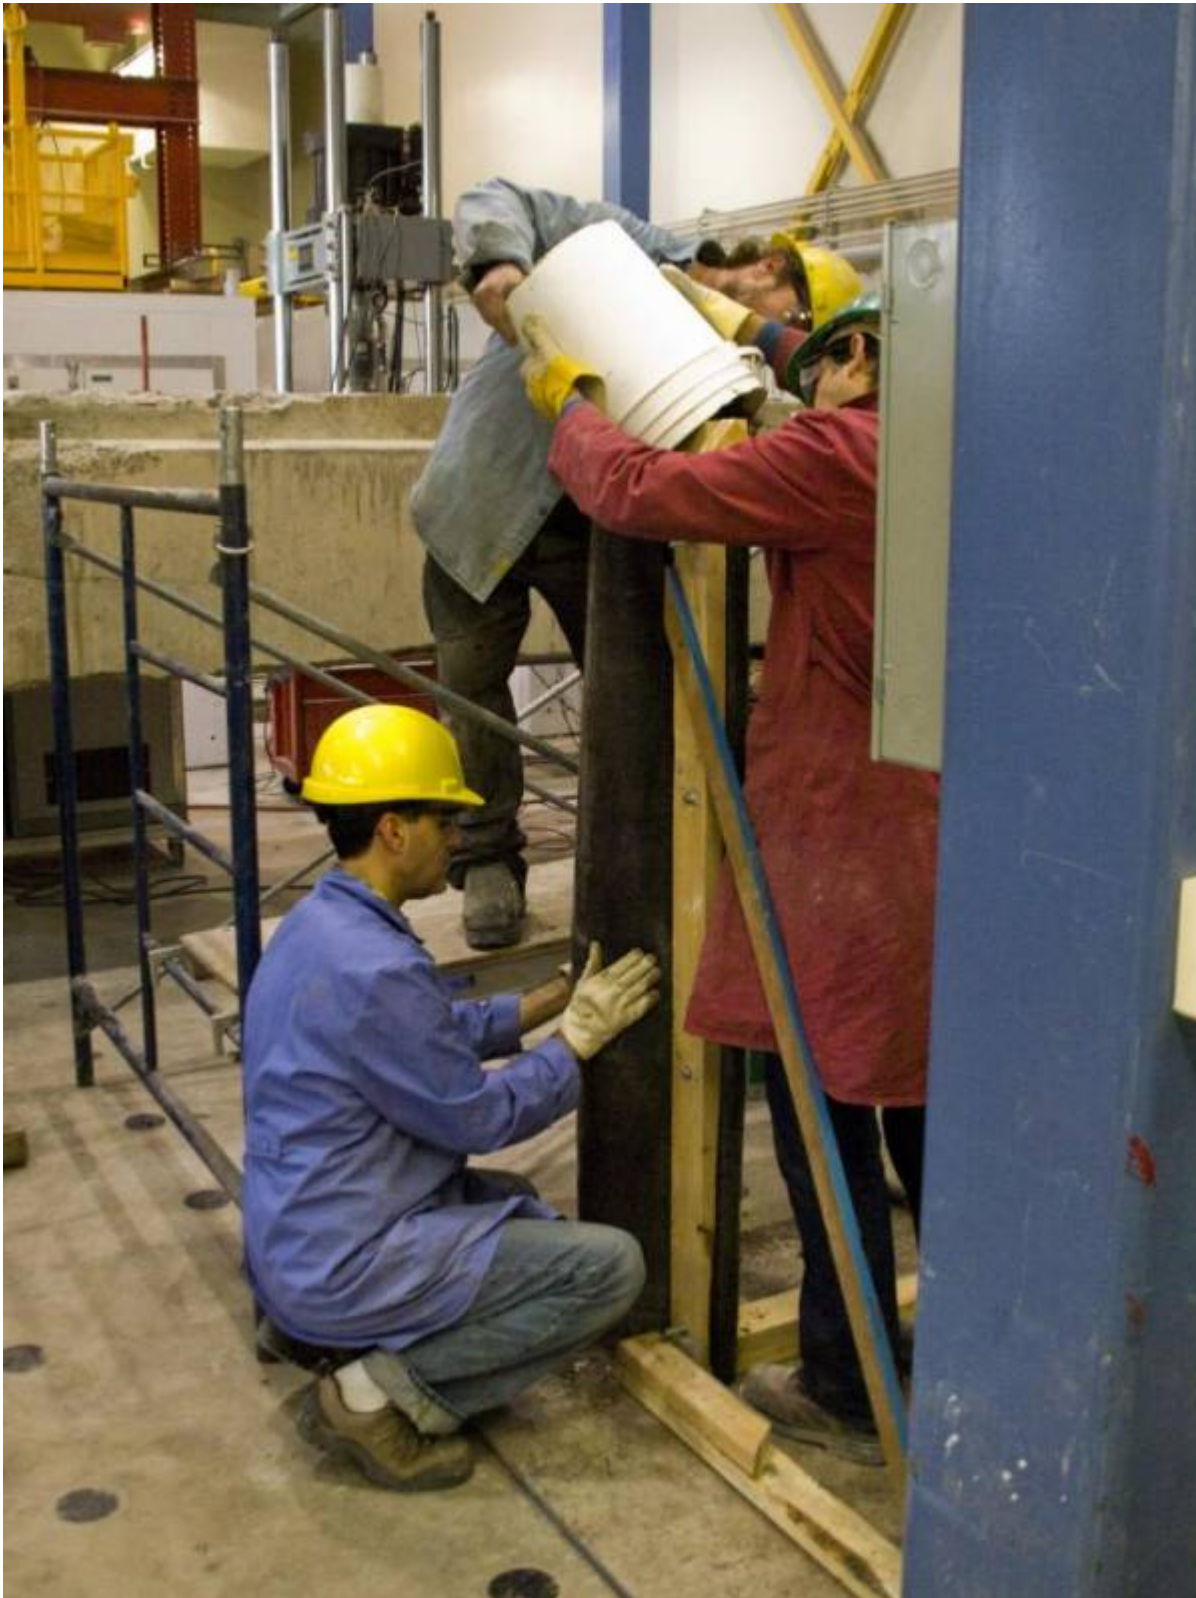
Figure 47: casting of column in fabric formwork.

When the concrete was delivered, the slump value was measured and fifteen 101 by 203 mm (4 by 8 in.) PVC control compressive strength test specimens were cast. Fresh concrete was transferred by hand directly from the truck mixer's discharge chute to buckets and then into the forms as demonstrated in Figure 47. Each specimen was vibrated both inside and outside, using a portable electric internal vibrator at 5 to 15 second intervals. In case of fabric formwork, hand tapping the mold wall was also used to vibrate the concrete and help the bleeding of the air bubbles and extra water from the concrete. All columns and companion cylinders were cured in the same manner. Forms were stripped after one day, after which the columns, as well as the control samples were cured for another 3 days using wet burlap and plastic sheets as vapour barrier cover. Unlike in the cardboard formed columns, no sign of color variation was observed in fabric formed columns. No imperfections such as bug holes or the appearance of large aggregates were seen on the fabric-formed concrete surface. Such column could be easily used as exposed concrete structural members with no necessity for expensive patch ups, epoxy coatings or paintings or architectural veneers.

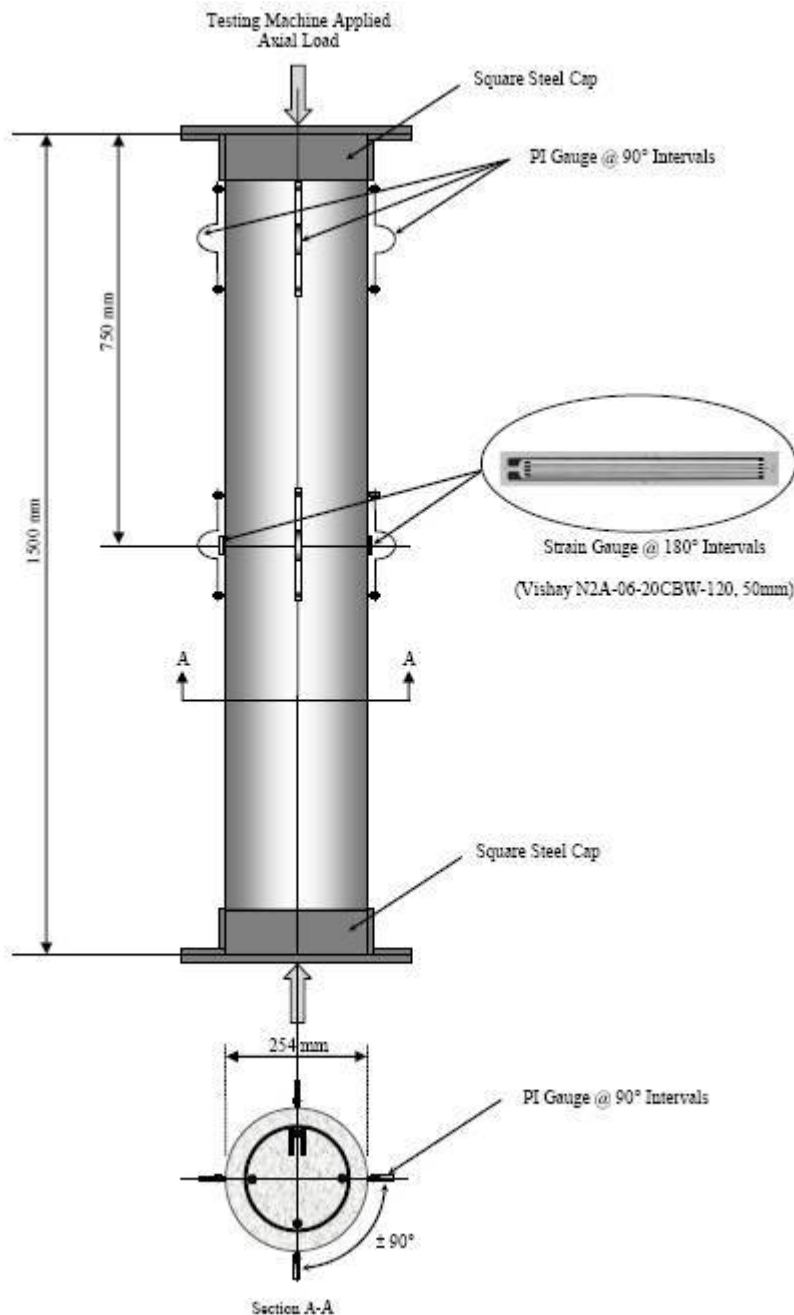
Figure 48: Configuration of the instrumentation of the concrete columns.

Cured, ready-to-test columns were instrumented at mid-height and top end to measure the longitudinal and circumferential strains under the axial load. To measure circumferential strains, two strain gauges

were installed on mid-height of each column, 750 mm from the top end with a 180 degree interval. The concrete surface was first scrubbed with a grinder before the installation of the strain gauges. Voids were then filled with epoxy. After about one hour, extra epoxy was removed by sanding the surface down. Strain gauges were then attached to the smooth void-free concrete surface using adhesive. Strain gauges were tested for correct resistance after installation using a volt meter. Wires were soldered to the strain gauges and then covered with a protective film of acrylic coating to protect them from possible damage before testing. Except the first two columns (FF-NC-1 and CT-NC-1) which had pi-gauges only on mid-height, a total of eight pi-gauges were in-stalled on each column. Four pi-gauges were placed on mid-height and four at the top end of each column to measure the displacement over the initial 200 mm length of the pi-gauges as shown in Figure 48. A Data Acquisition System (DAQ) was used to record the information gathered from 11 channels coming from the column instrumentations and testing machine (8 channels for the pi-gauges, 2 channels for the strain gauges and one channel for the load applied to the columns by the machine). Strain and pi-gauges were all tested for proper resistance and calibration just before every test session.

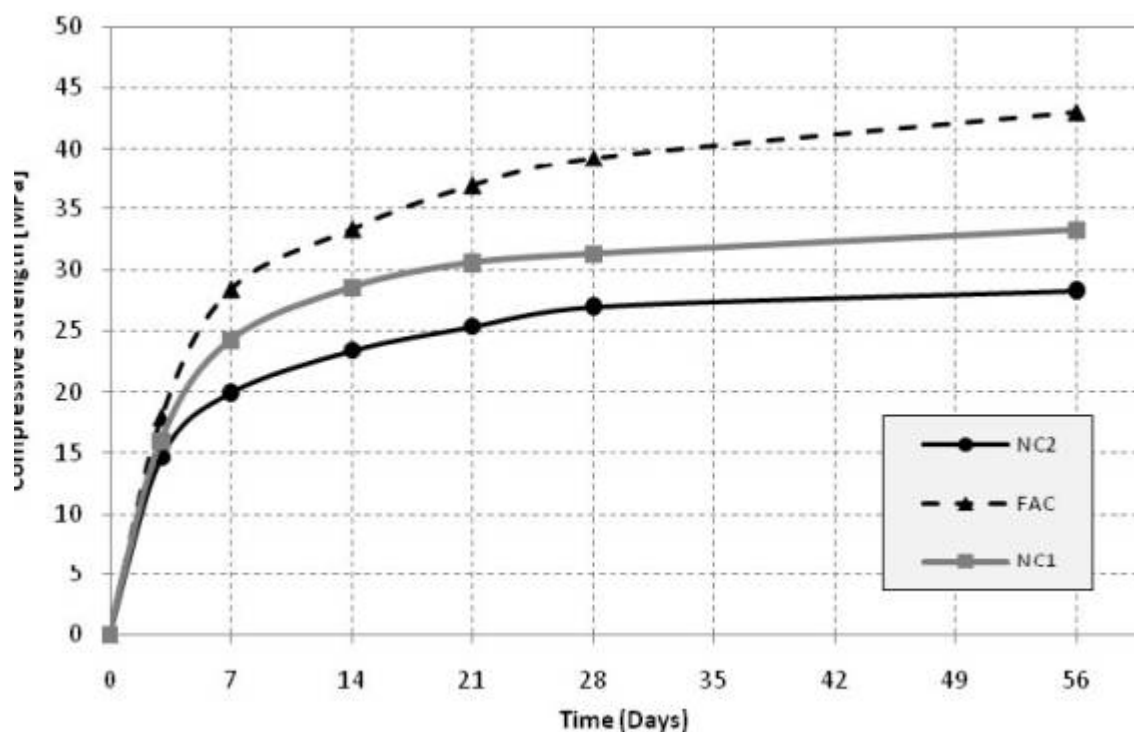
Figure 49: Concrete strength gain with time.

A compression testing machine was used to test the companion 101 by 203 mm (4 by 8 in.) concrete cylinders at the ages of 3, 7, 14, 28 and 56 days. All cured columns and the concrete cylinders were taken out of their molds simultaneously and were kept in the laboratory till testing. Figure 49 provides the data concluded from the cylinder compression tests. Both batches were specified to reach compressive strength of 25 MPa at 28 days but as the results show, the flyash concrete gained more compressive strength compared to the normal concrete. As seen in Figure 49, average compressive strength of the flyash sample at 28 days was measured as 39.2 MPa while the normal concrete specimens had average compression strength of 27 and 28.30 MPa. The actual compressive strength in both concretes was used to estimate the actual maximum axial load capacity of the columns.

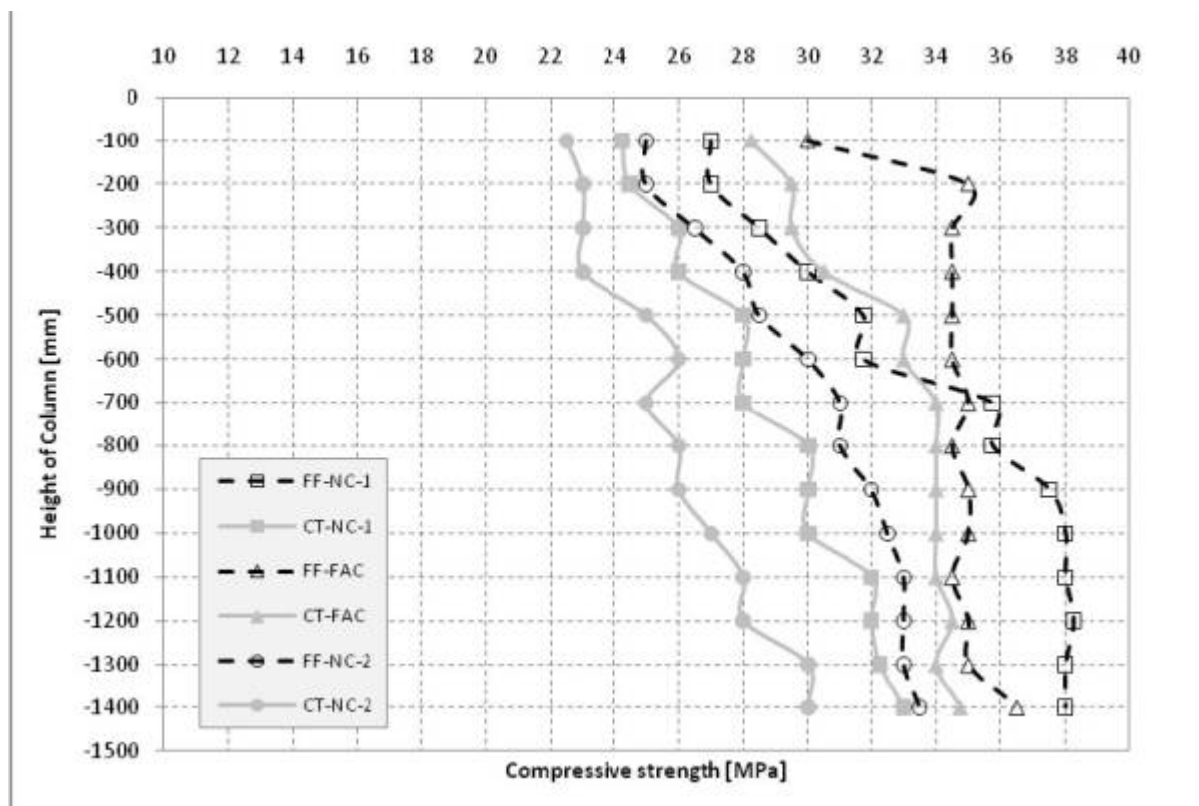
Figure 50: Results from the Rebound tests showing the variation of strength...

As seen in the chart, all columns formed with fabric showed more surface strength than those formed with cardboard. When normal concrete is used, the difference between the compressive strength of the specimens cast in cardboard versus fabric formwork at the bottom of the column is between 12 and 15%. The difference between the formworks when using flyash concrete has minimal significance (5% difference). This is an indication of flyash particles possibly clogging fabric pores and therefore, reducing the amount of water bleeding and eventually resulting in less increase in compressive strength. In

addition, regardless of the formwork type and referring to the results obtained from Schmidt hammer tests, the top end of the columns always proved to be weaker than other sections of the column. A phenomenon that appeared in both cardboard and fabric formed columns due to less compaction and less concrete density at top end of each column.

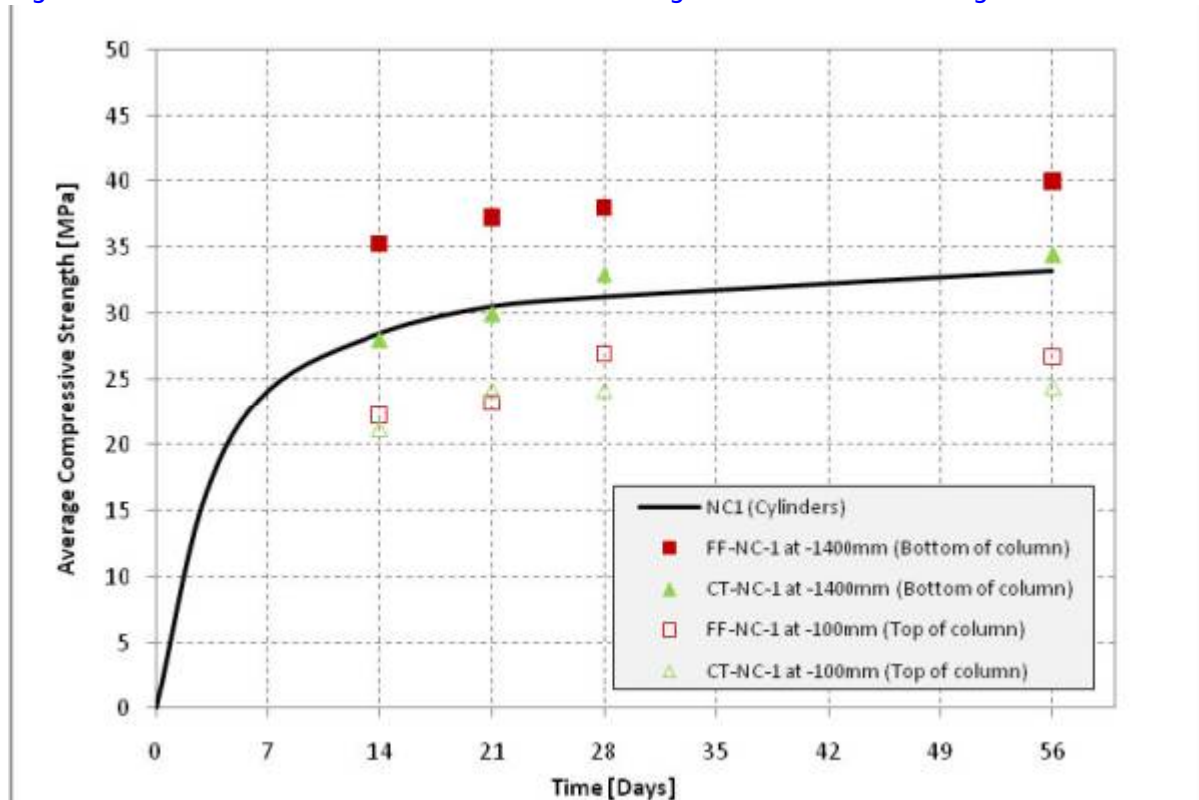
Figure 51: Normal concrete cylinders compared to Schmidt hammer results (Columns...

Compression strength test results from Schmidt hammer test have been compared to those from cylinder test for both normal and flyash concrete. As seen in Figures 51, 52 and 53, there are some fluctuations between the results obtained from Schmidt hammer and the PVC formed cylinders. The filled markers in the graph represent the bottom of the column, while the empty ones represent the top of the column.

As seen in Figure 51, compared to results from cylinder tests fabric formed column has gained an average of 21.8% extra strength at the bottom of the column while the bottom of the cardboard formed column shows almost the same results as the cylinders. At the top of the column, both cardboard and fabric formed columns showed an average of 28% less strength compared to the cylinder test results. As seen in Figure 52, cylinder test results for flyash concrete show more compressive strength than both top and bottom readings of the Schmidt hammer.

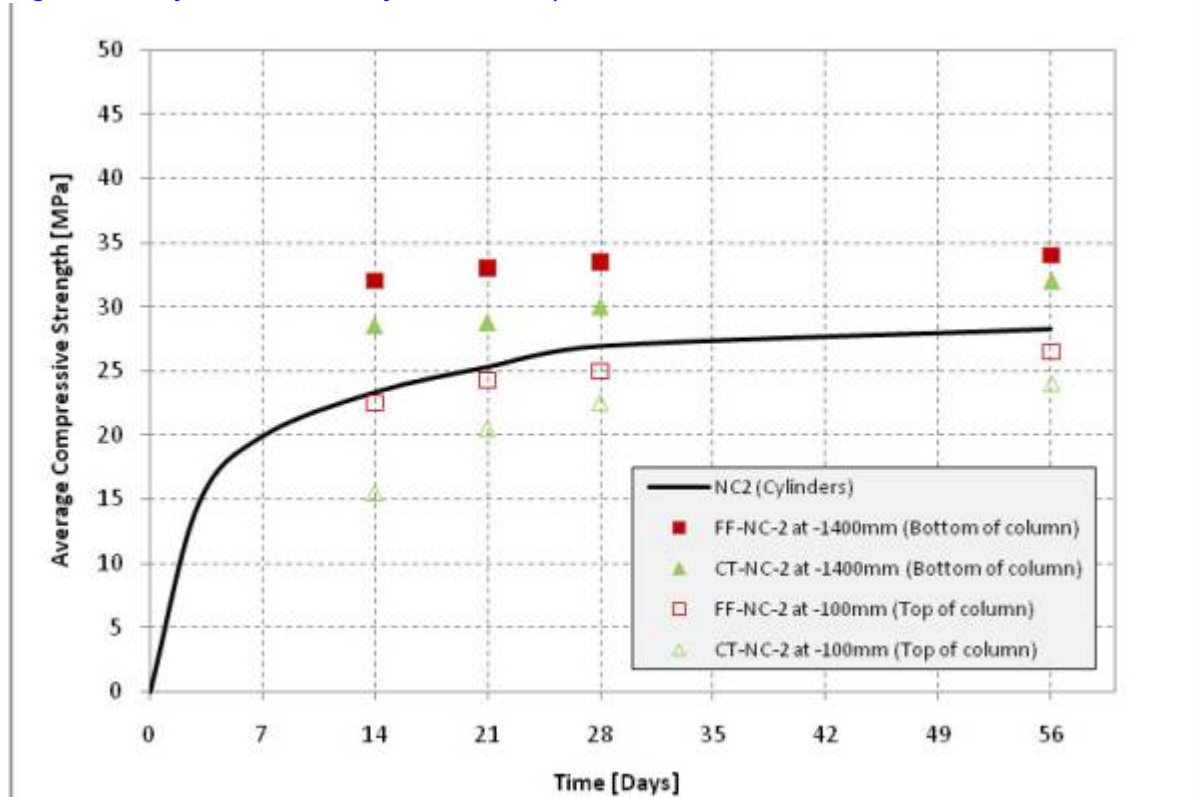
Figure 53: Normal concrete cylinders compared to Schmidt hammer results (Columns...

The difference between the readings of the Schmidt hammer at different ages stays constant but for some reason does not follow the strength indicated from cylinder tests. For the second set of normal concrete columns and cylinders, it can be seen in Figure 53 that compared to results from cylinder tests, fabric formed column has gained an average of 28% extra strength at the bottom of the column while cardboard formed column shows 14% difference. Schmidt hammer reading from the top of the columns shows 15% less compressive strength for cardboard formed columns and 6% less for fabric formed columns.

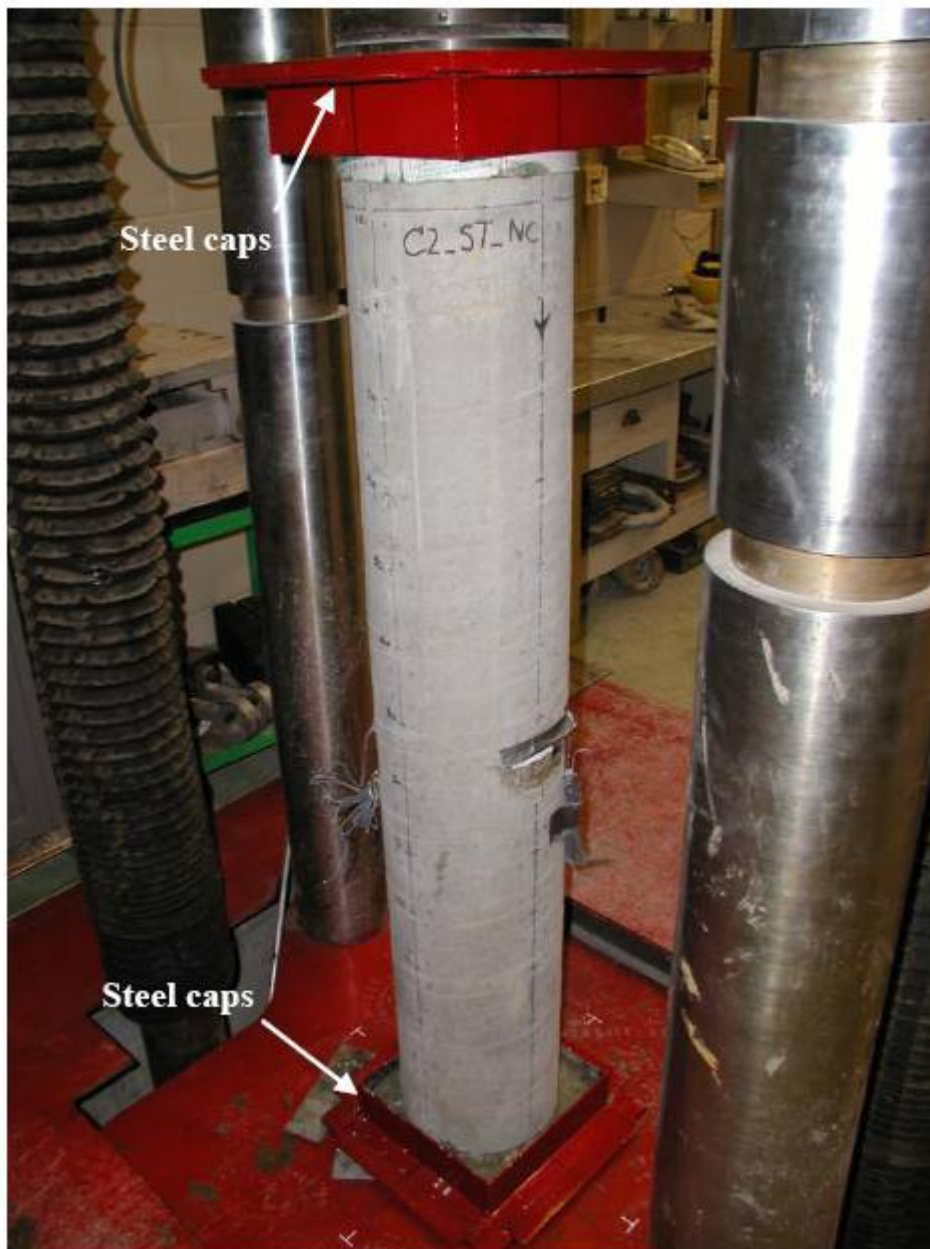
Figure 54: Columns test setup.

Two 280 by 280 mm (11 by 11 in.) custom made steel caps were made using a square base plate and four pieces of steel L-profiles welded vertically to the base plate as shown in Figure 54. Steel caps were made to confine the levelling grout on both ends of each column so that the axial load was evenly distributed over the column sections. No lateral supports were used to support the caps or columns.

Sika Grout 212 HP was used to level top and bottom of each column. Each column was first brought to the loading position, then lifted vertically using straps and cross head of the loading machine for about two feet. While the column was hung in the air, the steel cap was filled with 10-20 mm of the grout mixture.

The column was then slowly brought down to sit in the centre of the cap. After levelling the columns in a vertical position, specimen was left in place for 48 hours prior to testing day to let the grout gain its proper strength. To cap the top end of the column, a 75 mm circular cardboard mold was cut and used as a collar to retain the fresh grout in place when grouting the top end. First the collar was installed on top of the column, leaving only small room for the levelling grout. Then, grout mix was poured on top of the concrete. Steel cap was immediately placed on the fresh grout and levelled. A slight engagement of the machine's load piston also helped the cap being fixed in position until the grout set.

Due to the hand-made construction of the fabric molds, the columns cast by fabric formwork, did not have a completely uniform diameter along their lengths, making for a slight undulation along their sides. This slightly uneven surface did not allow the direct use of a carpenter's level for alignment and vertical positioning. Once the columns were brought down to sit in the fresh grout inside the caps, they were aligned using two Theodolites and then fixed in place using the machine load piston. To achieve more accuracy in alignment when testing both types of the columns, they were pre-loaded to obtain some data readings and then using the data from the strain and pi-gauges, further adjustments were applied to centre the columns under the loading piston.

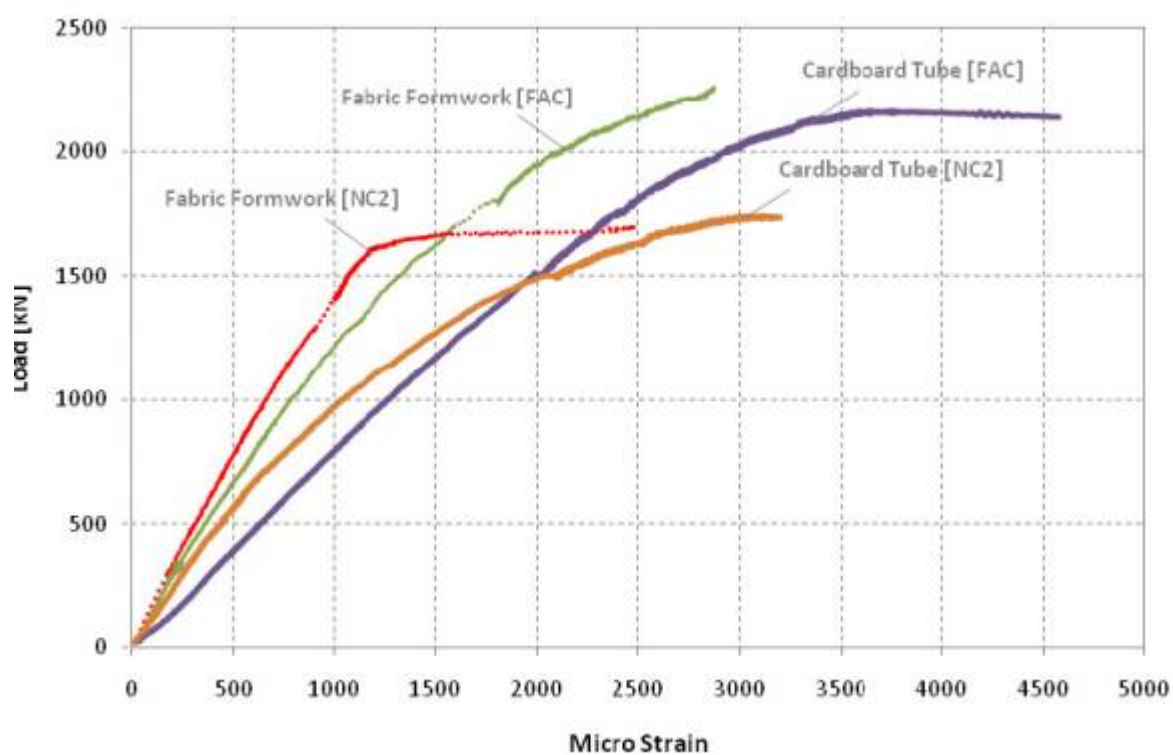
Figure 55: Maximum axial load of fabric-formed versus cardboard-formed steel...

As seen in Table 8, the first two columns (FF-NC-1 and CT-NC-1), normal concrete columns formed with fabric and cardboard, withstood 1850 kN and 2200 kN of axial load, respectively. Maximum axial load of flyash specimen (FF-FAC and CT-FAC) was 2271 kN for fabric formed column and 2165 kN for cardboard formed column. As shown in Figure 55, for the last two columns (FF-NC-2 and CT-NC-2), normal concrete columns formed with fabric and cardboard carried 1703 kN and 1744 kN of axial load, respectively.

The first normal concrete fabric formed column (FF-NC-1) became bulgy and uneven due to improperly installed fabric. This made it more challenging to centre the sample in testing machine. This fabric formed column failed at 1850 kN that is 15.9% lower compared to the companion cardboard formed column CT-NC-1. For this reason, another set of two columns were cast using normal concrete (FF-NC-2 and CT-NC-2). The maximum strain values plotted in Figure 55 are provided in Table 9 for all the columns tested. Regardless of the location of the pi-gauges, these strain values are the highest recorded values in the concrete at the time of failure of the column.

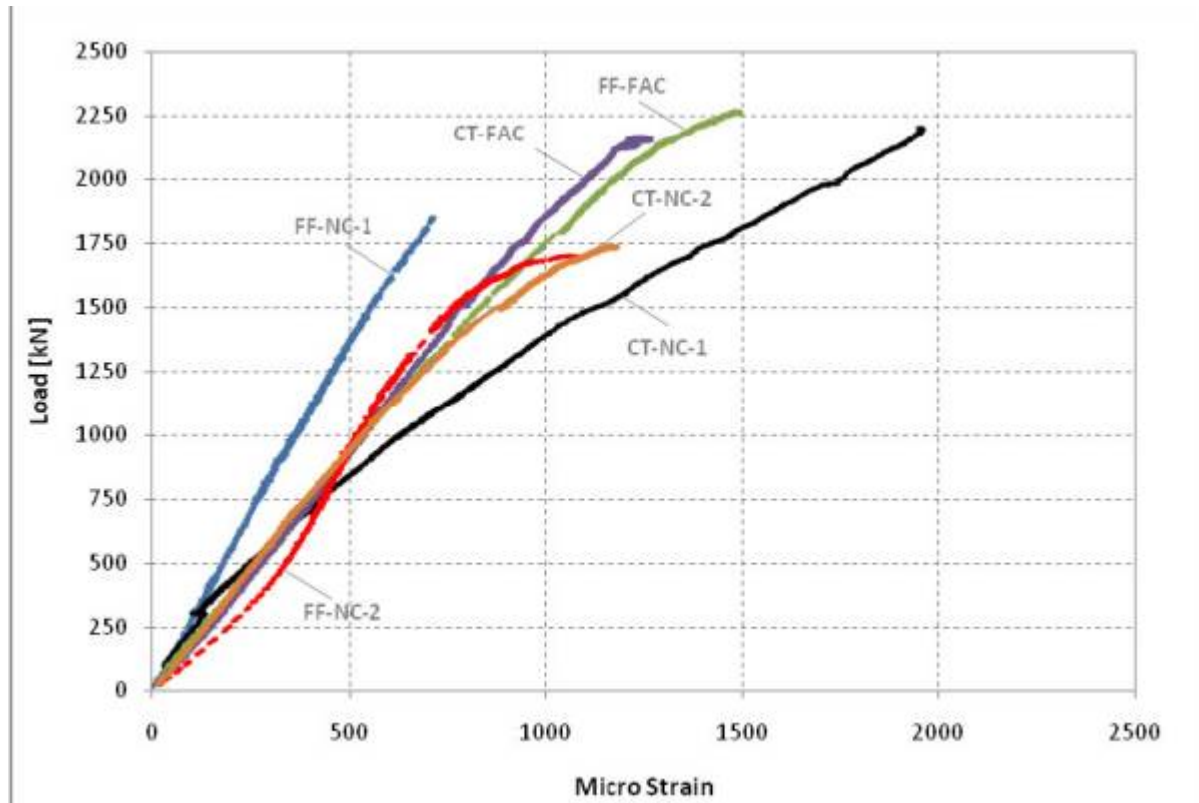
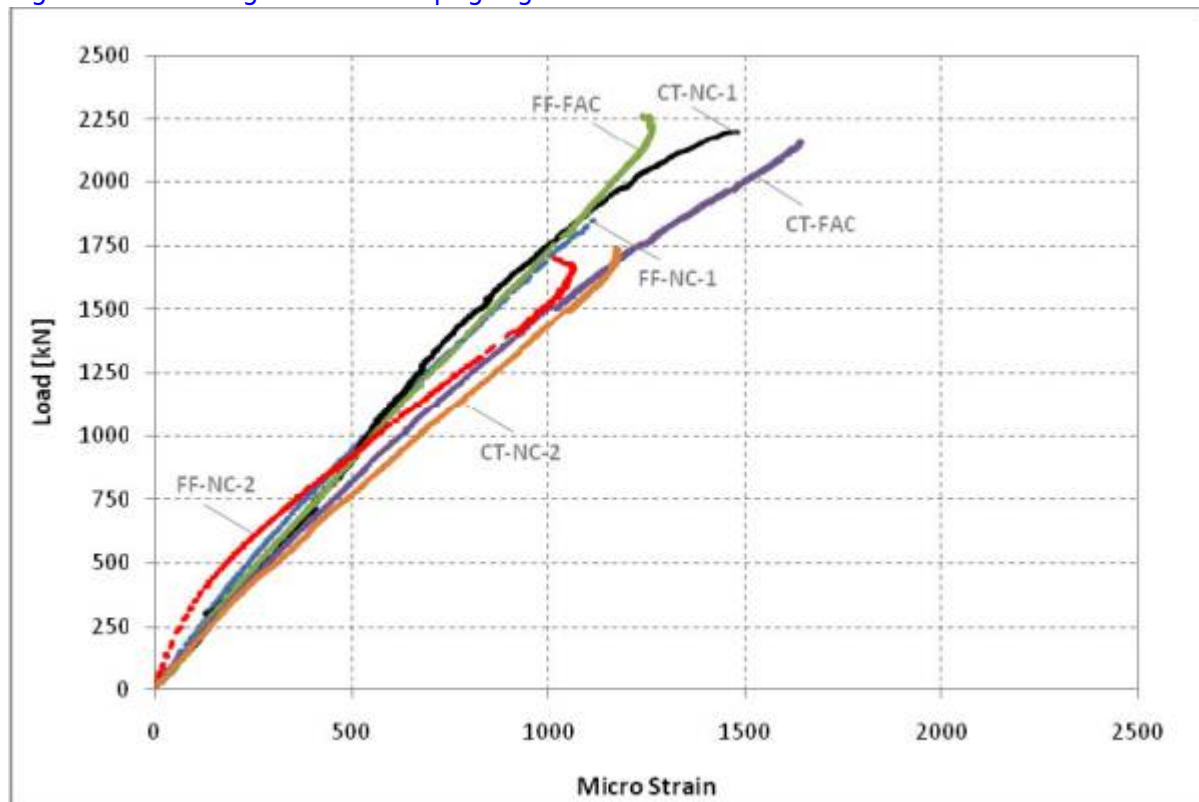
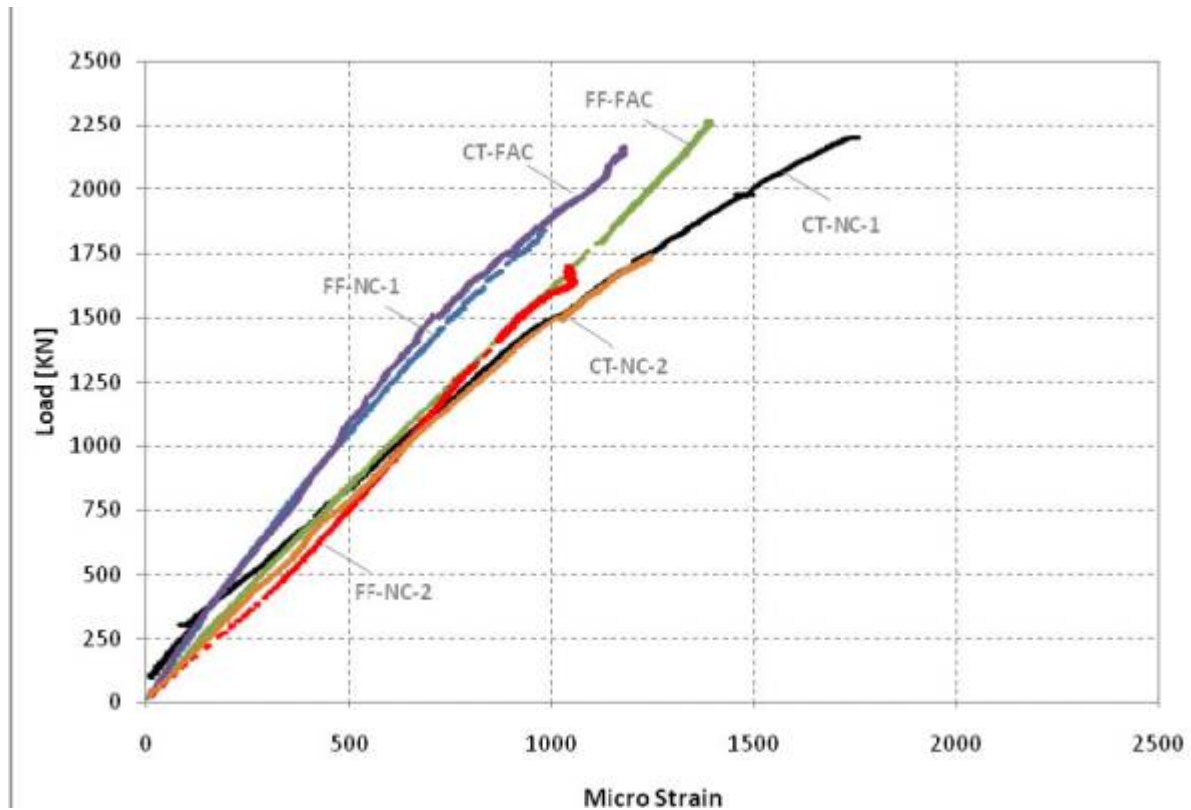
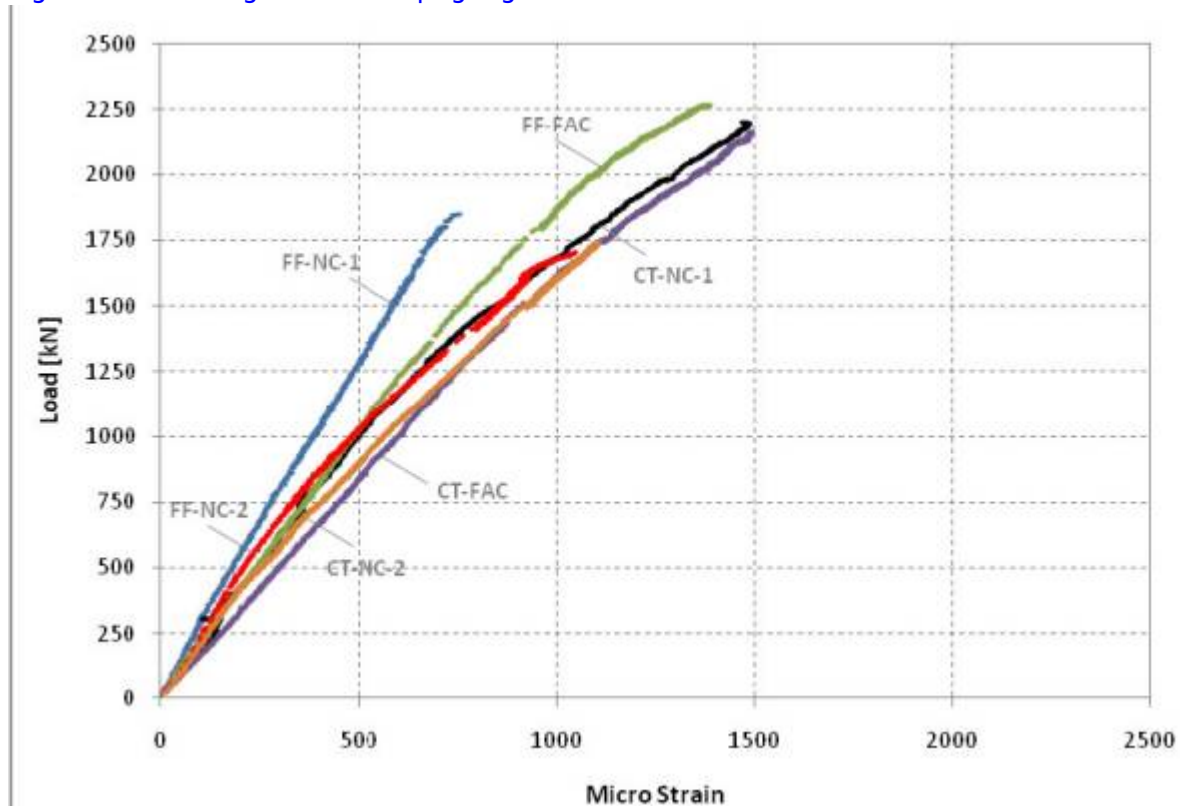
Figure 56: Readings from North pi-gauges at the middle of all columns.

Figure 57: Readings from South pi-gauges at the middle of all columns.

Figure 58: Readings from East pi-gauges at the middle of all columns.

Figure 59: Readings from West pi-gauges at the middle of all columns.

Figure 56 to 59 depict the strains in the middle, while Figures 60 to 63 depict the strains at the top of the column. Each figure represents one location either North, South, East or West and strains of that location in each column were plotted in the same graph for comparison.

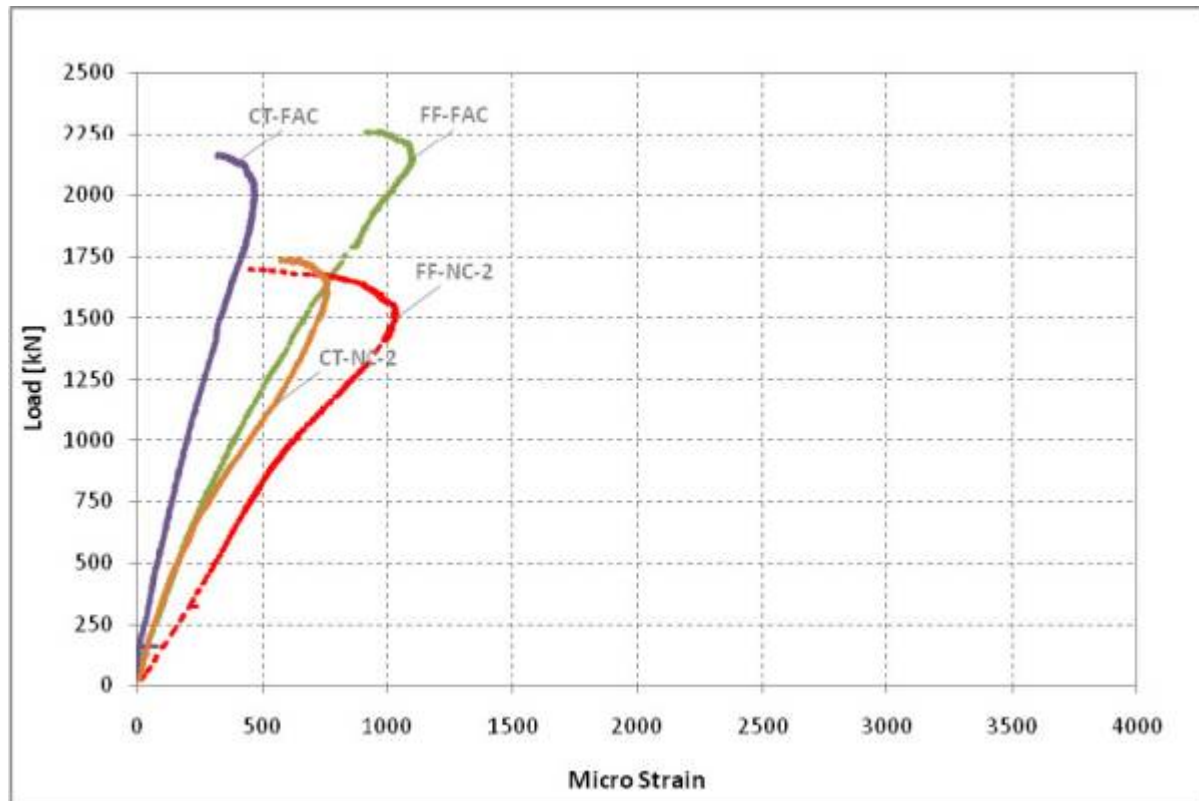
Figure 60: Readings from North pi-gauges at the top of all columns.

As seen in Figure 60 which represents the readings from North pi-gauges at the top of all columns, a trend of reverse strain close to the failure load is observed. This means that as columns were starting to crush at another location, the surrounding concrete was experiencing some tension. Figure 61 represents readings from South pi-gauges at the top of all columns. As seen in this figure, columns undergo much
