Column Tests

In order to evaluate the effect of fabric formwork on structural behaviour of a column, full size fabric-formed and conventionally formed reinforced concrete columns were de-signed and tested to failure under concentric axial load. The variables in these tests were two types of formwork; permeable fabric versus cardboard and two types of concrete; Flyash concrete and normal concrete. The fabric of choice was Geotex 315ST due to its better surface finish.

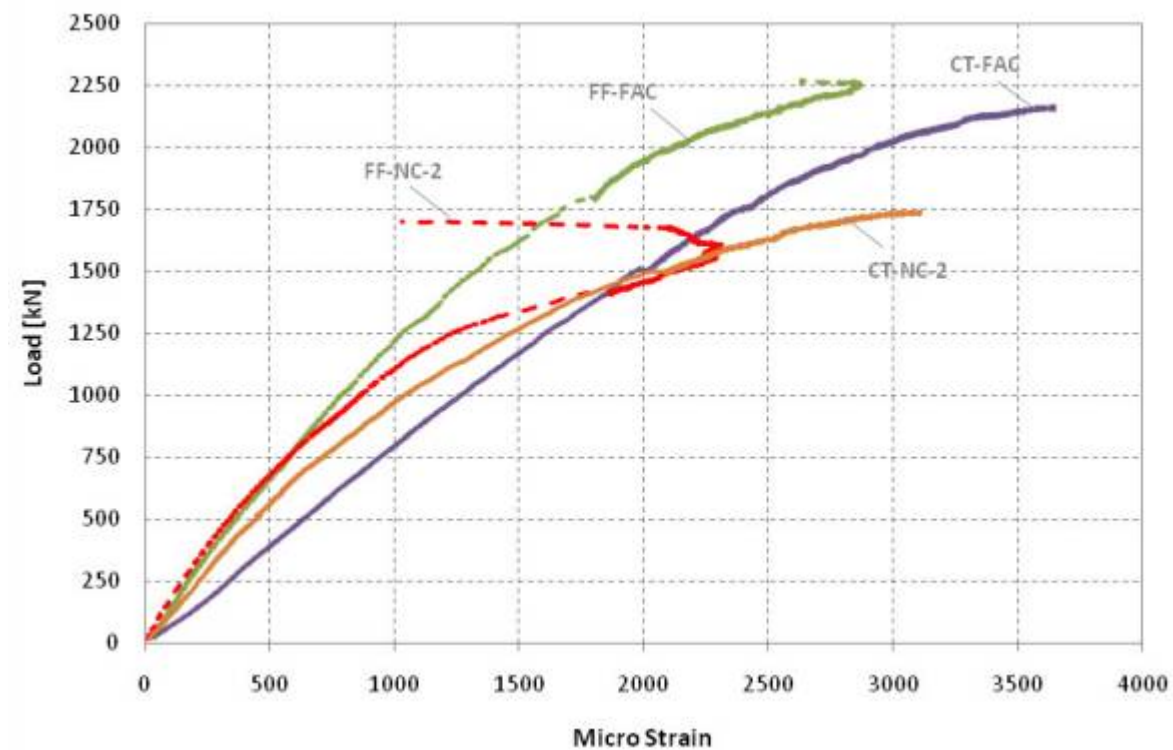
Figure 61: Readings from South pi-gauges at the top of all columns.

As seen in Figure 60 which represents the readings from North pi-gauges at the top of all columns, a trend of reverse strain close to the failure load is observed. This means that as columns were starting to crush at another location, the surrounding concrete was experiencing some tension. Figure 61 represents readings from South pi-gauges at the top of all columns. As seen in this figure, columns undergo much

larger strain values as high as 3600 micro strain at the load of about 2150 kN in case of column CT-FAC. Strain values read from the south pi-gauge of column FF-NC-2 change direction from compression to tension close to the failure load. This has been caused by the uneven failure of the column at top. As seen in Figure 64, the opposite side of the column across from the south pi-gauge has failed in compression and caused some tension in south-top-zone of the column. Figure 62 which represents the readings from West pi-gauges at the top of all columns shows the highest strain in column CT-NC-2 as 3000 micro strain at the corresponding load of 1750 kN. A similar trend is observed in Figure 63 from the values taken from top-East pi-gauges. Column FF-FAC carries 2700 micro strain at the load of 2250 kN. As seen in all top pi-gauge curves, except column CT-NC-2, regardless of the form-work type, flyash concrete experienced more strain than normal concrete. As seen in Figure 65, all six columns failed at the top. This type of failure in columns has been documented before in research conducted by Bazant and Kwon [2] which found that regardless of the cross sectional size of the column, the fracture mechanism stayed the same. The reason for the top end failure is that the top end of a vertically cast member will always have less compressive strength than the lower parts of the member, due to increased pressure and compaction towards the bottom of the mold [3]. This holds true regardless of the formwork used.

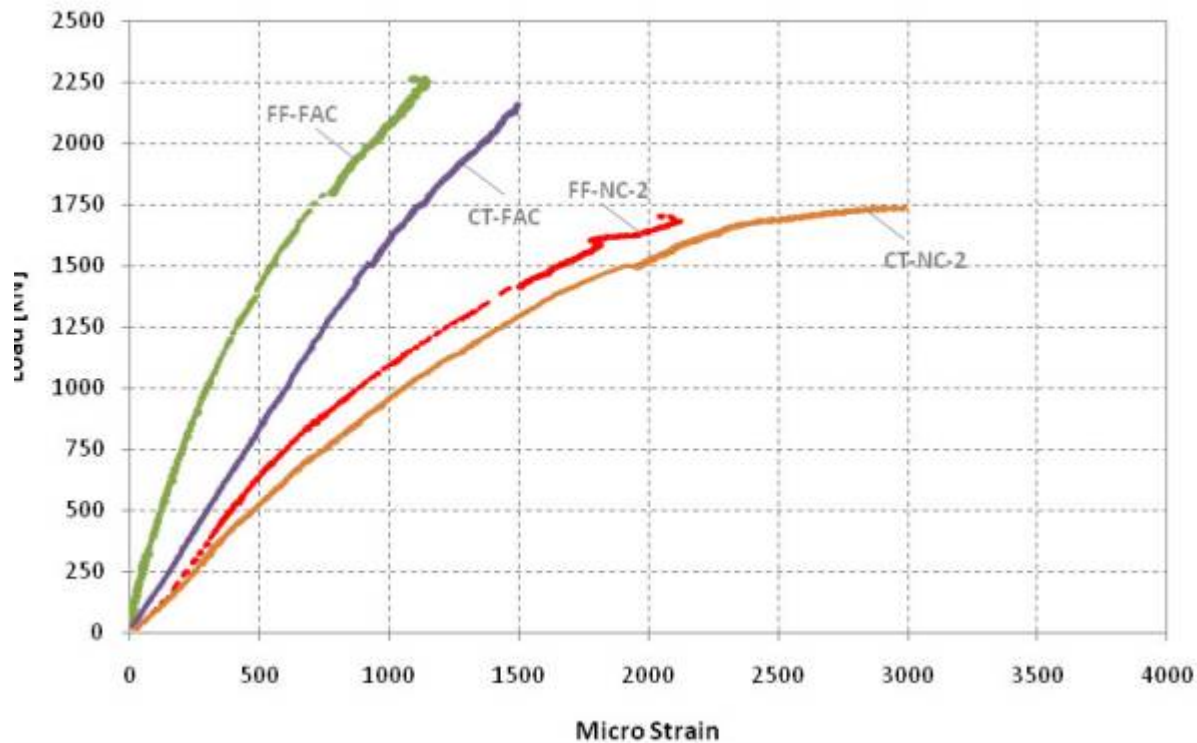
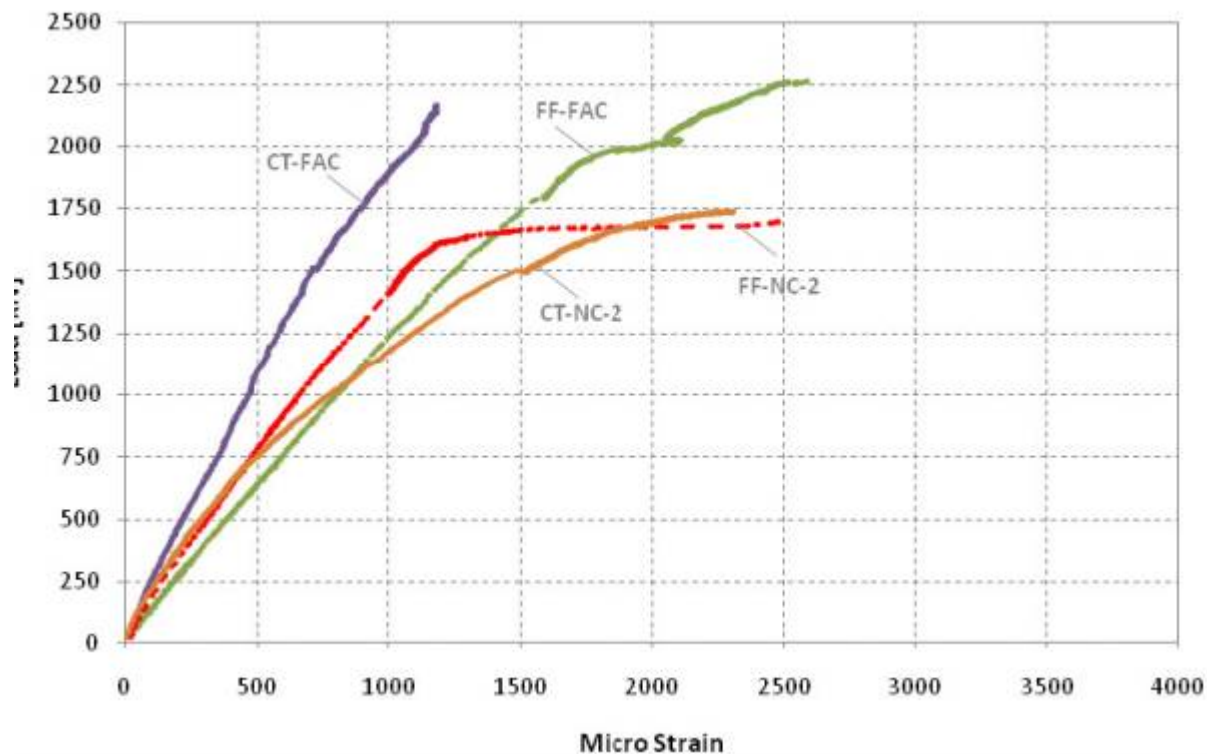
Figure 62: Readings from West pi-gauges at the top of all columns.

Figure 63: Readings from East pi-gauges at the top of all columns.

Figure 56 to 59 depict the strains in the middle, while Figures 60 to 63 depict the strains at the top of the column. Each figure represents one location either North, South, East or West and strains of that location in each column were plotted in the same graph for comparison.

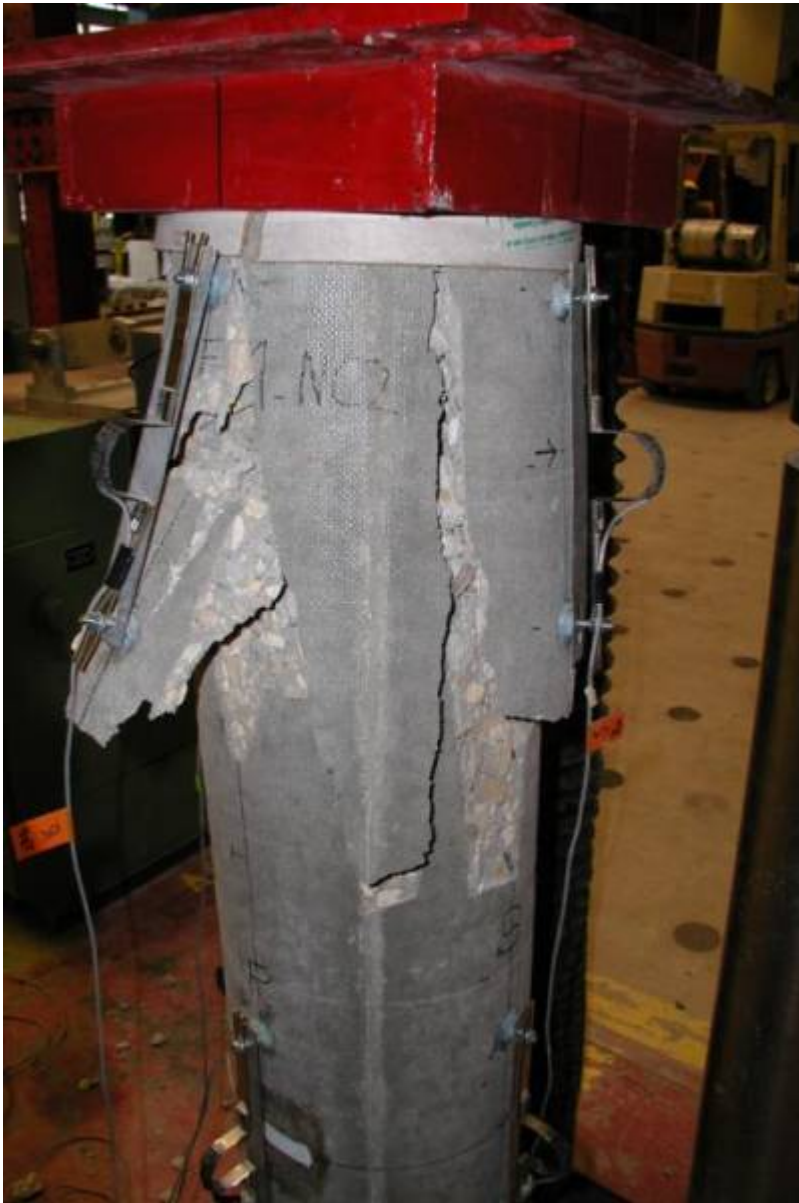
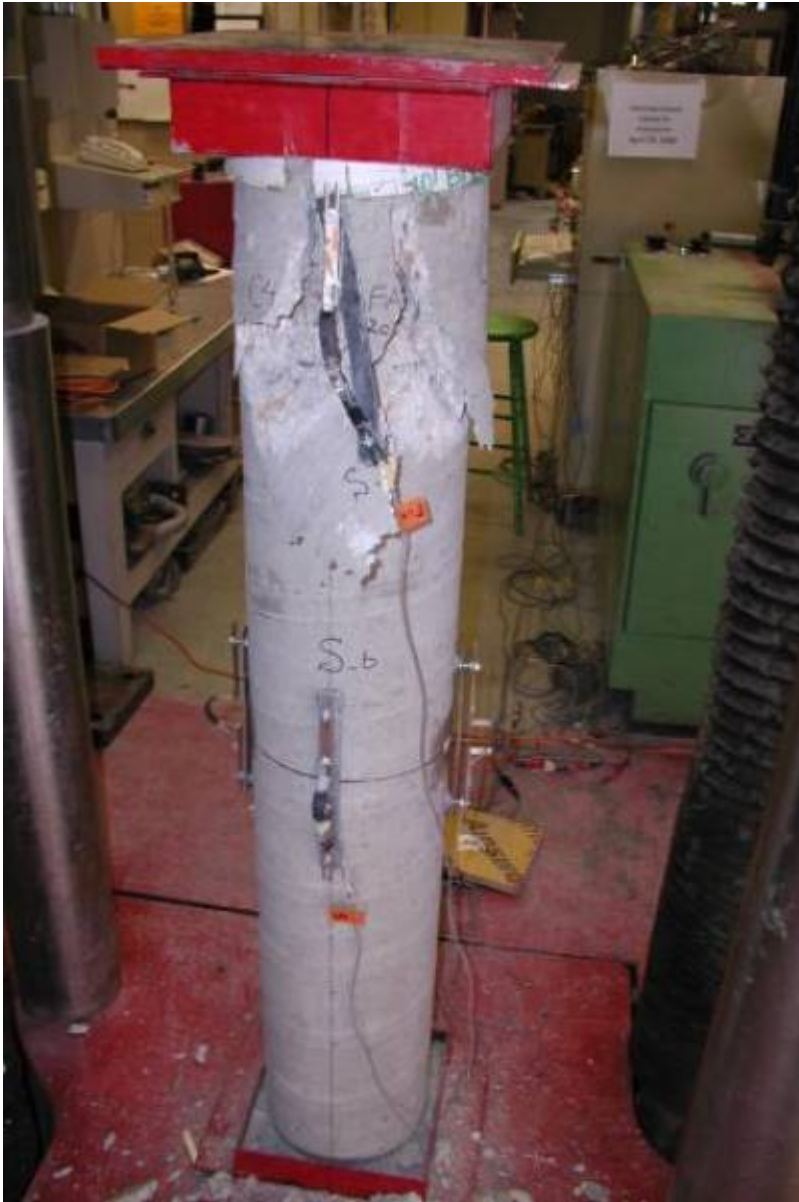
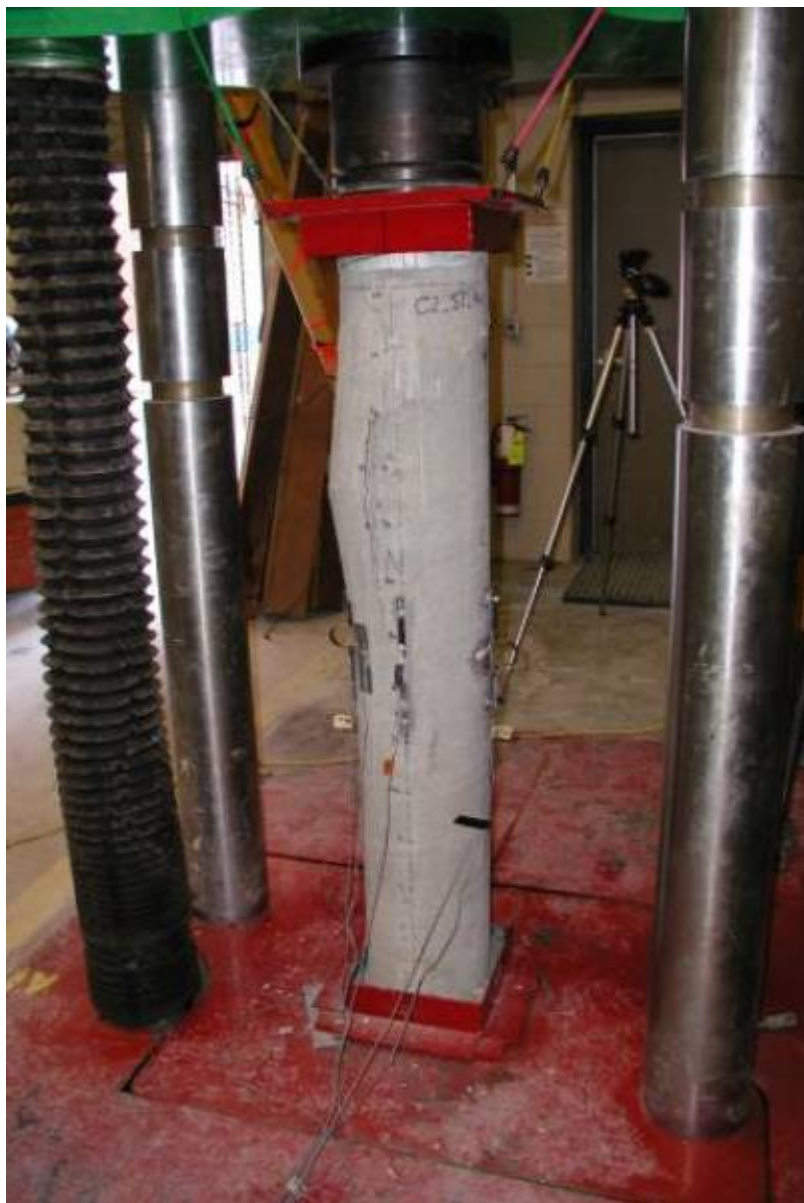
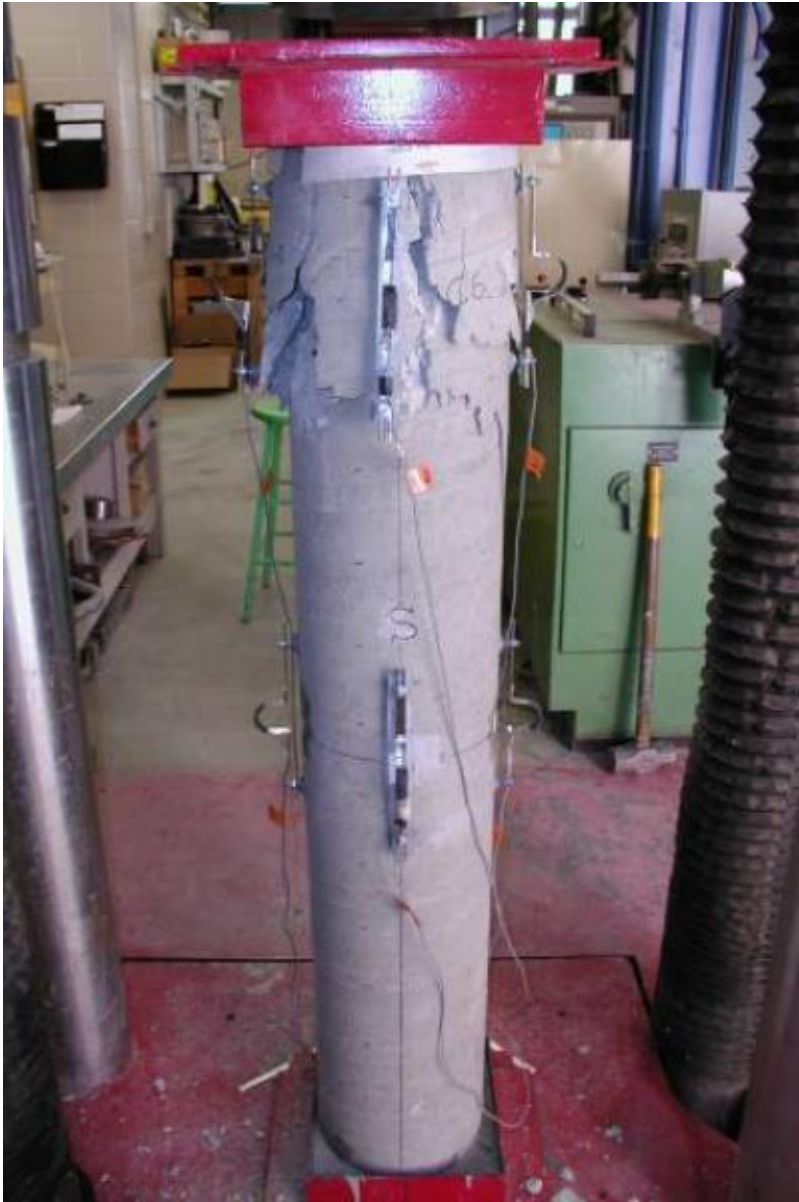
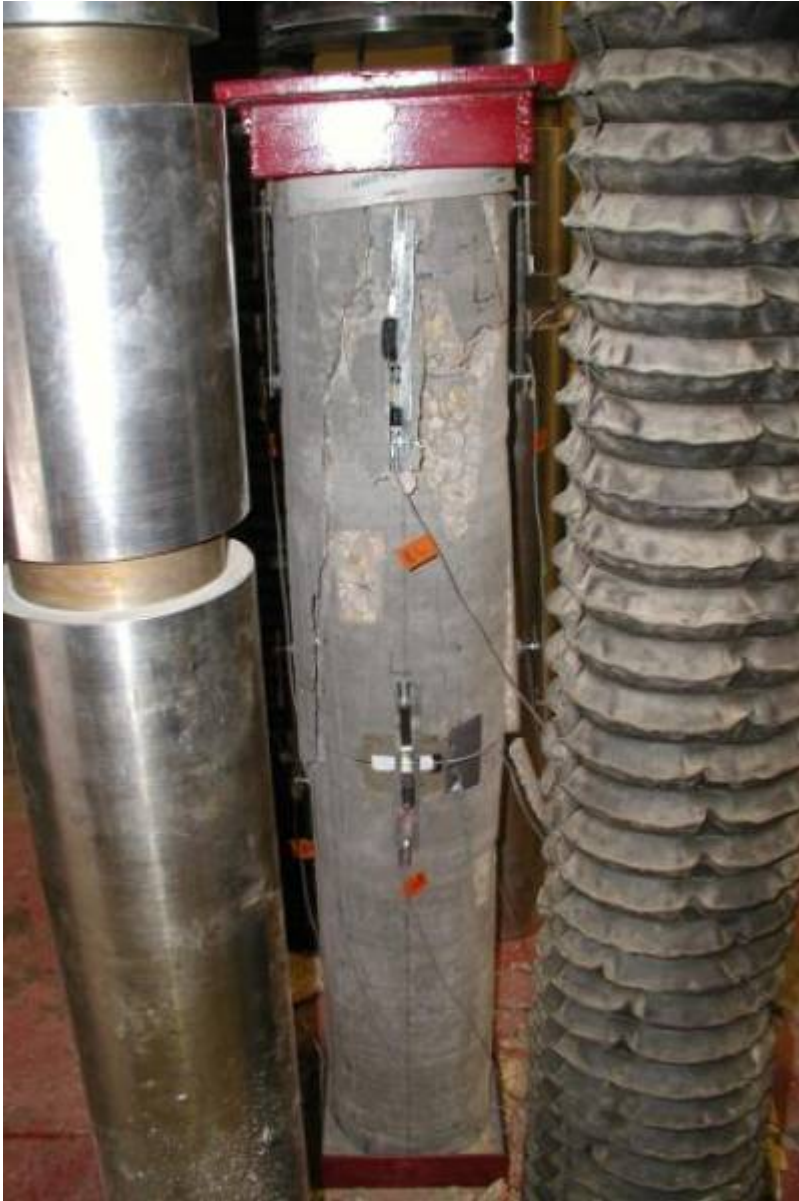
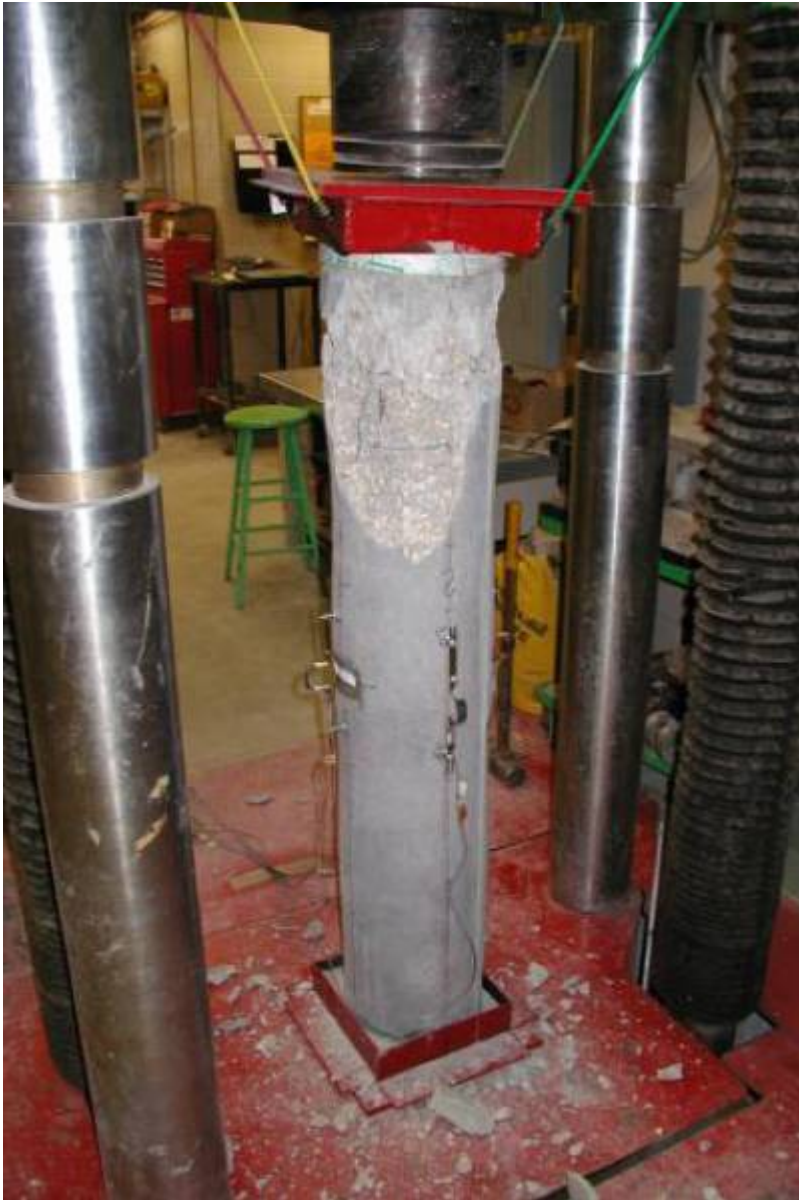
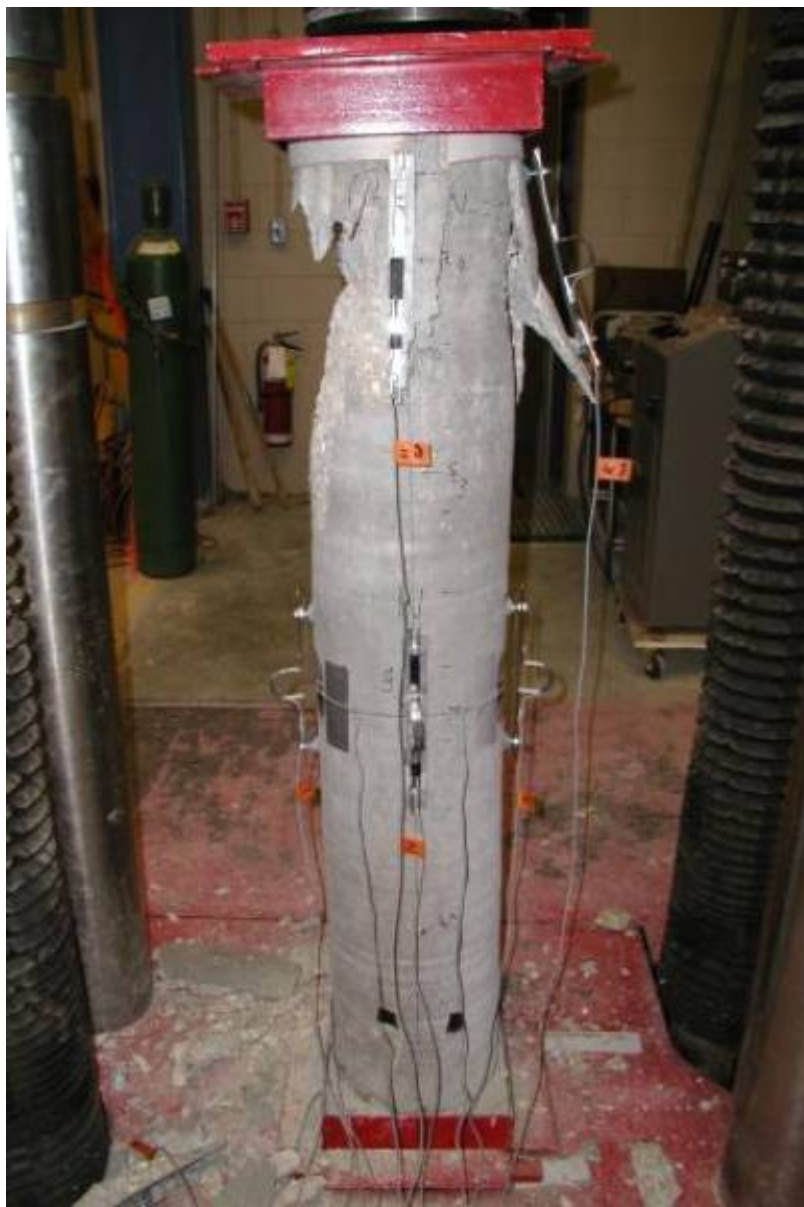
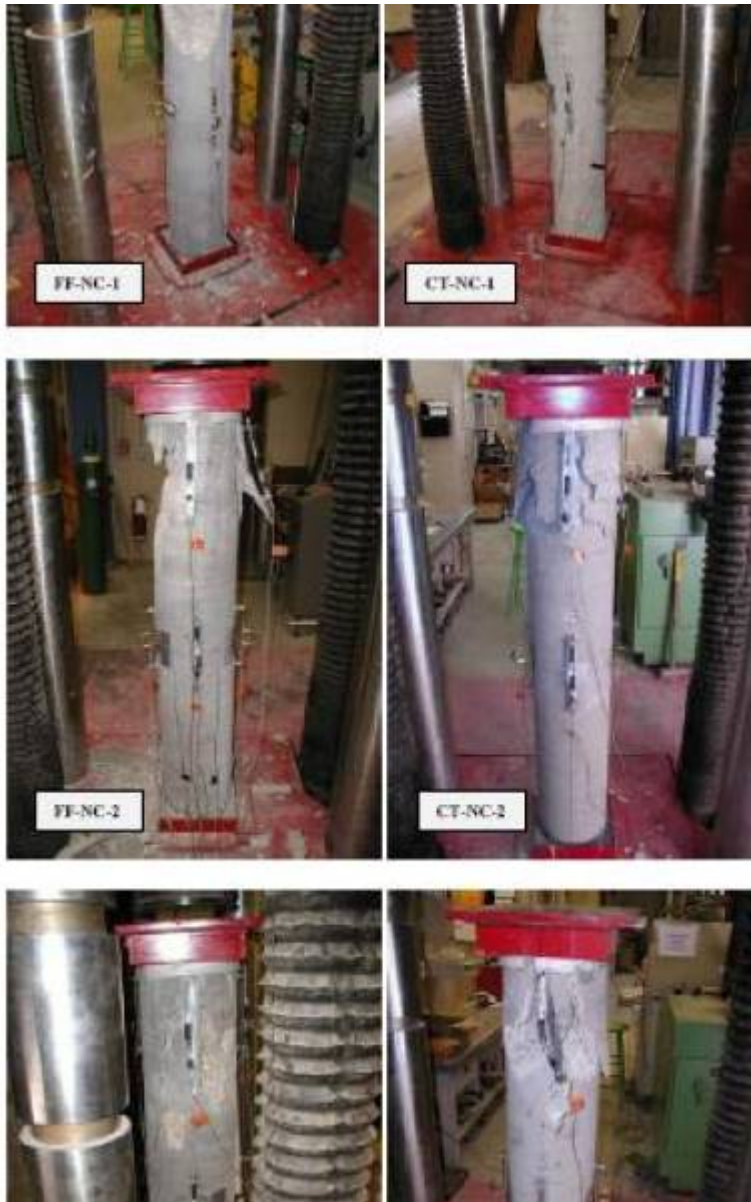
Figure 64: Column FF-NC-2 after failure.

Figure 65: Column CT-FAC after failure.

Figure 65: Column CT-NC-1 after failure.

Figure 65: Column CT-NC-2 after failure.

Figure 65: Column FF-FAC after failure.

Figure 65: Column FF-NC-1 after failure.

Figure 65: Column FT-NC-2 after failure.

Figure 65: All columns after failure.

In order to be able to better observe behaviour and the failure pattern of the columns, all tests were videotaped. The failure pattern of the columns was a factor to be investigated in this phase of the study. Based on observations of the two cardboard and two fabric-formed column tested, the failure of the cardboard formed column started with crushing on top and then spalling till failure. Cardboard-formed columns presented a typical gradual failure with no sign of brittleness, no longitudinal cracks and no flaking. On the other hand, fabric-formed columns started with crushing on top and development of longitudinal cracks at the same time along with spalling. Also, some flaking and relative sudden failure of

outside surface was observed. Photographs of these column failures are shown in Figure 65 (page 82).

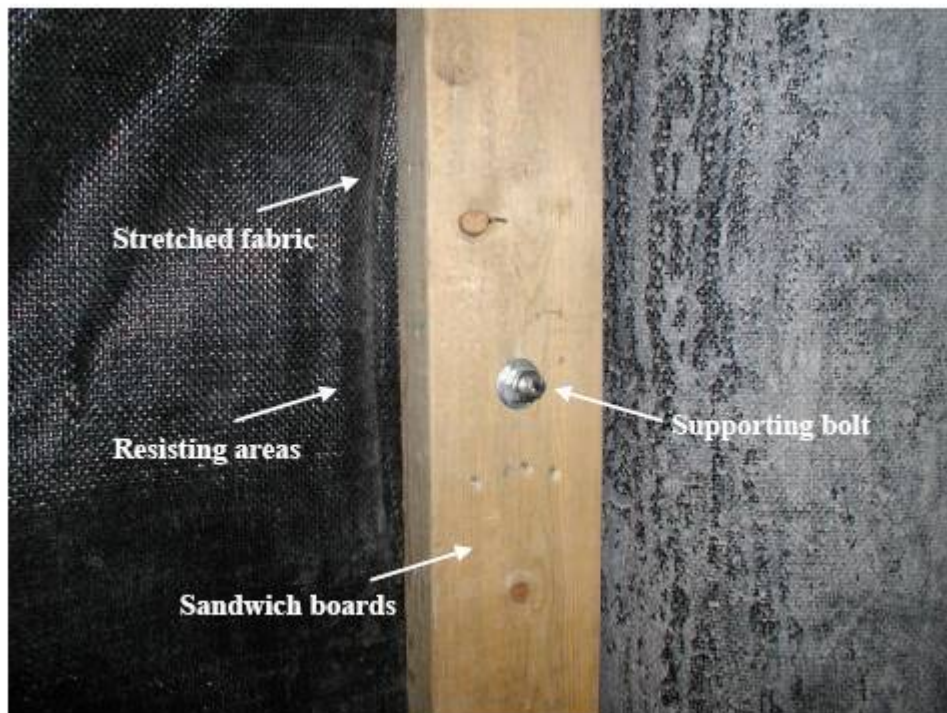
Figure 66: Tension created in fabric due to hoop pressure of the liquid...

Our first attempt of casting a concrete column using fabric formwork was not quite successful. The column was bulgy at some points and it did not have constant diameter along its length while cardboard molds that are industrially manufactured are perfectly symmetrical tubes and form perfectly symmetrical columns. The reason for this problem was that the fabric was sandwiched between the boards using bolts and when the concrete was poured inside the mold, the hoop tension created by the liquid concrete pulled the fabric out between the bolts (Figure 66). Areas supported by bolts resisted the pressure while parts away from bolts deformed creating bulges along the length of the hardened concrete column, as shown in Figure 67.

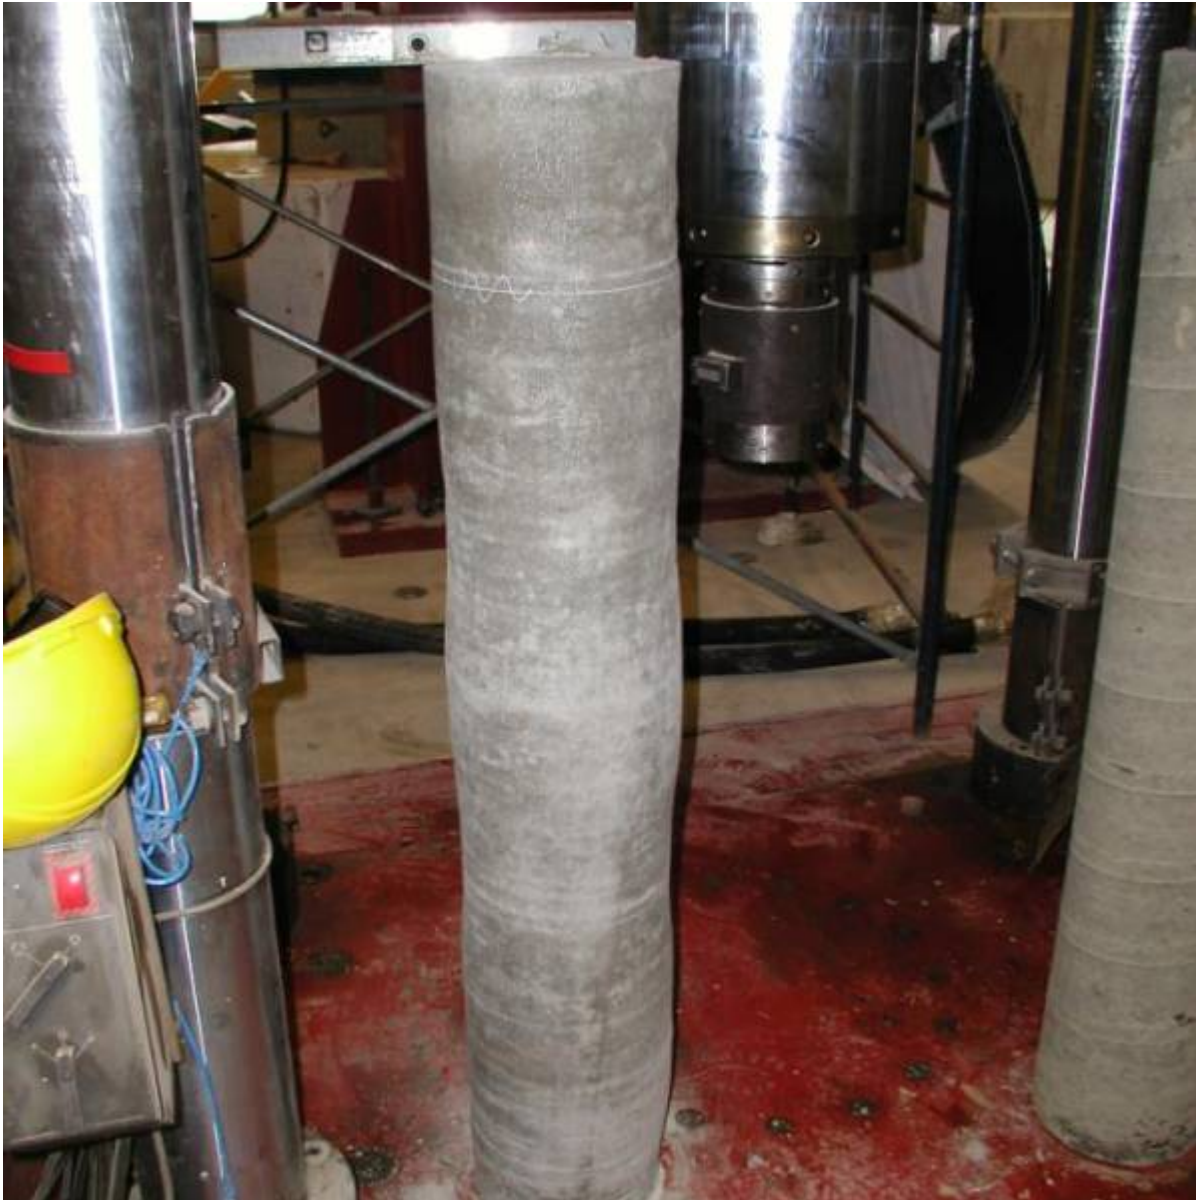
Figure 67: Bulged concrete column.

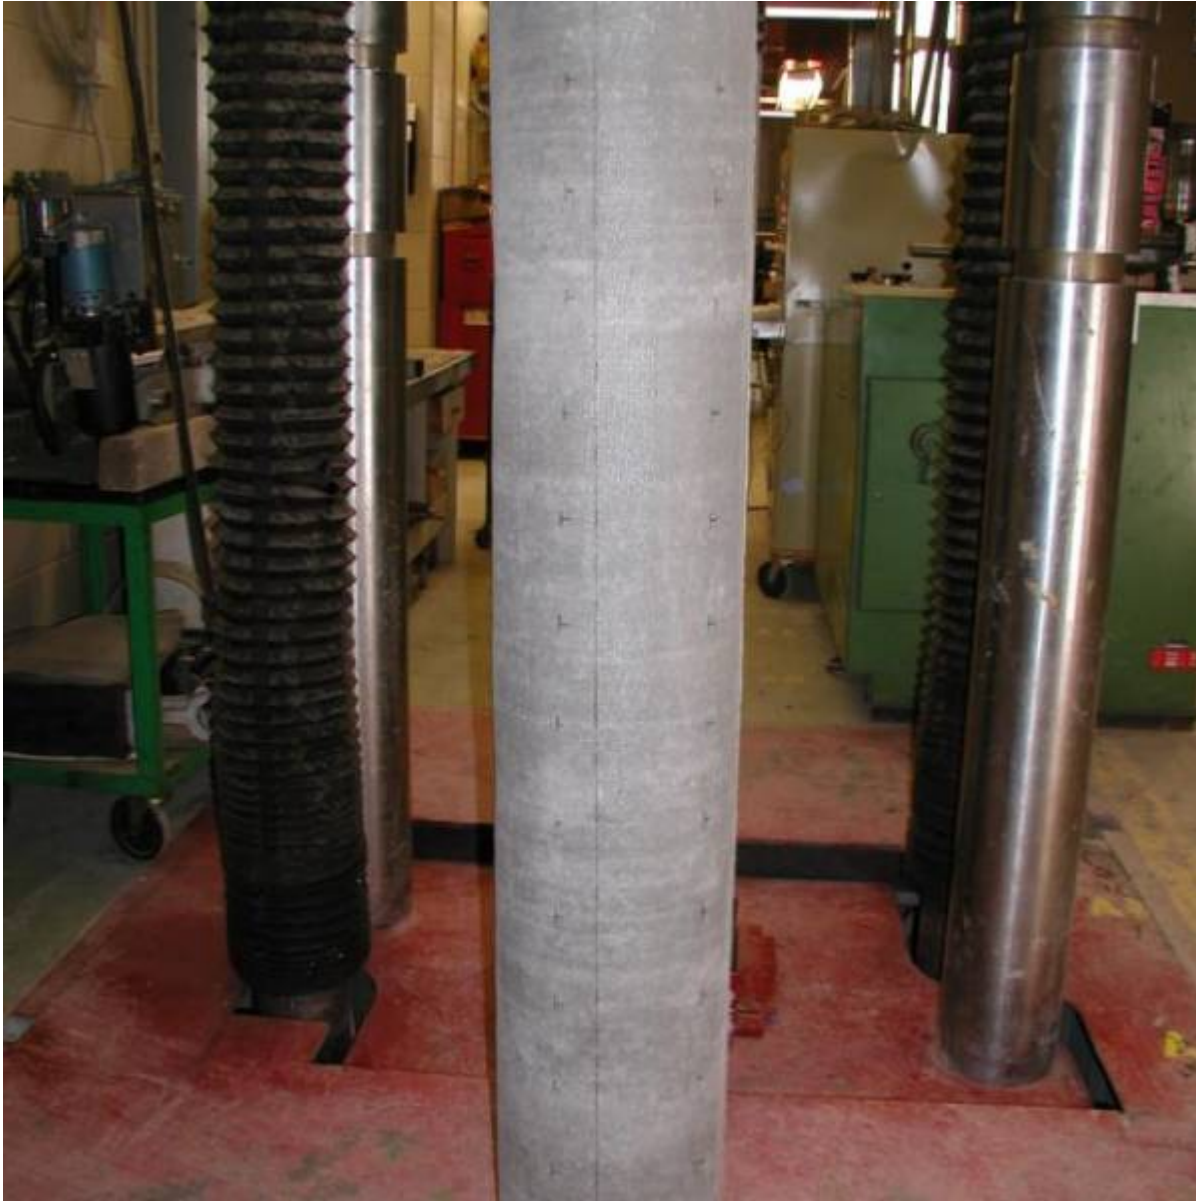
Figure 68: Modified fabric formwork resulting in a straight column.

from each other (though less staples would be probably also sufficient), providing a stitch line from top to bottom of the formwork. Orientation of the stitch line can be seen in Figure 43. Stapling provided an even distribution of the hoop forces along the height of the formwork and resulted in a uniform cylindrical geometry. The variation in diameter of the column along its length was dramatically reduced as demonstrated in Figure 68.
