Column Tests

In order to evaluate the effect of fabric formwork on structural behaviour of a column, full size fabric-formed and conventionally formed reinforced concrete columns were de-signed and tested to failure under concentric axial load. The variables in these tests were two types of formwork; permeable fabric versus cardboard and two types of concrete; Flyash concrete and normal concrete. The fabric of choice was Geotex 315ST due to its better surface finish.

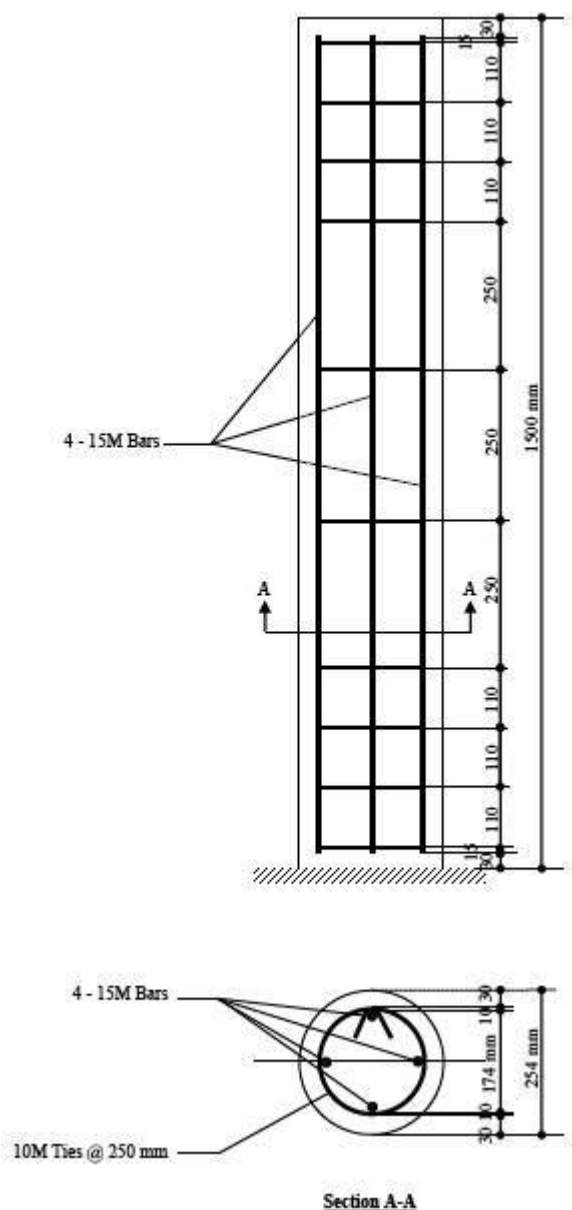
All columns had 254 mm radius and the column height was limited to 1500 mm. Based on calculations, four 15M bars were considered as the longitudinal bars, tie size was se-lected as 10M and tie spacing(s) was calculated as 250 mm (center to centre) and tie hooks, were set as 135 degrees. Arrangement and configuration of the reinforcement in the column has been shown in Figure 42.

Figure 42: Column reinforcement details.

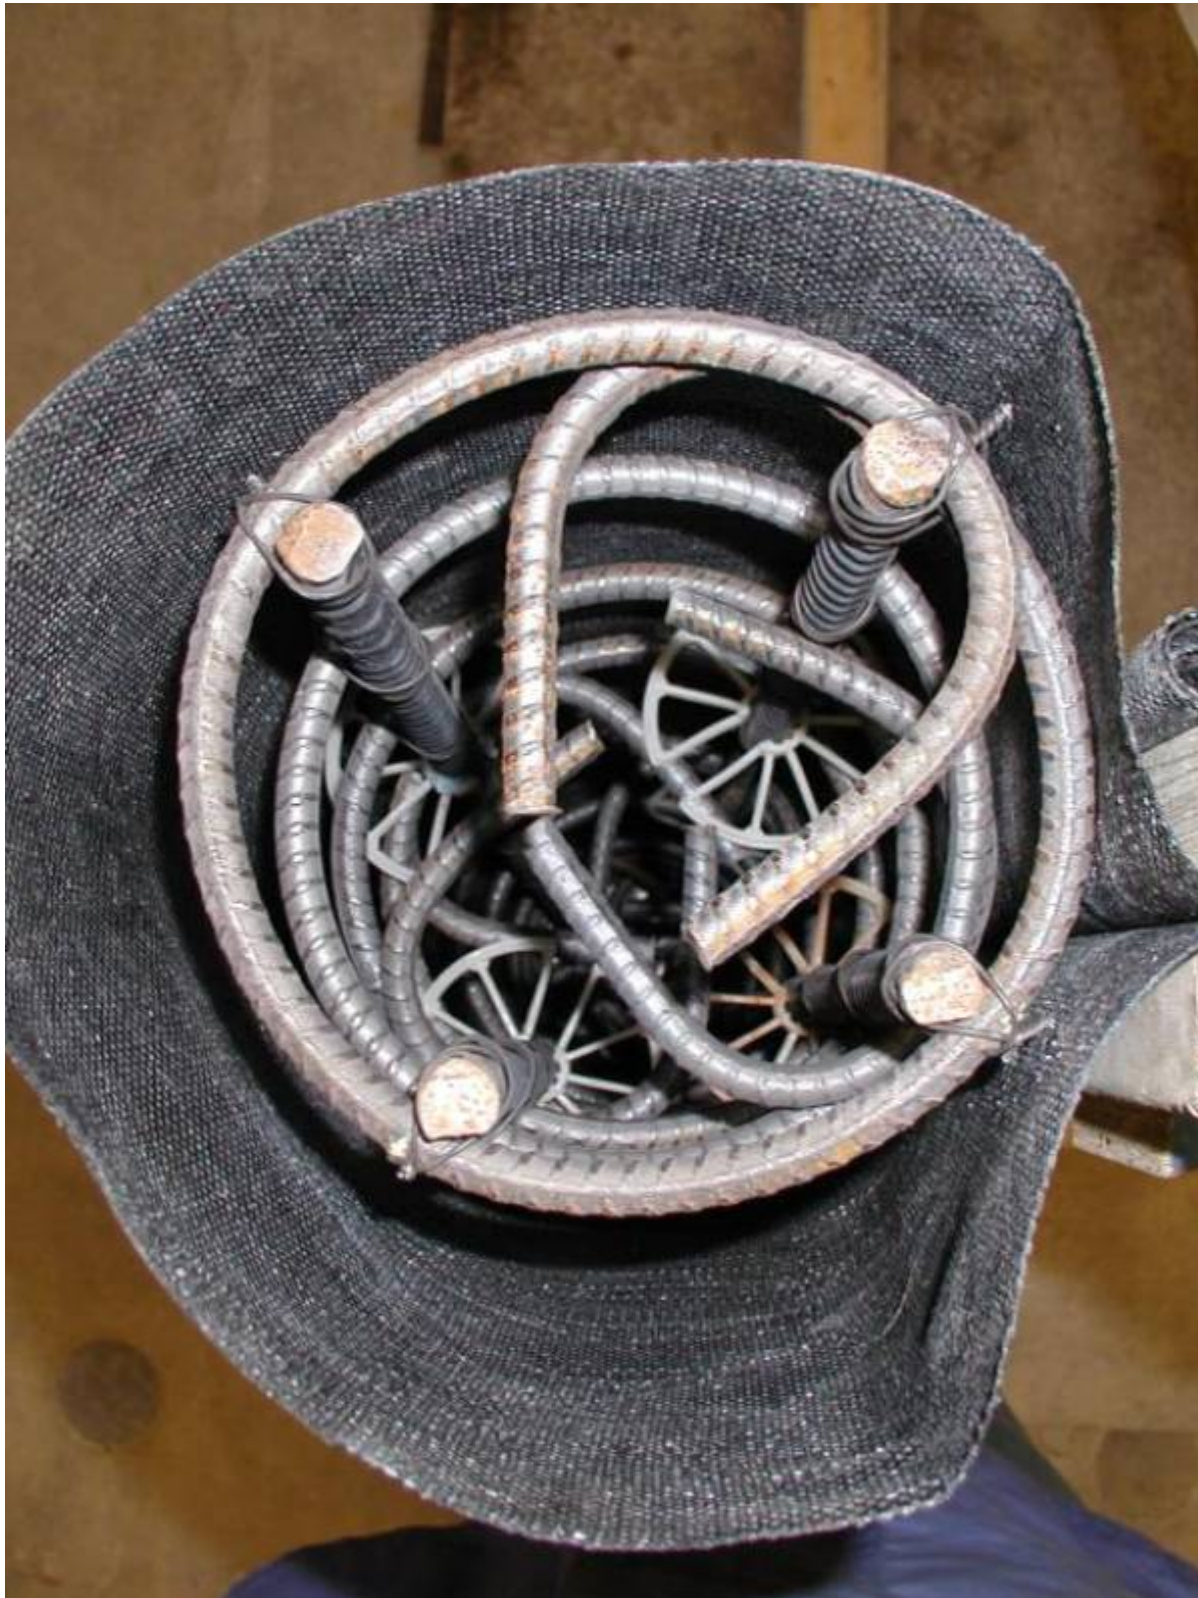
«fs medium>The cover distance between both fabric and cardboard formworks was maintained by using plastic wheel spacers on the longitudinal bars. These spacers were also used to keep the reinforcement cage in the centre of the formwork during casting as shown in Figure 46.</fs>

Figure 46: Reinforcement cage.

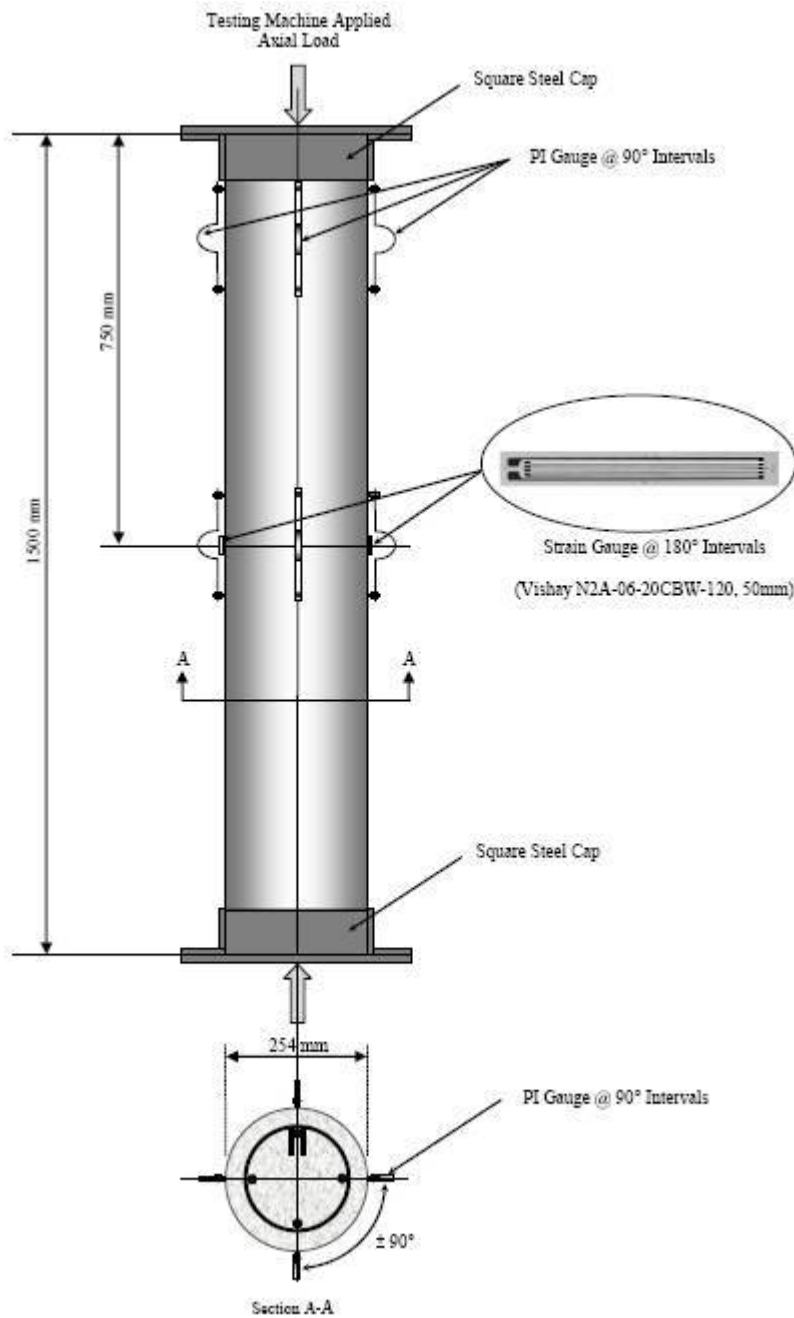
Cured, ready-to-test columns were instrumented at mid-height and top end to measure the longitudinal and circumferential strains under the axial load. To measure circumferential strains, two strain gauges

were installed on mid-height of each column, 750 mm from the top end with a 180 degree interval. The concrete surface was first scrubbed with a grinder before the installation of the strain gauges. Voids were then filled with epoxy. After about one hour, extra epoxy was removed by sanding the surface down. Strain gauges were then attached to the smooth void-free concrete surface using adhesive. Strain gauges were tested for correct resistance after installation using a volt meter. Wires were soldered to the strain gauges and then covered with a protective film of acrylic coating to protect them from possible damage before testing. Except the first two columns (FF-NC-1 and CT-NC-1) which had pi-gauges only on mid-height, a total of eight pi-gauges were in-stalled on each column. Four pi-gauges were placed on mid-height and four at the top end of each column to measure the displacement over the initial 200 mm length of the pi-gauges as shown in Figure 48. A Data Acquisition System (DAQ) was used to record the information gathered from 11 channels coming from the column instrumentations and testing machine (8 channels for the pi-gauges, 2 channels for the strain gauges and one channel for the load applied to the columns by the machine). Strain and pi-gauges were all tested for proper resistance and calibration just before every test session.

Figure 48: Configuration of the instrumentation of the concrete columns.

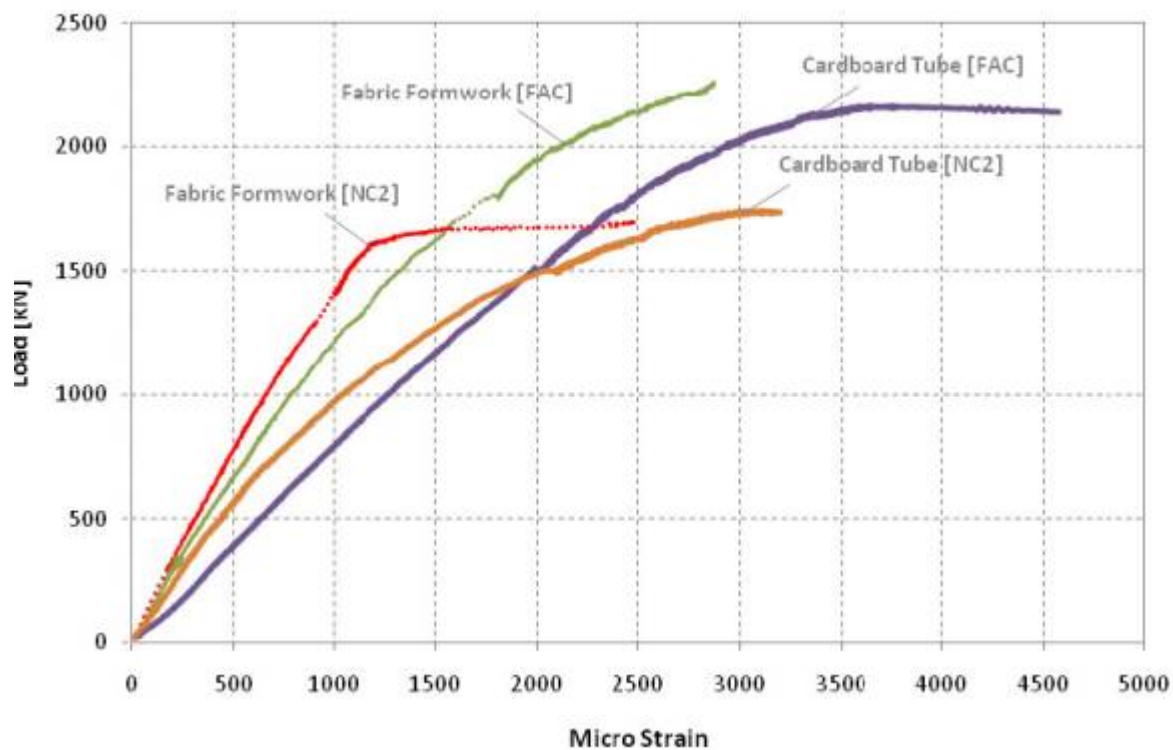
As seen in Table 8, the first two columns (FF-NC-1 and CT-NC-1), normal concrete columns formed with fabric and cardboard, withstood 1850 kN and 2200 kN of axial load, respectively. Maximum axial load of flyash specimen (FF-FAC and CT-FAC) was 2271 kN for fabric formed column and 2165 kN for cardboard formed column. As shown in Figure 55, for the last two columns (FF-NC-2 and CT-NC-2), normal concrete columns formed with fabric and cardboard carried 1703 kN and 1744 kN of axial load, respectively.

The first normal concrete fabric formed column (FF-NC-1) became bulgy and uneven due to improperly installed fabric. This made it more challenging to centre the sample in testing machine. This fabric formed column failed at 1850 kN that is 15.9% lower compared to the companion cardboard formed column CT-NC-1. For this reason, another set of two columns were cast using normal concrete (FF-NC-2 and CT-NC-2). The maximum strain values plotted in Figure 55 are provided in Table 9 for all the columns tested. Regardless of the location of the pi-gauges, these strain values are the highest recorded values in the concrete at the time of failure of the column.

Figure 55: Maximum axial load of fabric-formed versus cardboard-formed steel...

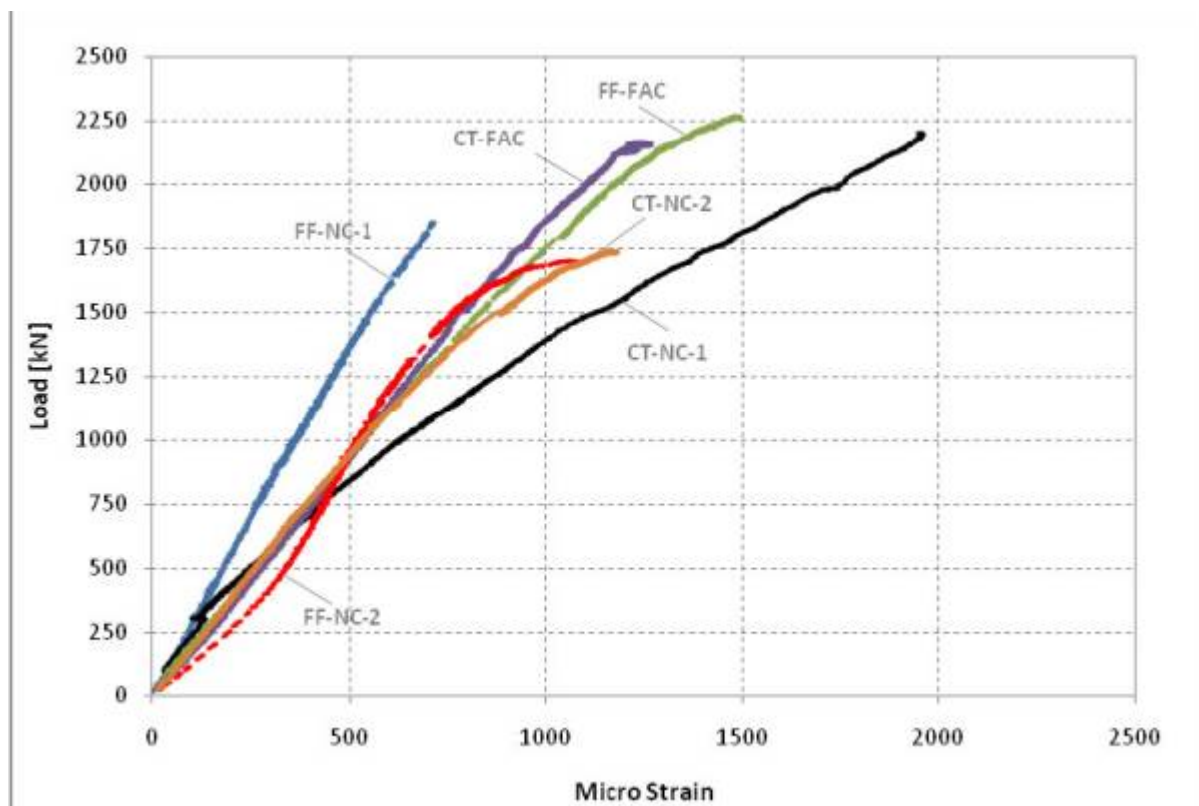
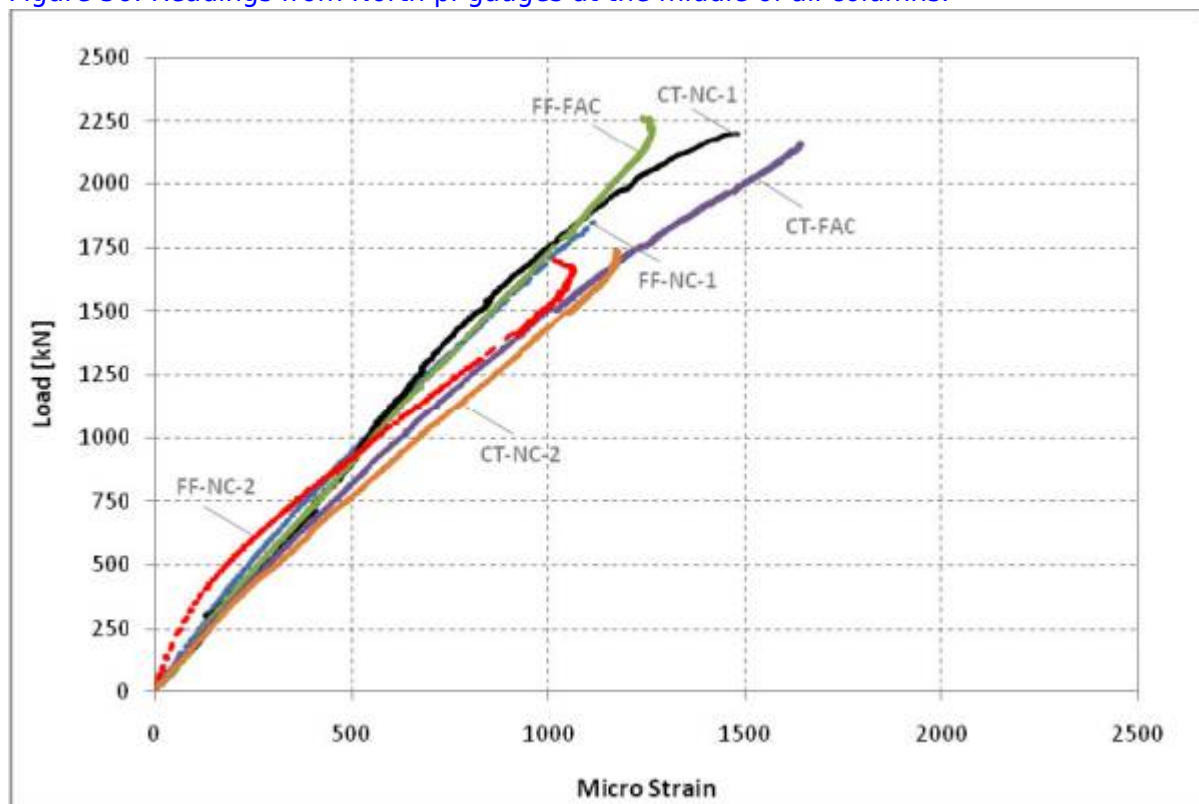
Figure 56 to 59 depict the strains in the middle, while Figures 60 to 63 depict the strains at the top of the column. Each figure represents one location either North, South, East or West and strains of that location in each column were plotted in the same graph for comparison.

Figure 56: Readings from North pi-gauges at the middle of all columns.

Figure 57: Readings from South pi-gauges at the middle of all columns.

Figure 58: Readings from East pi-gauges at the middle of all columns.

Figure 59: Readings from West pi-gauges at the middle of all columns.

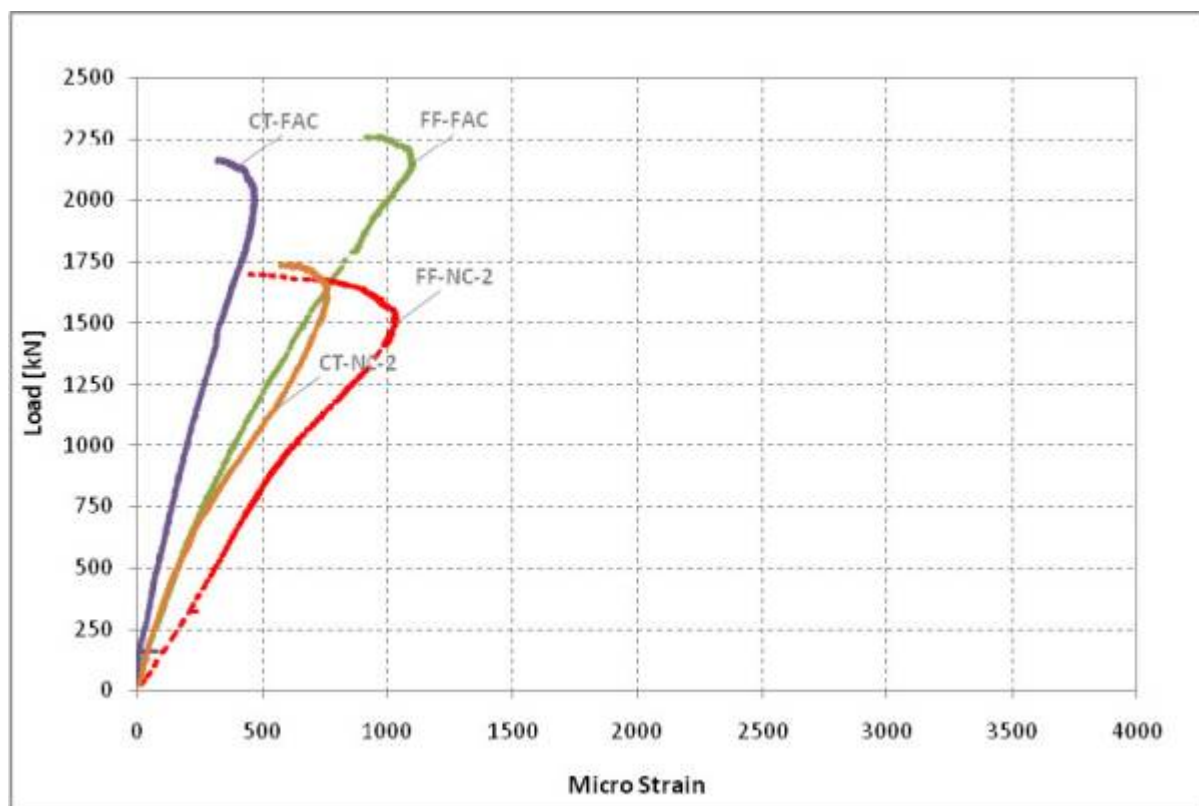
Figure 60: Readings from North pi-gauges at the top of all columns.

As seen in Figure 60 which represents the readings from North pi-gauges at the top of all columns, a trend of reverse strain close to the failure load is observed. This means that as columns were starting to crush at another location, the surrounding concrete was experiencing some tension. Figure 61 represents readings from South pi-gauges at the top of all columns. As seen in this figure, columns undergo much

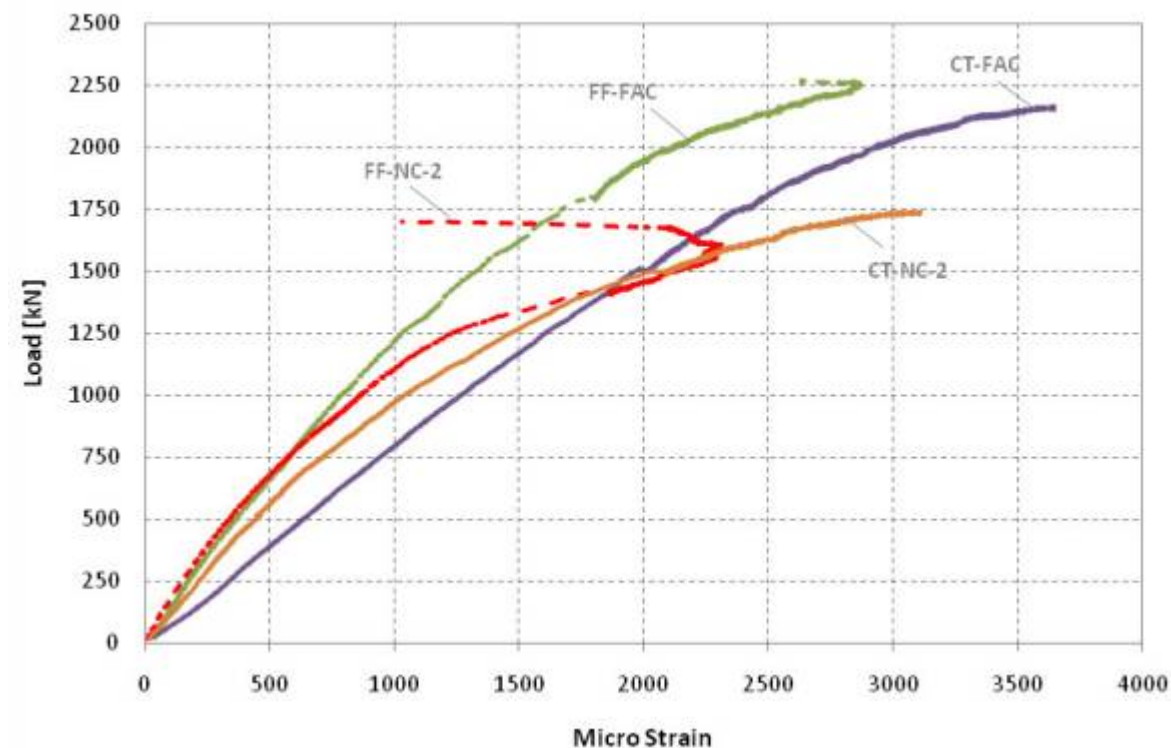
Figure 61: Readings from South pi-gauges at the top of all columns.

larger strain values as high as 3600 micro strain at the load of about 2150 kN in case of column CT-FAC. Strain values read from the south pi-gauge of column FF-NC-2 change direction from compression to tension close to the failure load. This has been caused by the uneven failure of the column at top. As seen in Figure 64, the opposite side of the column across from the south pi-gauge has failed in compression and caused some tension in south-top-zone of the column. Figure 62 which represents the readings from West pi-gauges at the top of all columns shows the highest strain in column CT-NC-2 as 3000 micro strain at the corresponding load of 1750 kN. A similar trend is observed in Figure 63 from the values taken from top-East pi-gauges. Column FF-FAC carries 2700 micro strain at the load of 2250 kN. As seen in all top pi-gauge curves, except column CT-NC-2, regardless of the form-work type, flyash concrete experienced more strain than normal concrete. As seen in Figure 65, all six columns failed at the top. This type of failure in columns has been documented before in research conducted by Bazant and Kwon [2] which found that regardless of the cross sectional size of the column, the fracture mechanism stayed the same. The reason for the top end failure is that the top end of a vertically cast member will always have less compressive strength than the lower parts of the member, due to increased pressure and compaction towards the bottom of the mold [3]. This holds true regardless of the formwork used.

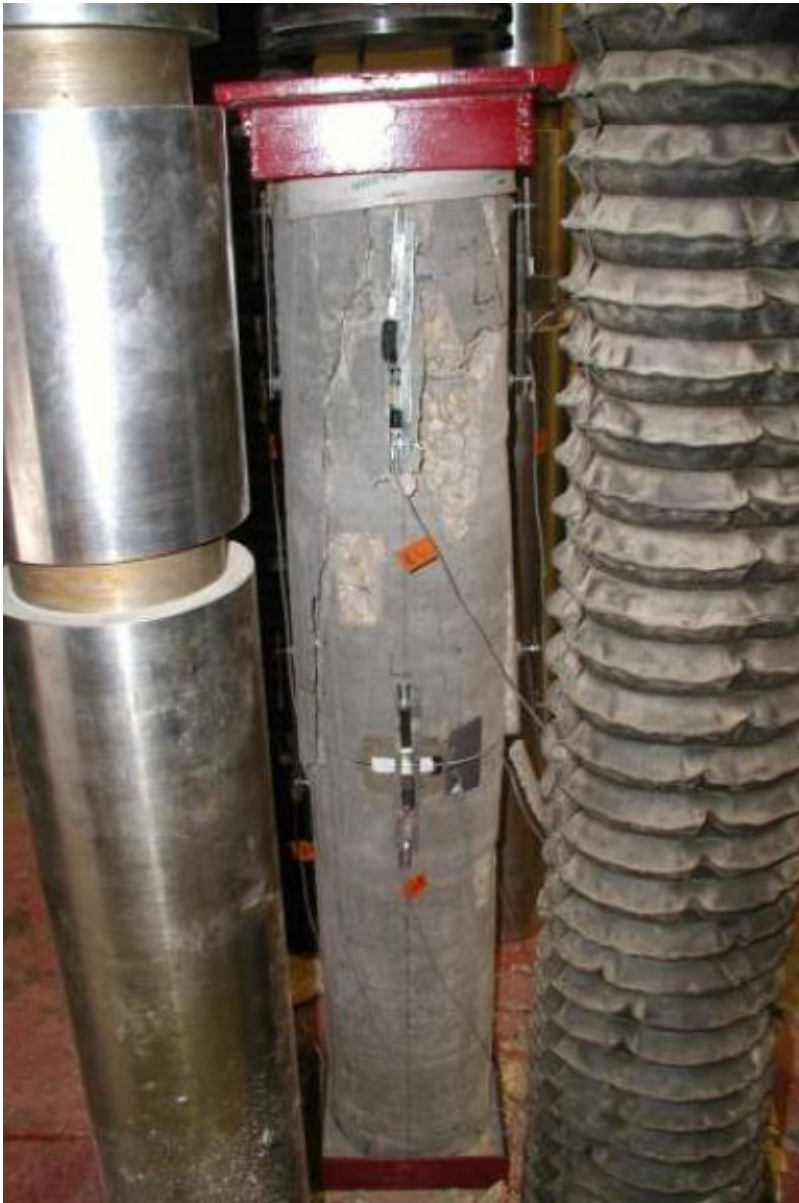
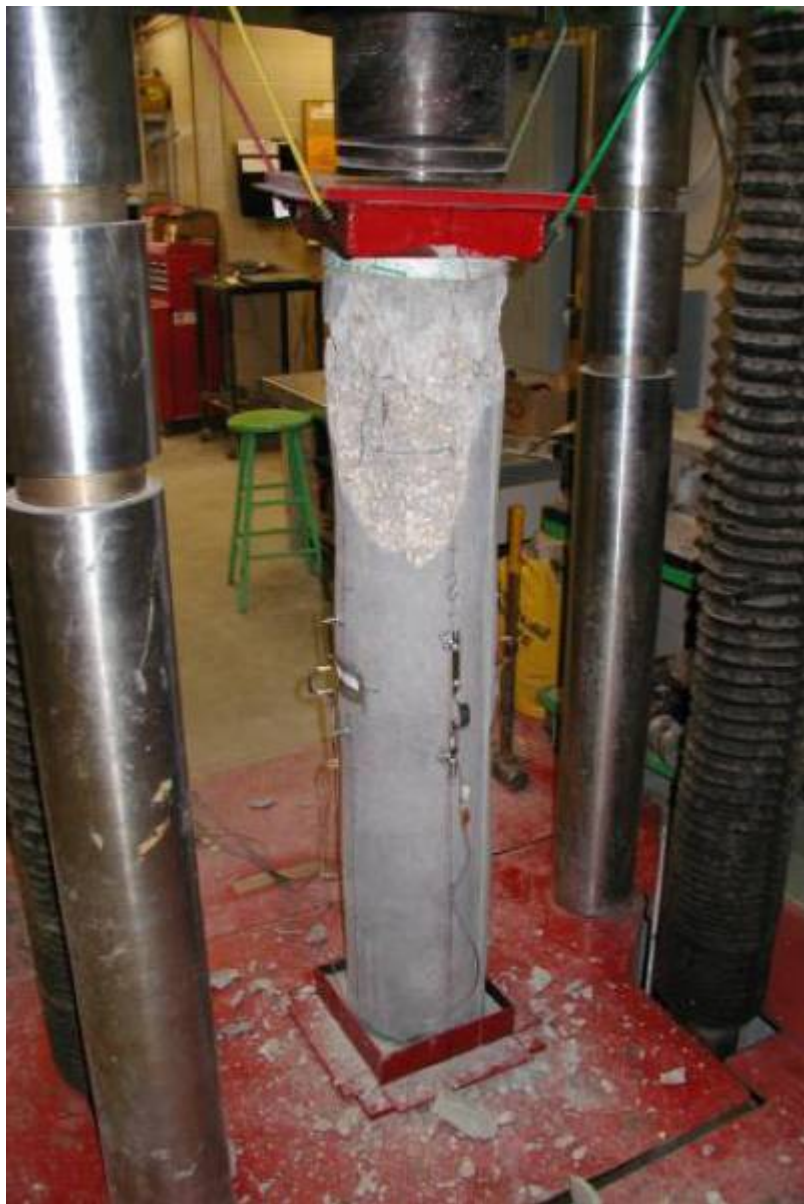
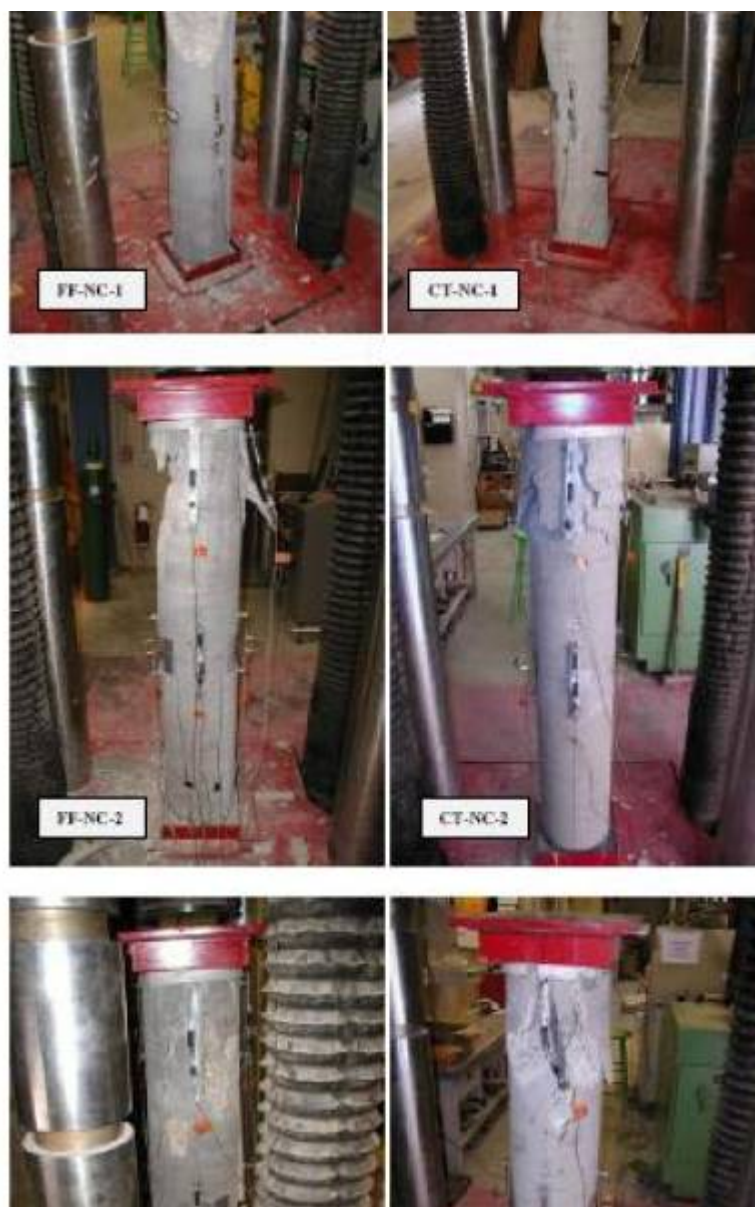
In order to be able to better observe behaviour and the failure pattern of the columns, all tests were videotaped. The failure pattern of the columns was a factor to be investigated in this phase of the study. Based on observations of the two cardboard and two fabric-formed column tested, the failure of the cardboard formed column started with crushing on top and then spalling till failure. Cardboard-formed columns presented a typical gradual failure with no sign of brittleness, no longitudinal cracks and no flaking. On the other hand, fabric-formed columns started with crushing on top and development of longitudinal cracks at the same time along with spalling. Also, some flaking and relative sudden failure of

outside surface was observed. Photographs of these column failures are shown in Figure 65 (page 82).

Figure 65: All columns after failure.

Flaking and surface concrete delamination observed in the failure of both fabric-formed columns also confirms that the surface of the concrete cast in fabric formwork was more brittle than concrete cast in conventional formwork. The change in Poisson's ratio was also studied when these columns were tested. The value was derived from dividing the average value of the data from two circumferential strain gauges placed at 180° apart from one another, by their corresponding axial pi-gauges. Both flyash and normal concrete fabric formed columns, proved to have lower Poisson's ratio value which is another indication of brittleness and less surface deformation in the fabric-formed specimens. It is necessary to mention that it is nearly impossible to form a perfectly straight column using handmade fabric column formwork, so very small values of eccentricity in loading condition may occur. Since small values of the eccentricity do not create large moment values at end portion of the columns, the effects of small eccentricities can be neglected [2].

In each concrete type, both fabric-formed columns withstood the same axial load level as the cardboard formwork control samples. All samples failed at the top portion. At the extreme top portion of a concrete column, a permeable fabric mold does not loose appreciably more water than a conventional formwork or a cardboard tube. Therefore, in columns cast with the similar type of concrete, regardless of formwork material, strength of the concrete at top zone always remains the same and constitutes the area of weakest concrete in each column.

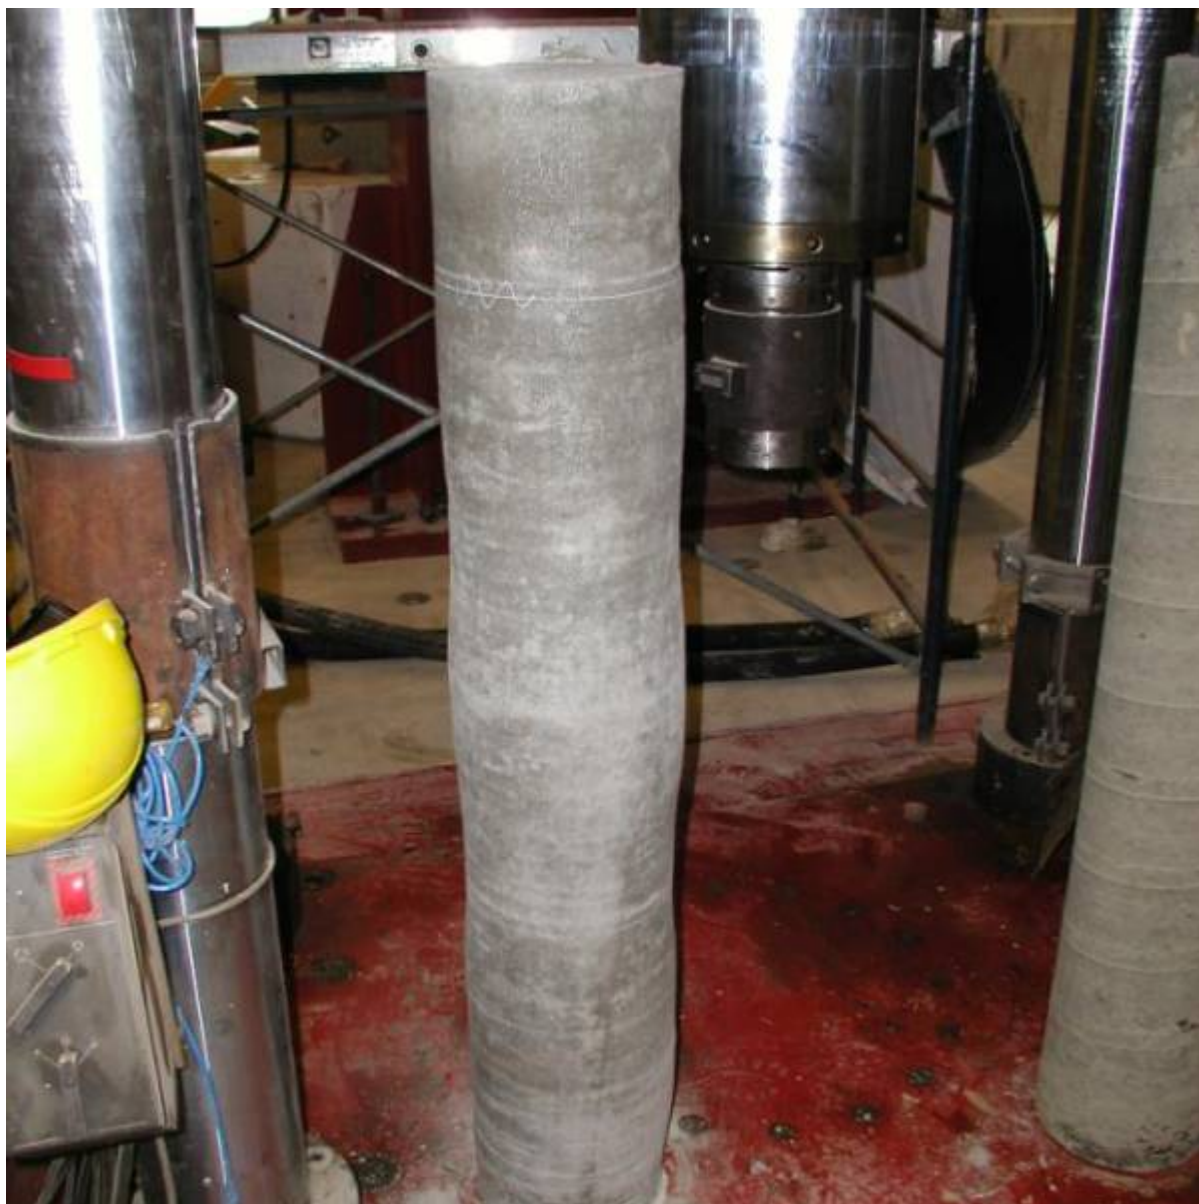
Our first attempt of casting a concrete column using fabric formwork was not quite successful. The column was bulgy at some points and it did not have constant diameter along its length while cardboard molds that are industrially manufactured are perfectly symmetrical tubes and form perfectly symmetrical columns. The reason for this problem was that the fabric was sandwiched between the boards using bolts and when the concrete was poured inside the mold, the hoop tension created by the liquid concrete pulled the fabric out between the bolts (Figure 66). Areas supported by bolts resisted the pressure while parts away from bolts deformed creating bulges along the length of the hardened concrete column, as shown in Figure 67.

Figure 67: Bulged concrete column.
