# Strength Tests

## Casting and Testing Concrete Cylinders with Fabric Formwork

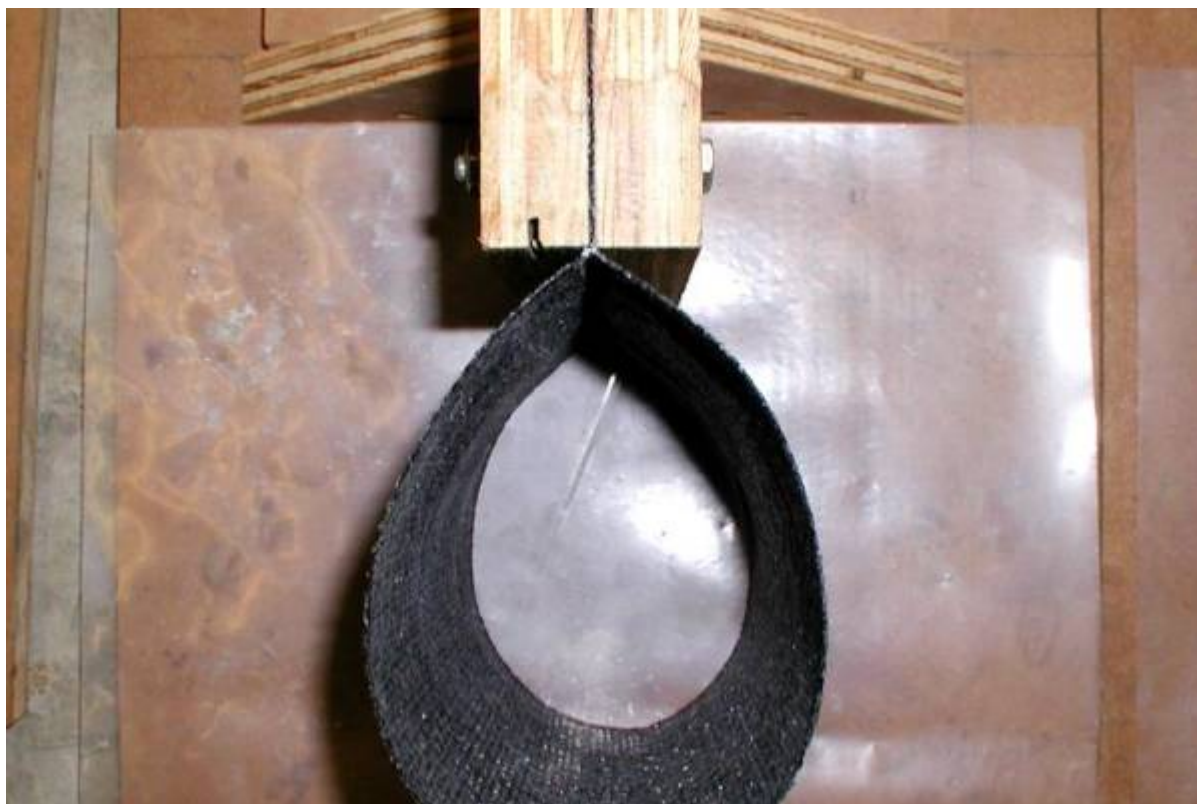
Figure 33: Fabric formwork shown from above.

Both fabric-formed and PVC formed control cylinders were cast in a vertical position (Figure 33) and compacted using the standard placement and vibration procedures [1]. The bottom of each fabric formed cylinder was protected by a plastic sheet in order to prevent water absorption from the wood base, simulating the same condition as in the PVC molds (Figure 34). All PVC and fabric-formed specimens were cast using the same batch of fresh concrete made on premises. The same mix designs were adopted as in earlier tests [Table 2 and Table 3], (Chapter 2, Table 1 and Table 4). Aggregates were washed thoroughly and precise scaling was employed when weighing the aggregates. A 100 litre pan concrete mixer was used to mix the fresh concrete.

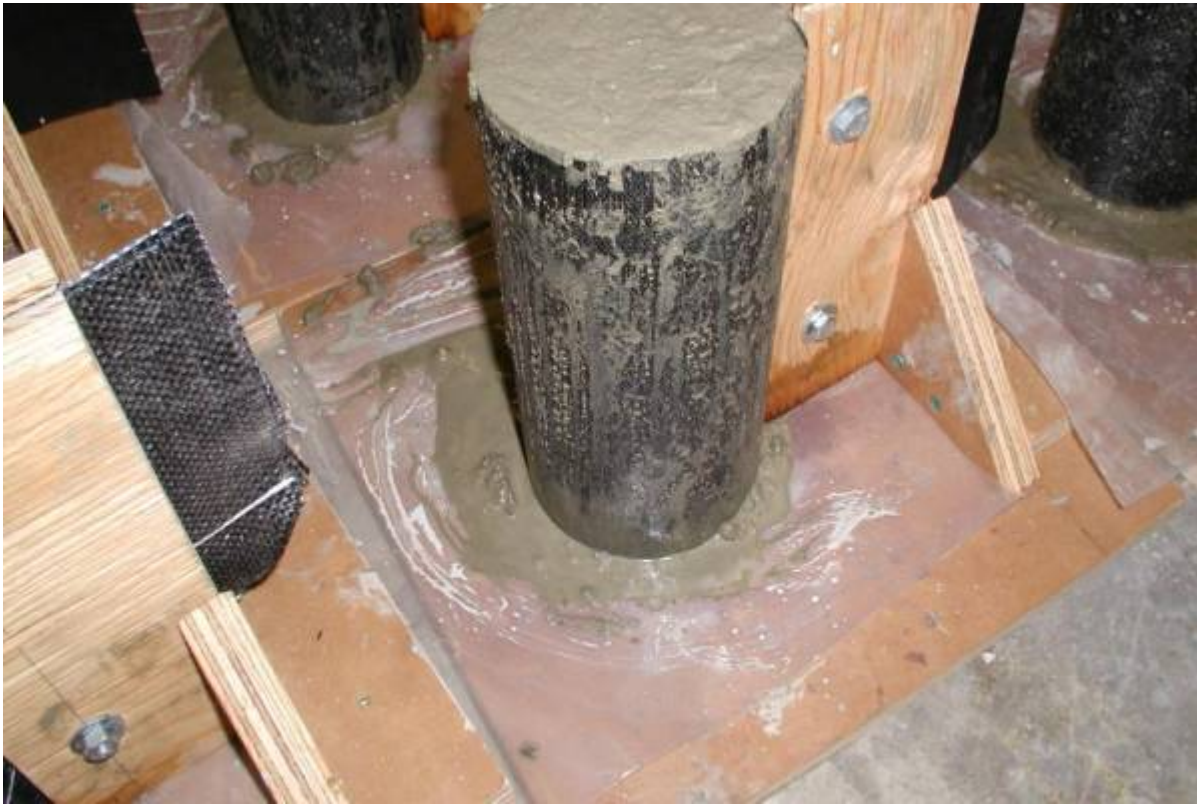
Figure 34: Fabric-formed concrete cylinders.

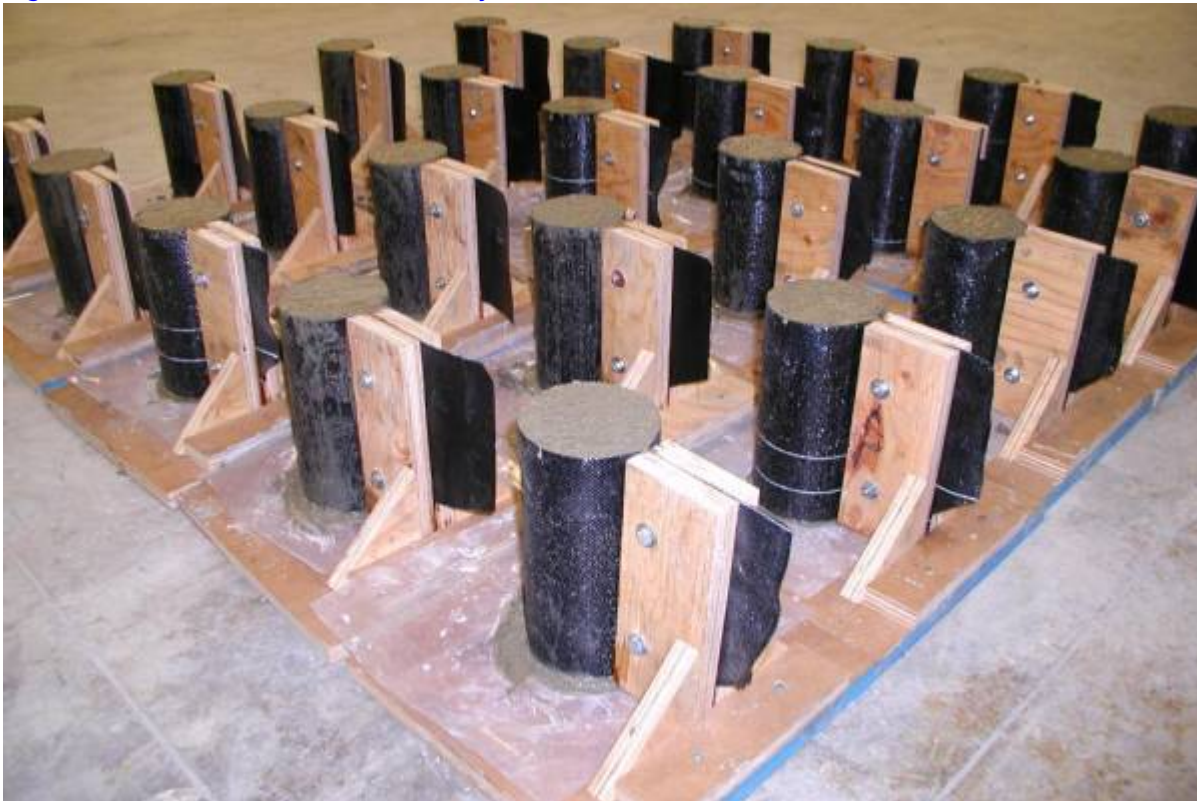
Figure 35: Fabric-formed cylinders after casting.

When the concrete was ready it was brought to the molds by wheel barrow for casting. Cylinders right after casting are shown in Figure 35. When casting the normal concrete, ambient temperature of the laboratory was recorded as 22 degree Celsius and the slump of the fresh concrete measured as 90 mm. For the flyash concrete, the temperature was recorded as 24 degree Celsius and the slump value was measured as 85 mm.

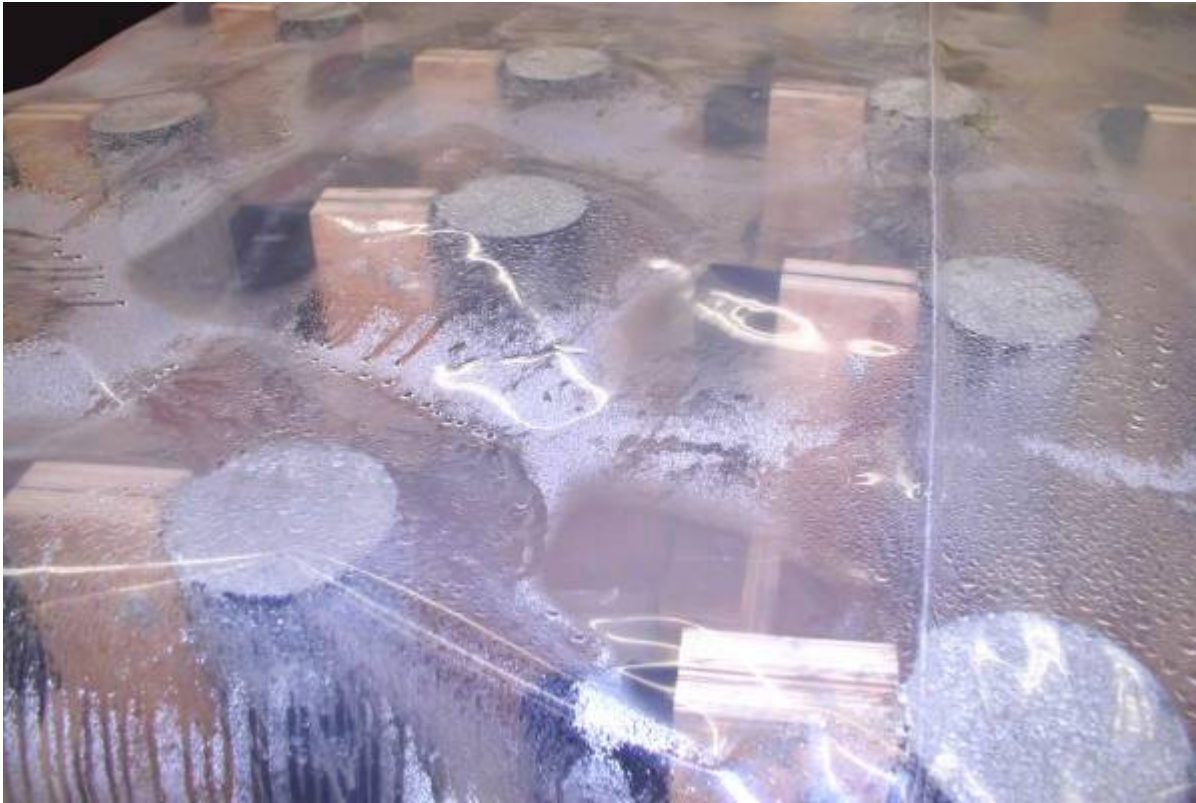
Figure 36: Cylinders curing.

Two hours after casting, all specimens were covered with plastic sheets (Figure 36) and left in place for 24 hours. Sandwich boards, bolts and fabric forms were carefully taken off the fabric formed specimens after the first day. PVC cast hardened concrete cylinders were removed from the PVC molds after one day using air pressure. All specimens were then transferred to a curing room in order to maintain uniform curing conditions before testing. The temperature of the curing room was recorded as 20 degree Celsius and relative humidity as 100 percent.

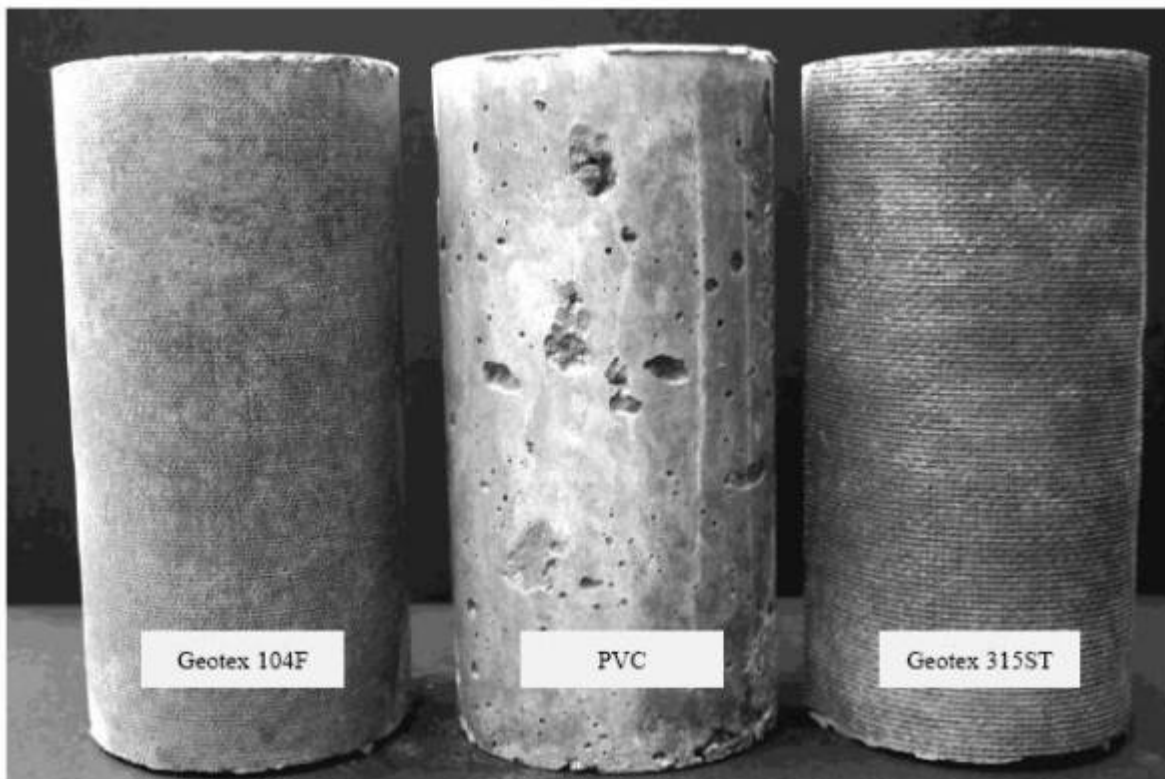
Figure 37: The effect of mold on quality of quality of concrete finish.

When visually inspected, the surface of the specimens formed with fabric had a finely textured surface imprint. Unlike PVC formed samples, no large aggregate or bug holes were visible on the concrete

surface. Figure 37 shows three cylinders cast from left to right, Geotex 104F, PVC and Geotex 315ST.

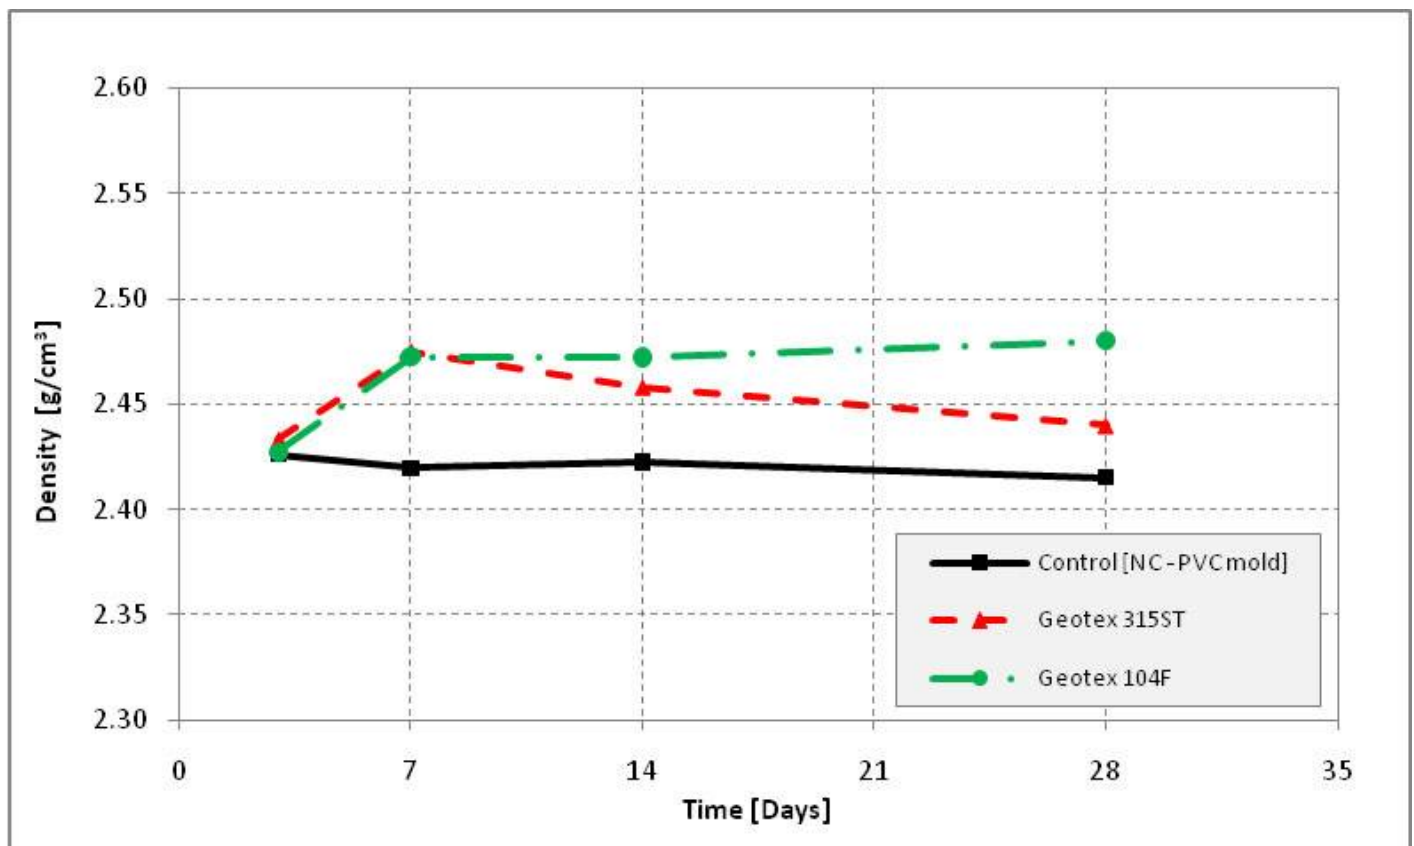
Figure 38: Average density of normal concrete cylinders.

Samples were tested at 3, 7, 14 and 28 days using a compression testing machine at the University of Manitoba structures laboratory. Strength gains of fabric formed cylinders were compared to PVC formed cylinders. The densities of all cylinders were determined before testing in order to study the relationship between type of mold and the effect on density and strength of the hardened concrete. As seen in Figure 38 and Figure 39, regardless of type of concrete, fabric formed cylinders gained higher densities. When normal concrete was used, Geotex 104F gained higher density while Geotex 315ST shows higher density when flyash concrete is used. Compared to PVC-formed companion control samples, fabric-formed concrete cylinders showed an average of 2 percent higher overall density when normal concrete was used and 3.3 percent higher density when flyash concrete was used. This might be due to air and water loss through the porous mold wall. Studies suggest that increase in density of concrete can result in increase in compressive strength of concrete [2].

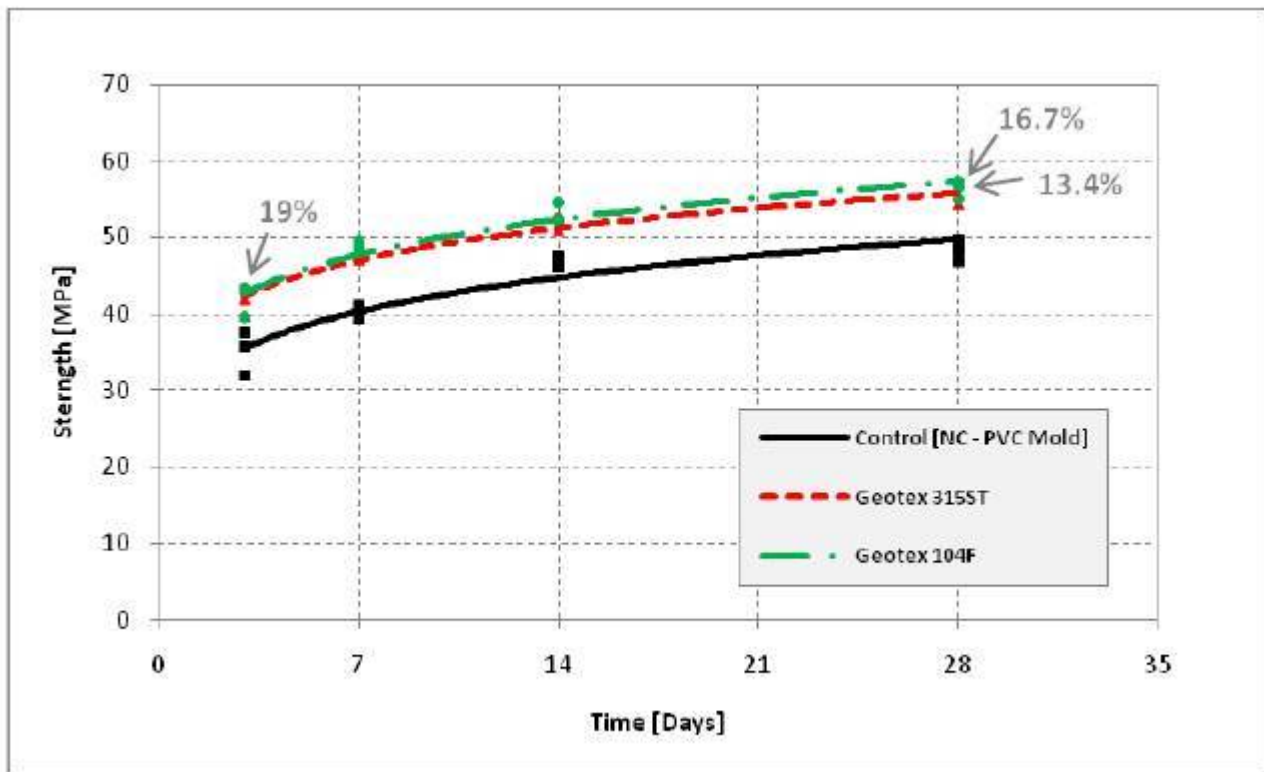
Figure 40: Strength gain of normal concrete.

Figures 40 and 41 show strength for normal and flyash concrete respectively. The fabric formed normal concrete had about 19% higher strength at three days for both fabrics compared to PVC mold. After 28 days, Geotex 315ST cast normal concrete gained 13.4% of strength, while Geotex 104F gained 16.7% of strength. This can be clearly seen in Figure 40.

In both normal and flyash concrete the difference between strength increase due to fabric formwork remained almost the same. Comparison of concrete strength gain between the two fabric used revealed only 3% difference. Considering the fact that the two fabrics that were chosen represented a wide range of pore sizes in available woven geotextiles, it can be suggested that within limits, the final strength of a fabric formed cylinder may not be dramatically affected by the type of fabric used.

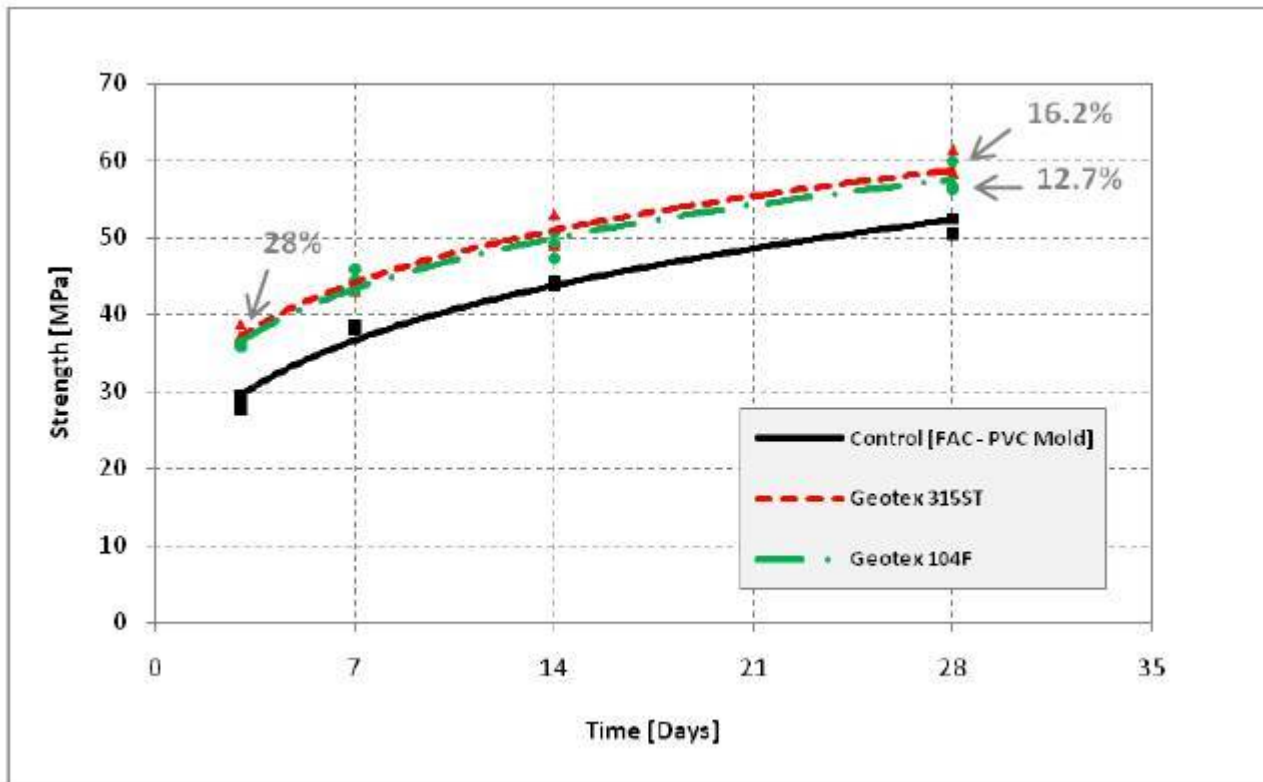
Figure 41: Strength gain of flyash concrete.

As seen in Figure 41, the fabric formed flyash concrete had a 28% higher strength at three days for both fabrics compared to PVC mold. After 28 days, samples formed with Geotex 315ST gained 16.2% extra strength compared to the control PVC samples, while Geotex 104F gained 12.7% of strength. Flyash samples gained higher overall strength compared to normal concrete.
