## Appendix C: Results from Rebound Tests (Schmidt Hammer Tests)

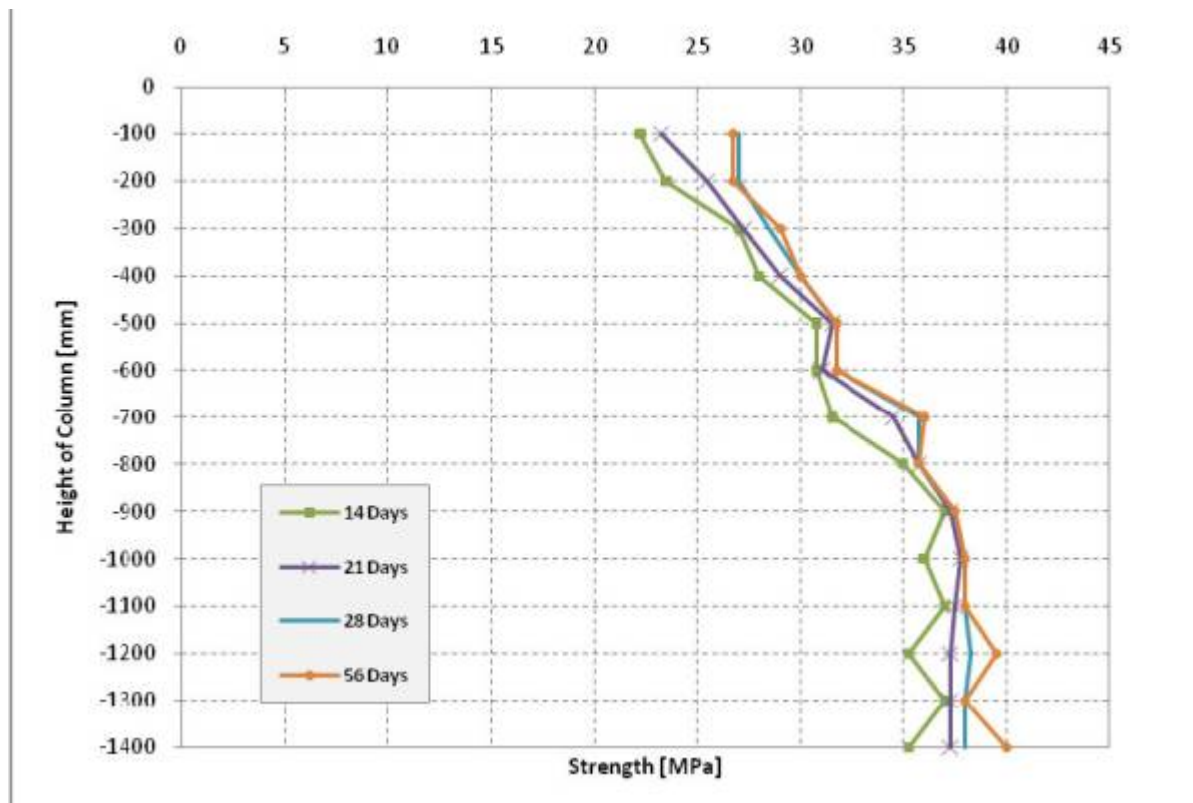
Figure C1: Column C1 – Fabric Formwork, Normal Concrete.

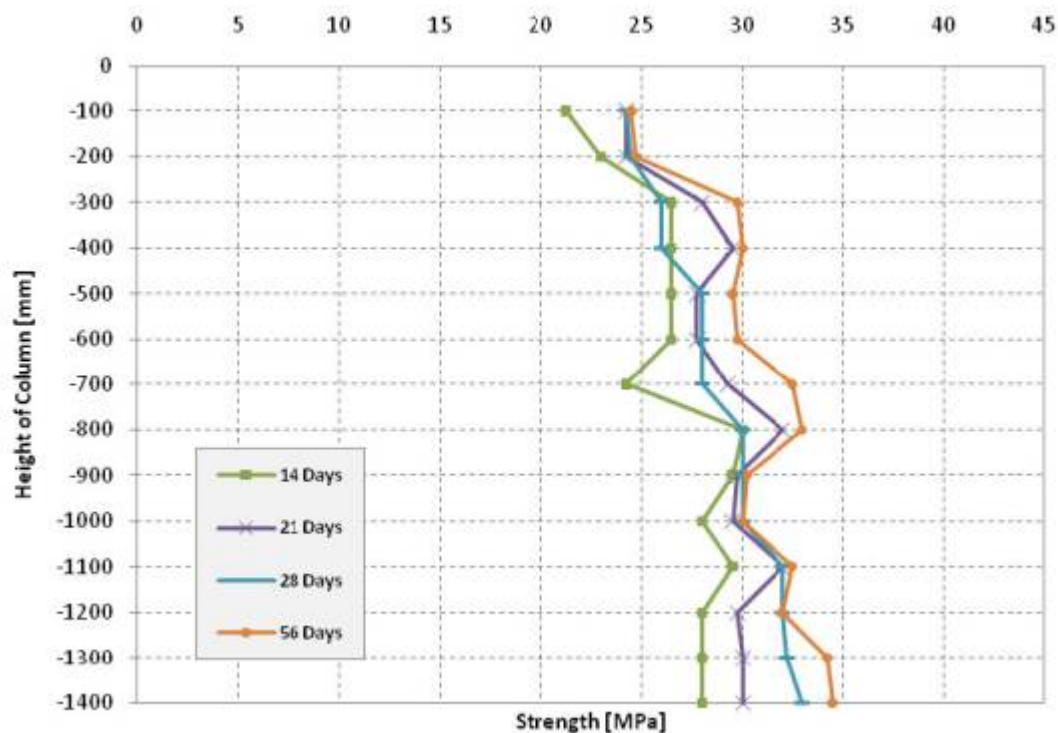
Figure C2: Column C2 - Cardboard Tube, Normal Concrete.

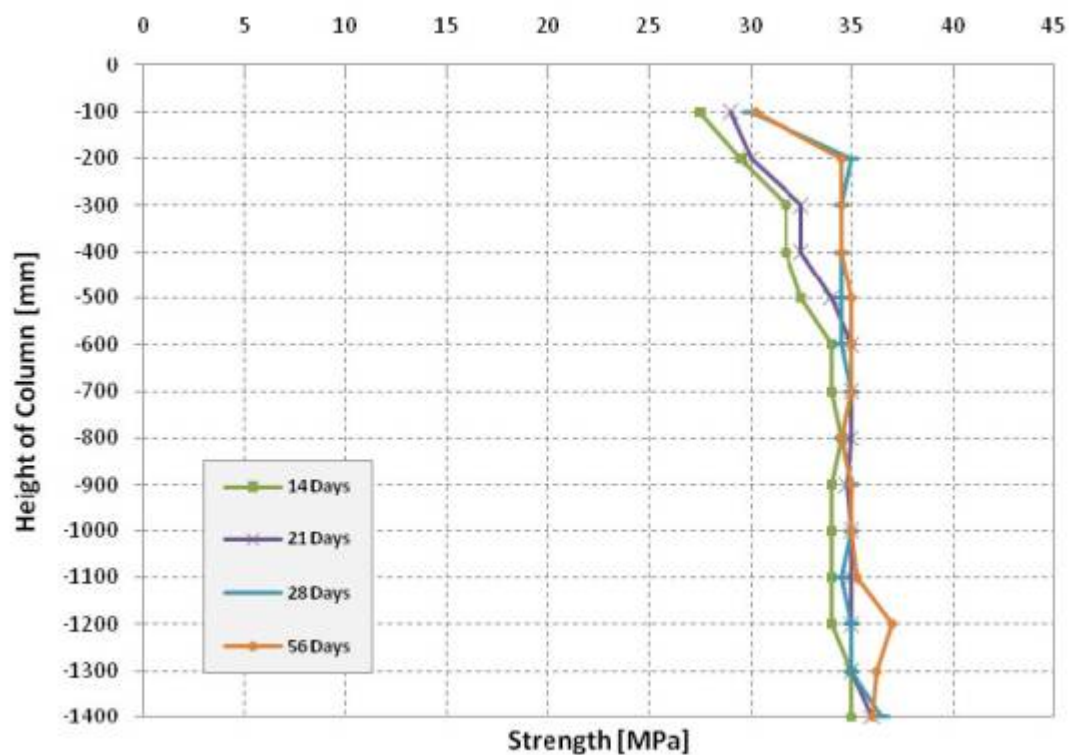
Figure C3: Column C3 - Fabric Formwork, Flyash Concrete.

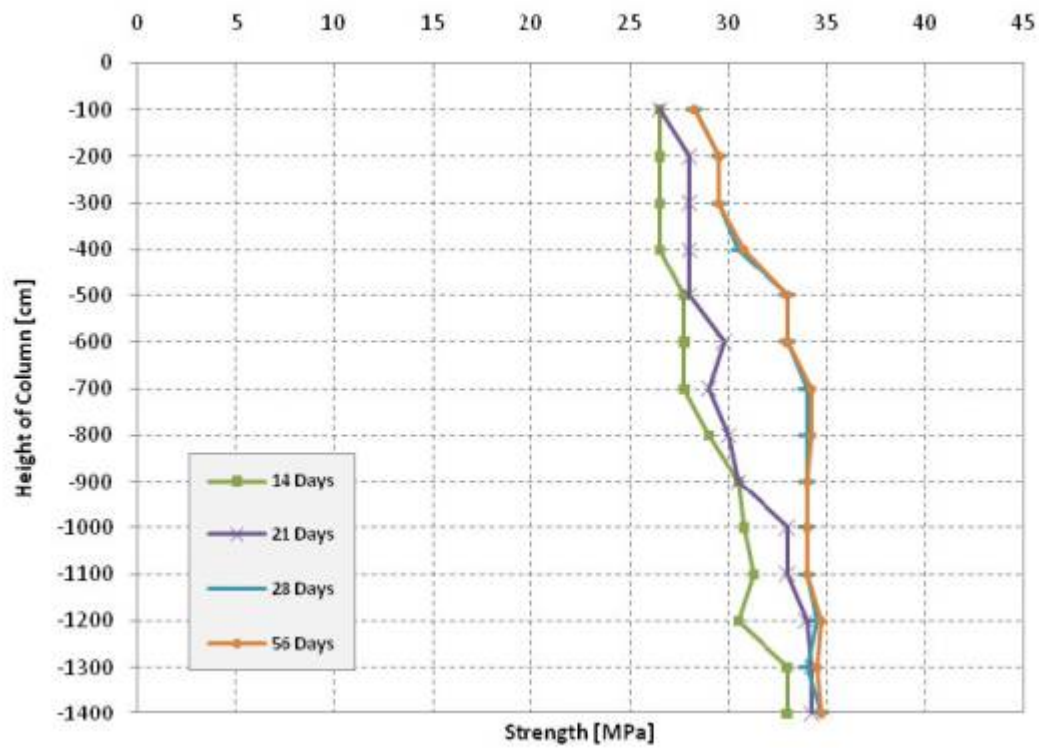
Figure C4: Column C4 – Cardboard Tube, Flyash Concrete.

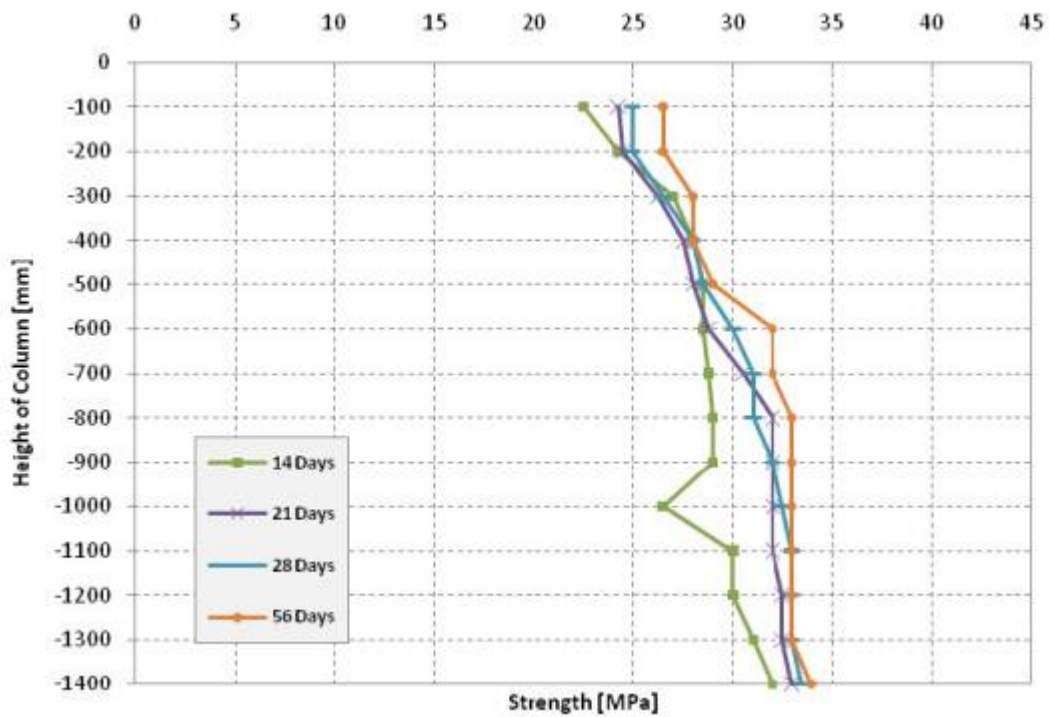
Figure C5: Column C5 – Fabric Formwork, Normal Concrete.

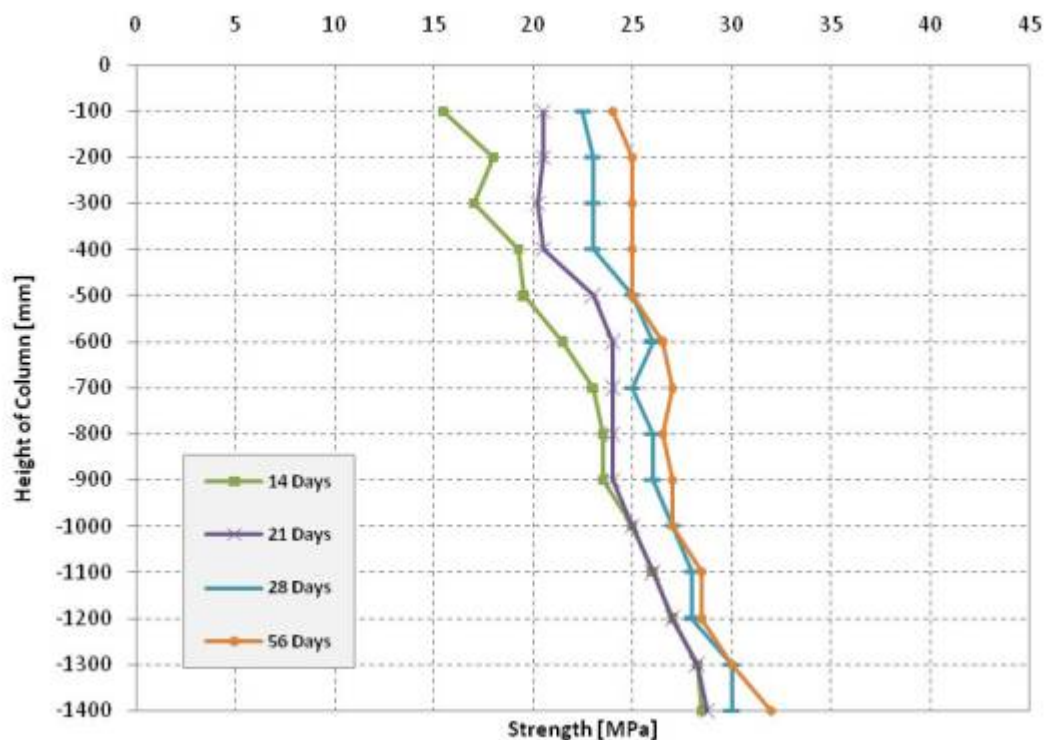
Figure C6: Column C6 – Cardboard Tube, Normal Concrete.
